Overrun

The crew applied reverse thrust too late.

at Midway

This article is based on NTSB Accident Report NTSB/AAR-07/06: “Runway Overrun and Collision; Southwest Airlines Flight 1248; Boeing 737-7H4, N471WN; Chicago Midway International Airport; Chicago, Illinois; December 8, 2005.”

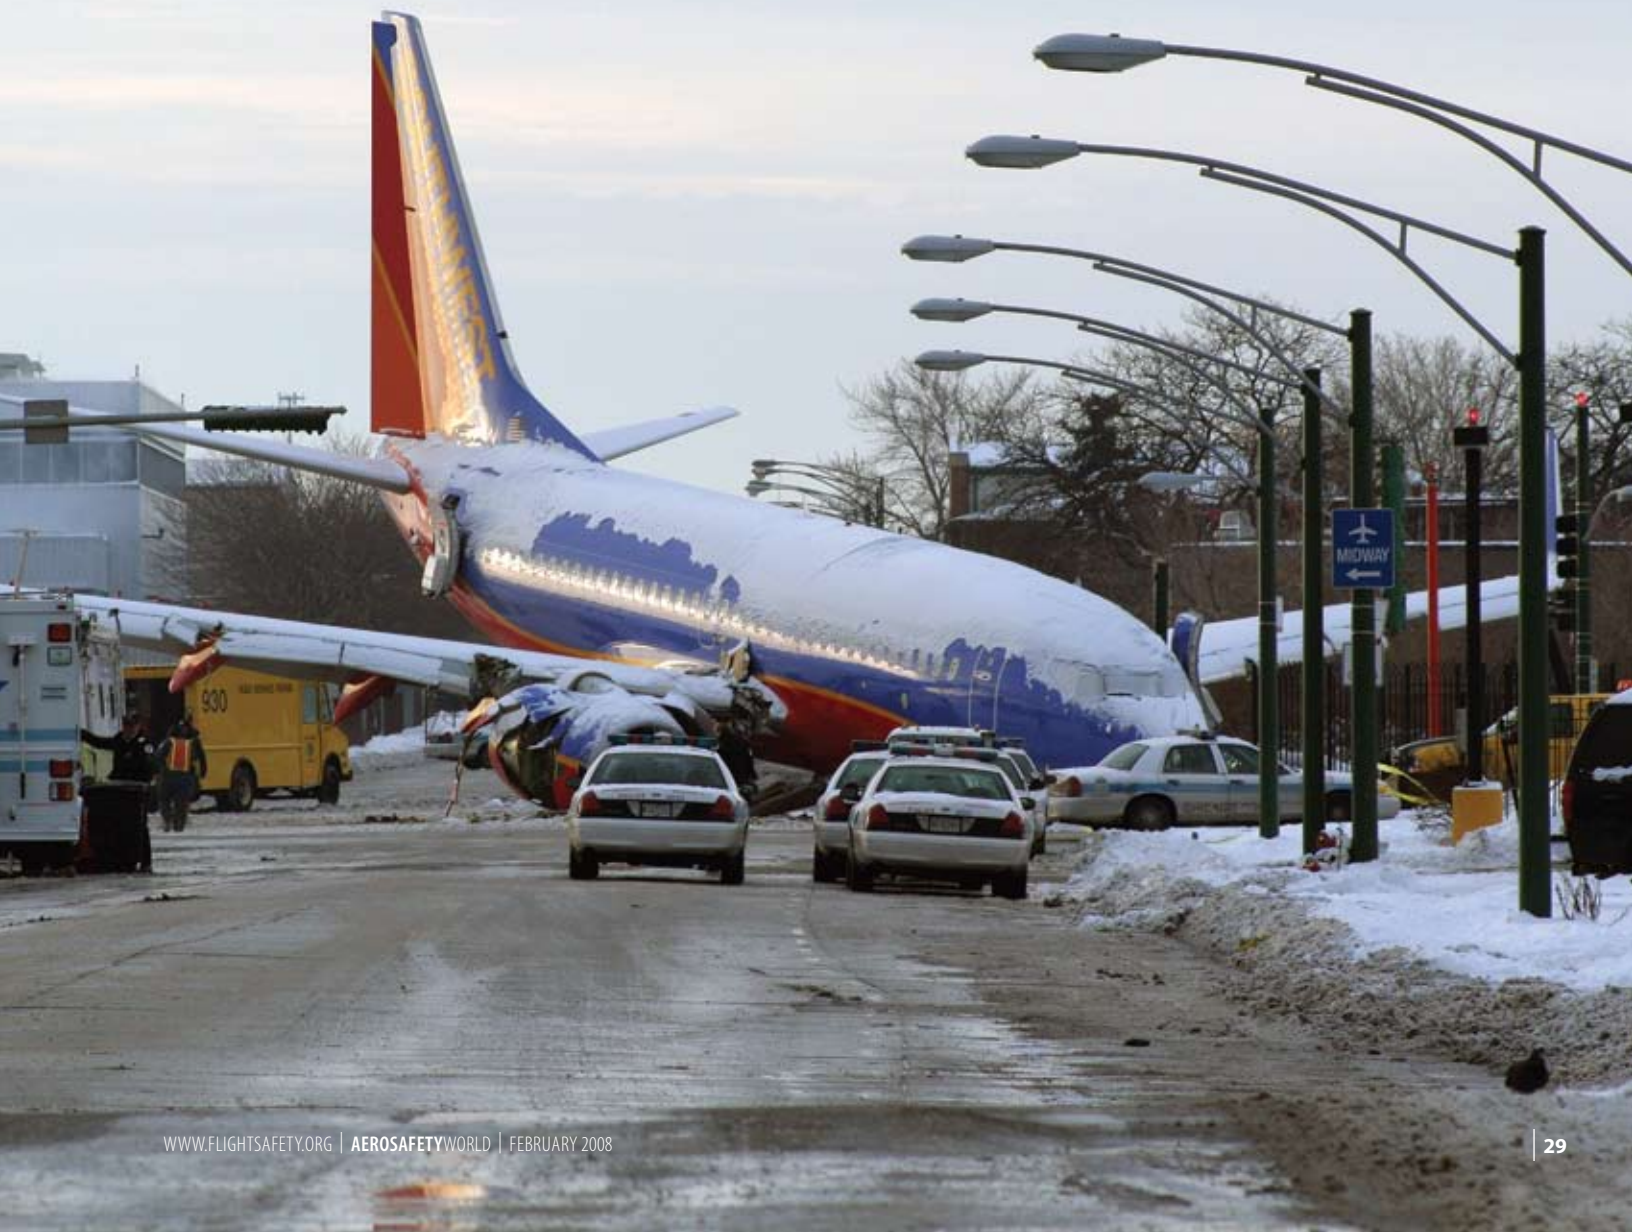
The accident airplane, after repairs, is shown in the photo above.

“Damage to the airplane was largely limited to the forward lower fuselage, engine cowlings and components, forward portions of the wings and other wing components, with limited damage farther aft,” the report said. Examination of the airplane disclosed no preimpact anomalies.
