FLIGHT SAFETY

Crew Error Cited as Major Cause of U.S. Aerial Fire Fighting Accidents

Errors in judgment and deficiencies in crew resource management and compliance with standard operating procedures were common causes of U.S. aerial fire fighting accidents involving fixed-wing aircraft in 1976–1998.

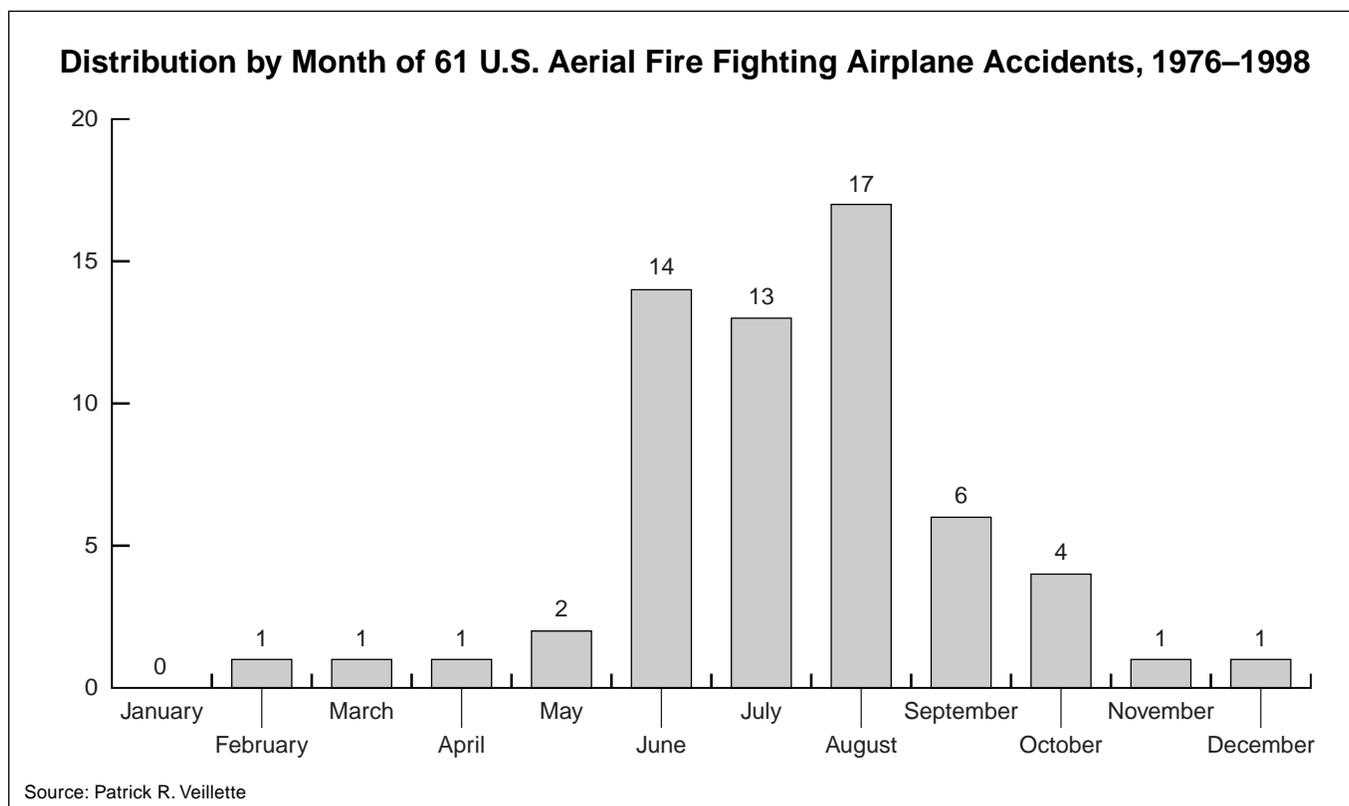
Figure 3 shows that 44 (72 percent) of the 61 aerial fire fighting accidents in 1976–1998 occurred in the months of June, July and August. This is the period in which the greatest fire activity occurs in the western U.S. The tempo of aerial fire fighting operations increases significantly during this time, thus increasing the risk of fatigue-related accidents and incidents.

Of the seven reported fatigue-related accidents in 1976–1998, one occurred in June, two in July, two in August, one in

September, and one in October. Three fatigue-related accidents occurred in 1988, a year in which fire activity was especially high.
