# FLIGHT SAFETY

## Safety Study

# Emergency Evacuation of Commercial Airplanes

NTSB Report

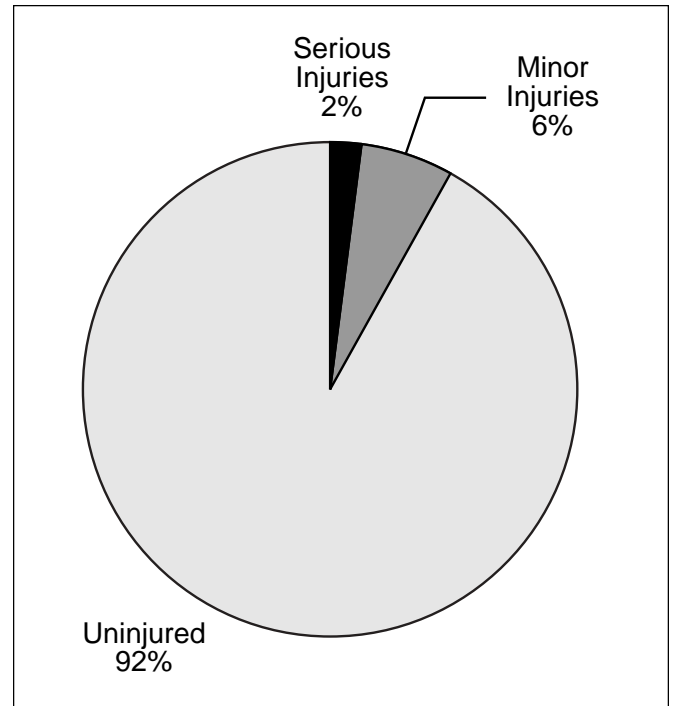
questionnaires. In the 46 study cases, 92 percent (2,614) of the 2,846 occupants on board were uninjured, 6 percent (170) sustained minor injuries, and 2 percent (62) sustained serious injuries (figure 3-1).

**Figure 3-1.** Percent of crew and passengers who sustained serious or minor injuries in the 46 study cases.

10 passengers and 1 crewmember were killed (table 3-5, page 13). One of the cases (case 45, in Little Rock, Arkansas), accounted for the most injuries (65 minor, 45 serious) and all the fatalities (11). Two of the fatalities were evacuation-related: one passenger died from smoke inhalation in the rear of the airplane; a second passenger died 16 days after the accident

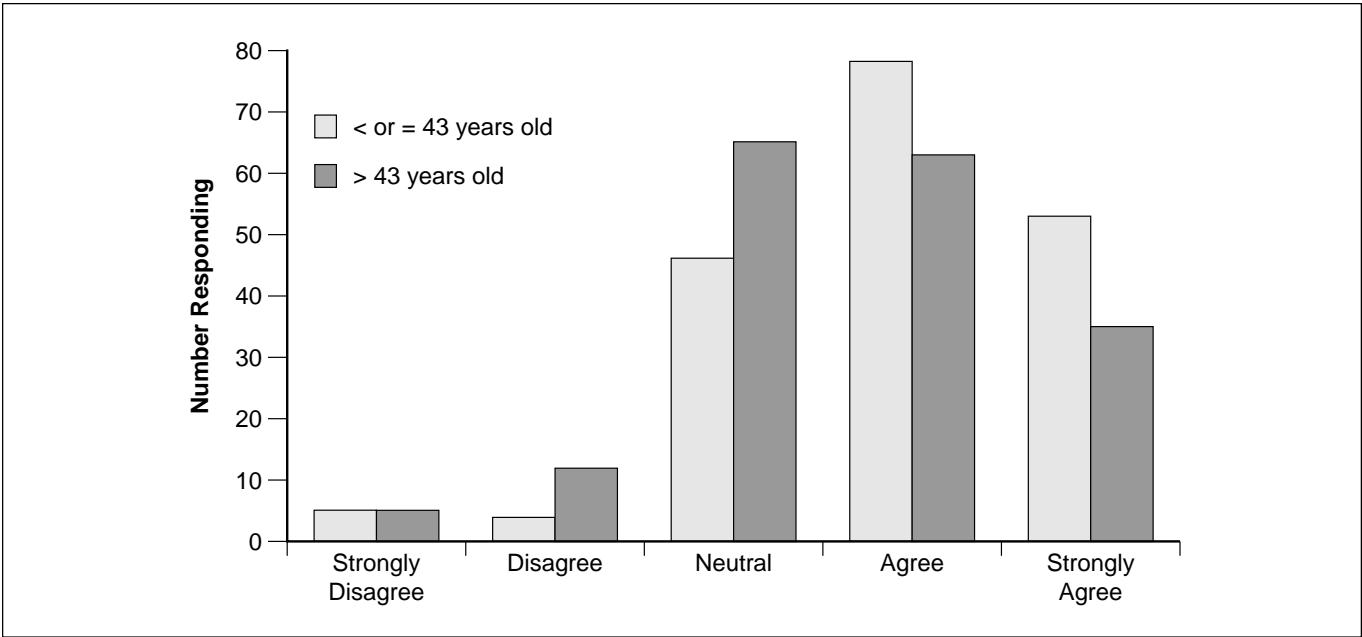
Despite the lack of differences with regard to injury, the older passengers (older than 43) had different perceptions of how their physical abilities affected their evacuation. Older passengers were more likely to disagree with statements that their physical size or condition assisted their evacuation [ $\chi^2(4) = 12.44, p < 0.05$ ] (figure 3-2, page 14). Further, they

**Figure 3-2.** Passenger agreement with the statement that their physical condition assisted their evacuation.

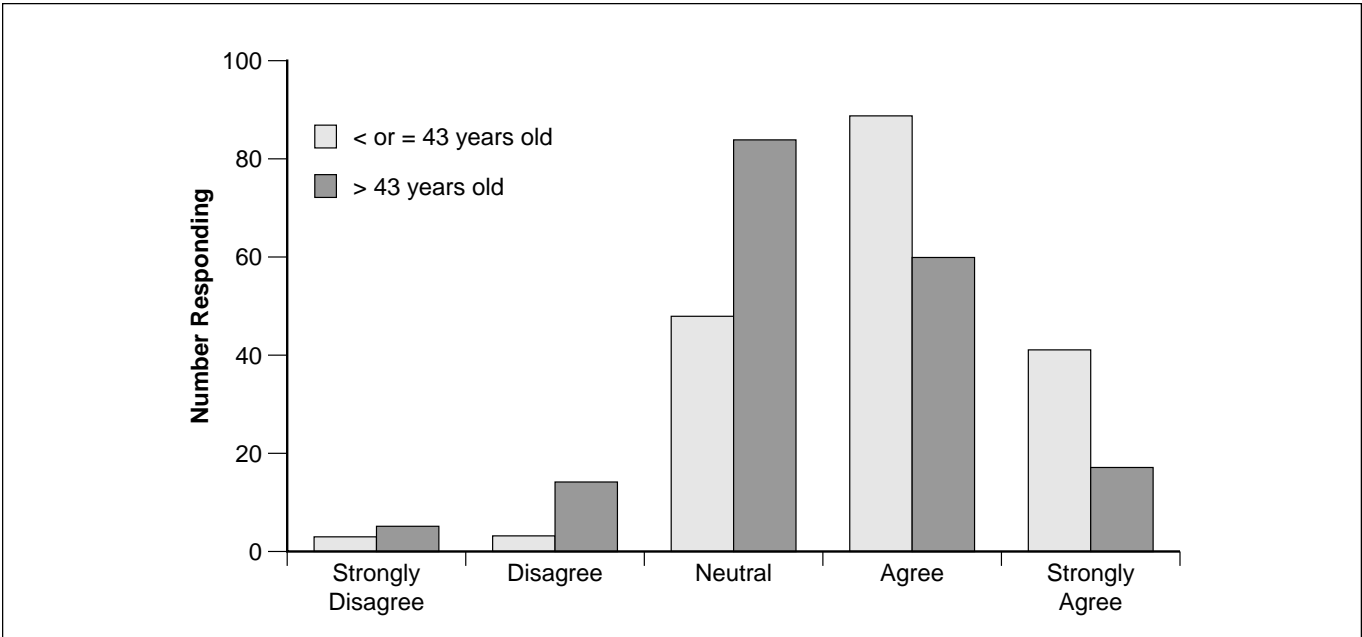
tended to disagree with statements that indicated their age assisted them (figure 3-3, page 14). Overall, older passengers were no more likely to sustain an injury, but they perceived their condition and age to hinder their evacuation.

**Figure 3-3.** Passenger agreement with the statements that their age assisted their evacuation.

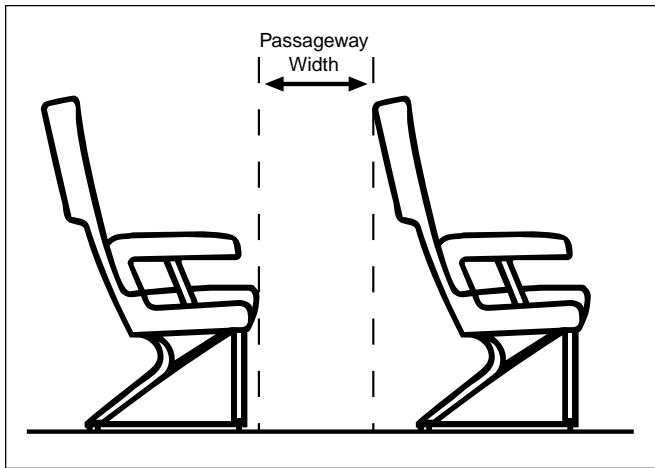
In 1989, CAMI conducted evacuation trials to examine the effects of exit path width—the distance between the forward-most point on an exit row seat and the aft-most point on the seat directly in front of it (figure 5-2, page 20)—on the evacuation rate at Type III overwing exits.<sup>49</sup> Participants were required to evacuate through a Type III exit or open a Type III exit hatch using four different seating conditions: a 6-inch unobstructed passageway, a 10-inch unobstructed passageway, a 20-inch passageway with 5 inches of the seat encroaching on the exit, and a central seat placement with the outboard seat removed. The researchers reported that egress times were quicker for the seating conditions using the 20-inch passageway and the outboard seat removed than were egress times using the 6-inch passageway. However, the various exit widths did not affect exit hatch removal time. As a result of these CAMI trials and the 1991 accident in Los Angeles (described in chapter 1 of this report), the FAA issued a notice of proposed rulemaking (NPRM) that required air carriers to increase the exit path width in exit rows from 6 inches to 20 inches. The

**Figure 5–2.** Type III exit row passageway width.

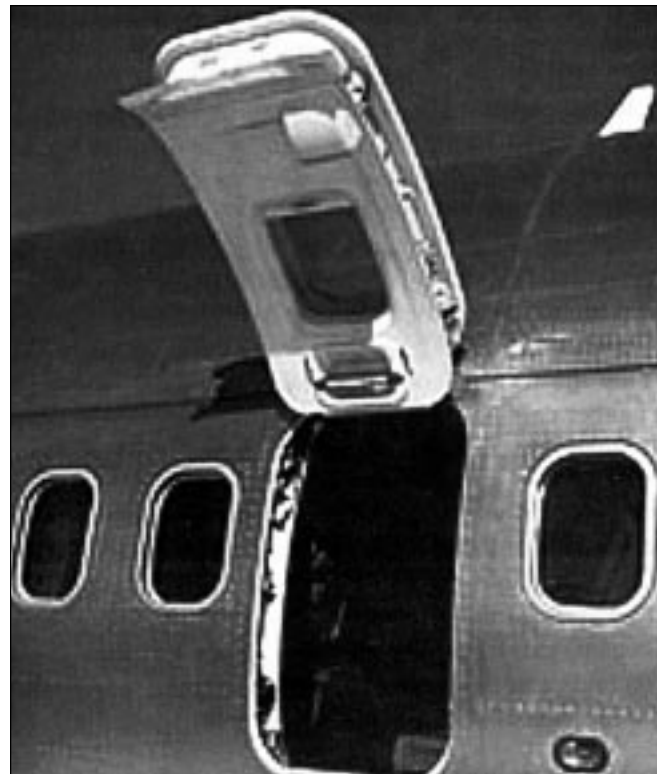
As case 16 (a 727 in Chicago) illustrated, the weight of the overwing exit hatch has also been a problem for some passengers. One air carrier acknowledges on its safety briefing card for an airplane type with Type III overwing exits the weight and awkwardness of this type of exit. The safety briefing card states in the introduction to the exit row seating requirements that "emergency exits are often heavy, awkward to lift, push, pull, and maneuver when opening. Because of this and for the safety of all passengers, Federal law requires that we only seat qualified passengers next to exits." Further, it is not intuitively obvious that after pulling the latch, the hatch is to be turned and either placed on the exit row seats or thrown out the opening. The opening and maneuvering of this exit is also difficult to display graphically. The Safety Board concludes that passengers continue to have problems opening overwing exits and stowing the hatch. The manner in which the exit is opened and the hatch is stowed is not intuitively obvious to passengers nor is it easily depicted graphically. Boeing has designed a new overwing exit for its 737 series airplanes based on human factors principles.<sup>61</sup> The exit is hinged and opens outward as passengers would intuitively expect (figure 5-6). This design also eliminates the problem of where to stow the exit hatch because it moves up and out of the egress route. In short, the design eliminates any guesswork about how the exit operates or what to do with the exit hatch once it is opened. The Safety Board believes the FAA should require Type III overwing exits on newly manufactured aircraft to be easy and intuitive to open and have automatic hatch stowage out of the egress path.

**Figure 5-6.** View of the newly designed Type III exit for the Boeing 737-600, -700, -800, -900.

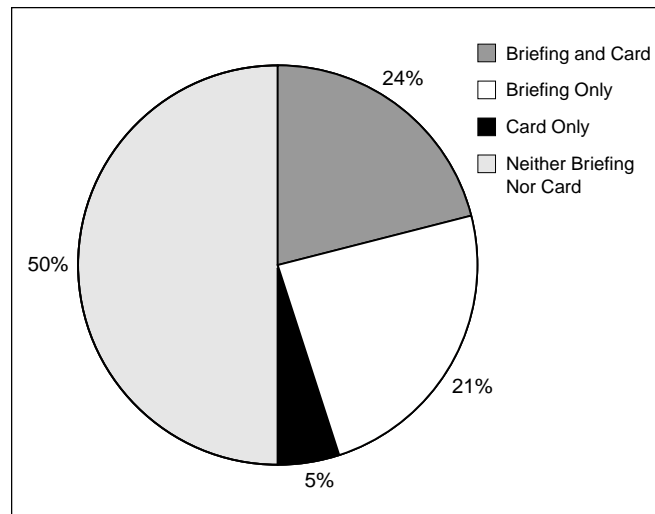
Some of the air carriers make a point to individually brief passengers on the exit row tasks. In the six study cases for which the Safety Board received overwing exit operation information, 9 of the 42 exit row passengers reported receiving such a briefing (figure 5-7). Four of these passengers reported examining their safety card. Twenty-four passengers reported receiving no briefing, and only two of these passengers had examined their briefing card. The two briefed passengers who opened overwing exits reported no difficulties. Four passengers who did not receive a briefing opened overwing exits. Two of these passengers reported no difficulty with the exit whereas the other two reported difficulties with their exit.

**Figure 5-7.** Percentage of exit row passengers who indicated whether or not they paid attention to safety information.

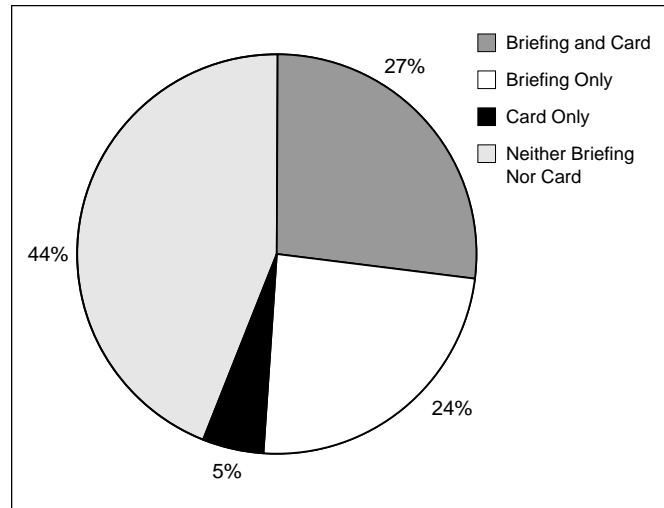
Passenger use of the safety cards on the airplanes in the study cases was consistent with previous findings that passengers tend not to look at the cards.<sup>79</sup> Of the 431 passengers who reported about reading the safety card, 68 percent (293) indicated that they did not read the safety card. Of those, 89 percent (259) indicated that they had read the card on previous flights. Of particular concern is that 44 percent (175) of 399 responding passengers reported that they neither examined the safety card nor listened to the safety briefing (figure 7-1).

**Figure 7-1.** Percentage of all passengers who indicated whether or not they paid attention to safety information.
