# Flight Safety

MARCH 2004

**Bracing the  
Last Line of Defense  
Against Midair Collisions**

### Bracing the Last Line of Defense Against Midair Collisions

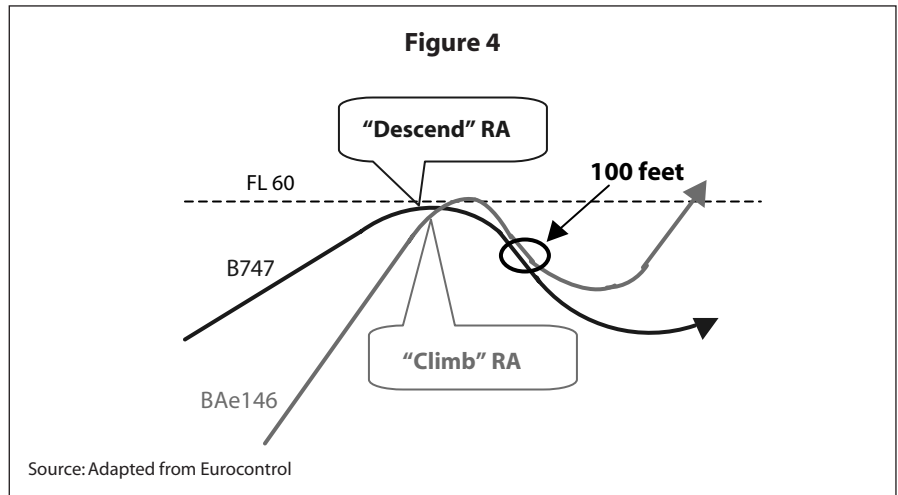
The B-747 pilot receives a "descend" RA that he follows: He stops his climb and starts to descend (Figure 4).

The BAe 146 pilot has the B-747 in visual contact. Nevertheless, due to the actual B-747 flight configuration, the descent maneuver is difficult to detect visually (positive pitch). Because he is also misled by the erroneous traffic information, he decides to descend visually to avoid the B-747 despite his "climb" RA.

Because the BAe 146 pilot did not follow his "climb" RA, the B-747 deviated by 1,200 feet. Nevertheless, despite this large vertical deviation, the B-747 pilot reported that the two aircraft passed "very, very, very close" (i.e., 100 feet vertically and 0.5 nautical mile [0.9 kilometer] horizontally).

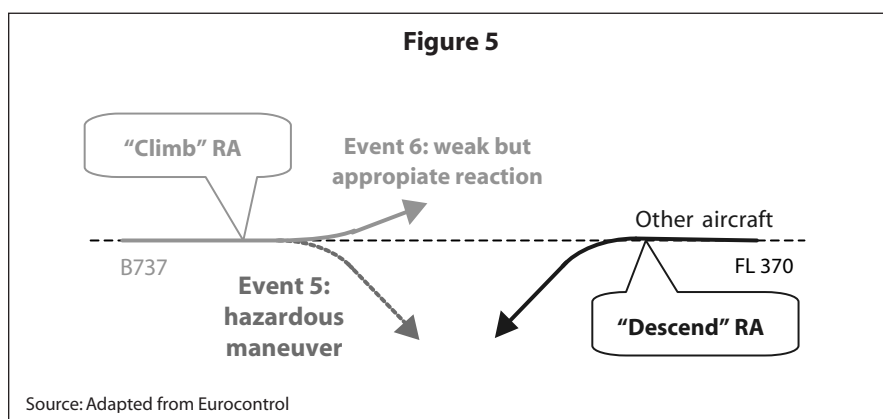
Two events involving B-737s cruising at FL 370, the maximum certified flight level for this specific aircraft type, have been identified where the pilot reaction to the "climb" RA was different. In both events, the B-737 was flying toward another aircraft level at the same altitude due to an ATC mistake and the ACAS generated a "climb" RA (Figure 5).

**Event 5:** The B-737 pilot decided not to climb in response to the RA because the aircraft was flying at the maximum certified flight level. Nevertheless, because he wanted to react to the ACAS alert, he decided to descend. He did not take into account that the other aircraft would

receive a coordinated "descend" RA. As a result, the B-737 pilot descended toward the other aircraft, which was correctly descending in accordance with its own RA.

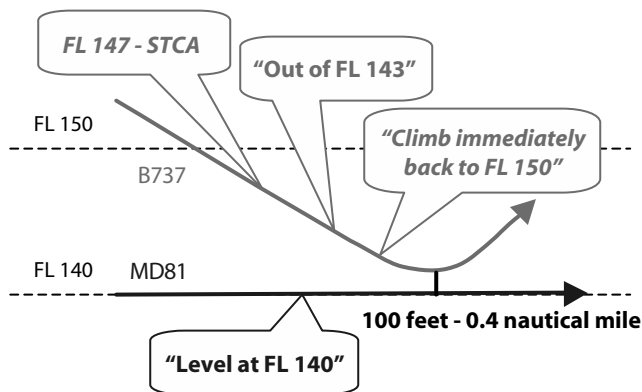
**Figure 14**

When the B-737 passes FL 147, still descending, the STCA system triggers an alert. As data blocks are overlapped on his display, the controller questions both pilots about their flight level, then he instructs the B-737 to climb immediately back to FL 150 (Figure 14).

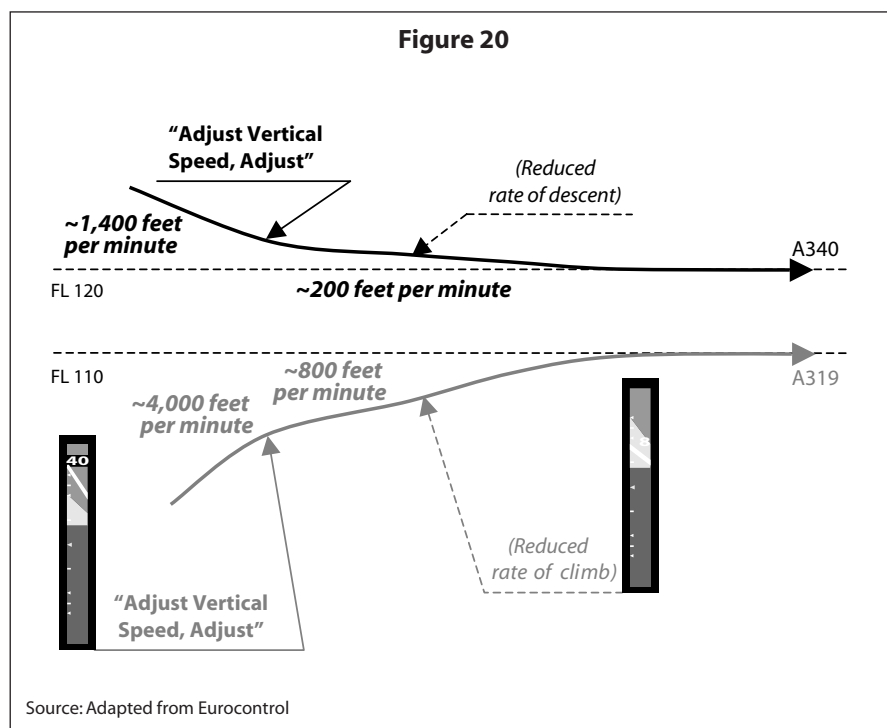
Figure 20

causes ACAS to trigger “adjust vertical speed” RAs before the aircraft have leveled off at their cleared flight levels (Figure 20):

- The A340 is required to reduce its rate of descent to 1,000 feet per minute; and,
- The A319 is required to reduce its rate of climb to 2,000 feet per minute.

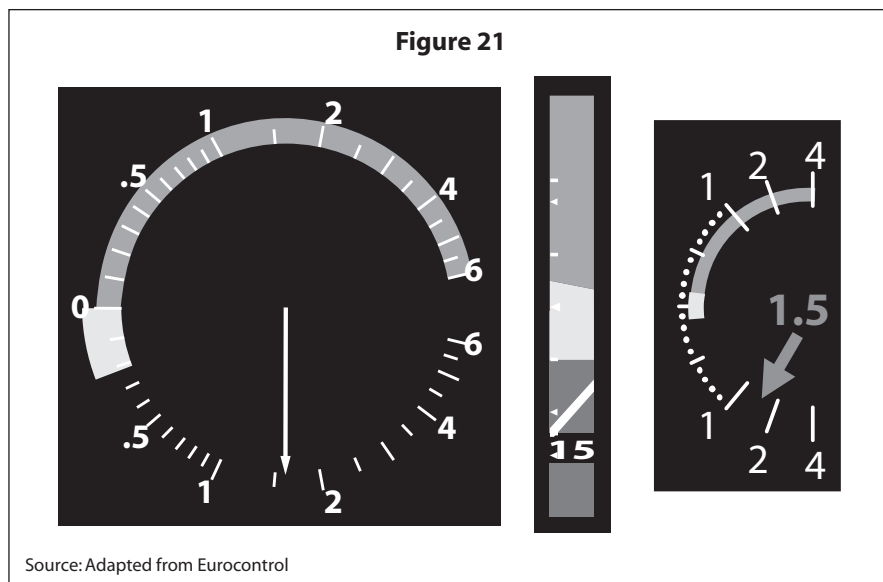
Figure 21

On a VSI, the vertical speed needle is outside the red area (Figure 21). Flying the aircraft to put the vertical-speed needle into the green area will achieve a level-off.

The current ACAS (i.e., TCAS II Version 7) addressed this issue on VSI and vertical-speed tape RA displays by adding a green area to the indication of the weakening RA.

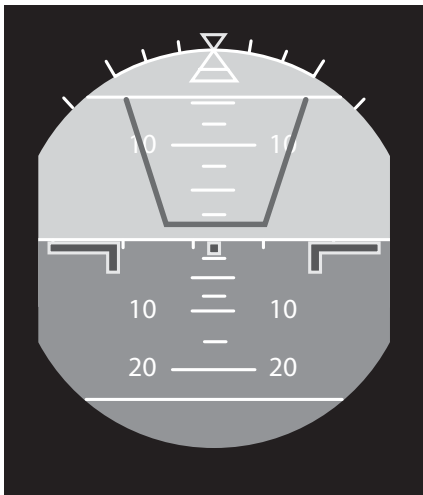
**Figure 22**

On an EADI, the current-pitch marker is outside the red-trapezoid area (Figure 22, page 27). Flying the aircraft to put the current-pitch marker on the bottom line of the red trapezoid will achieve a level-off.

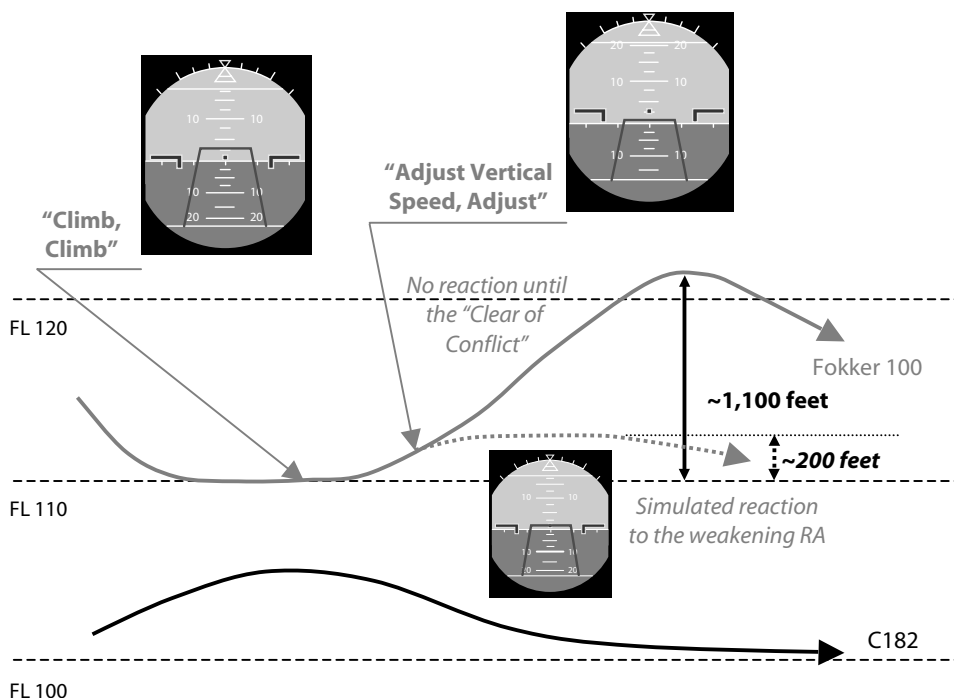
**Figure 23**

Because of the horizontal convergence and the small vertical distance between the aircraft, the Fokker 100 receives a “climb” RA, which the flight crew follows (Figure 23).
