MAY-JULY 2000

# FLIGHT SAFETY

## Controlled Flight Into Terrain Korean Air Flight 801 Boeing 747-300, HL7468 Nimitz Hill, Guam August 6, 1997

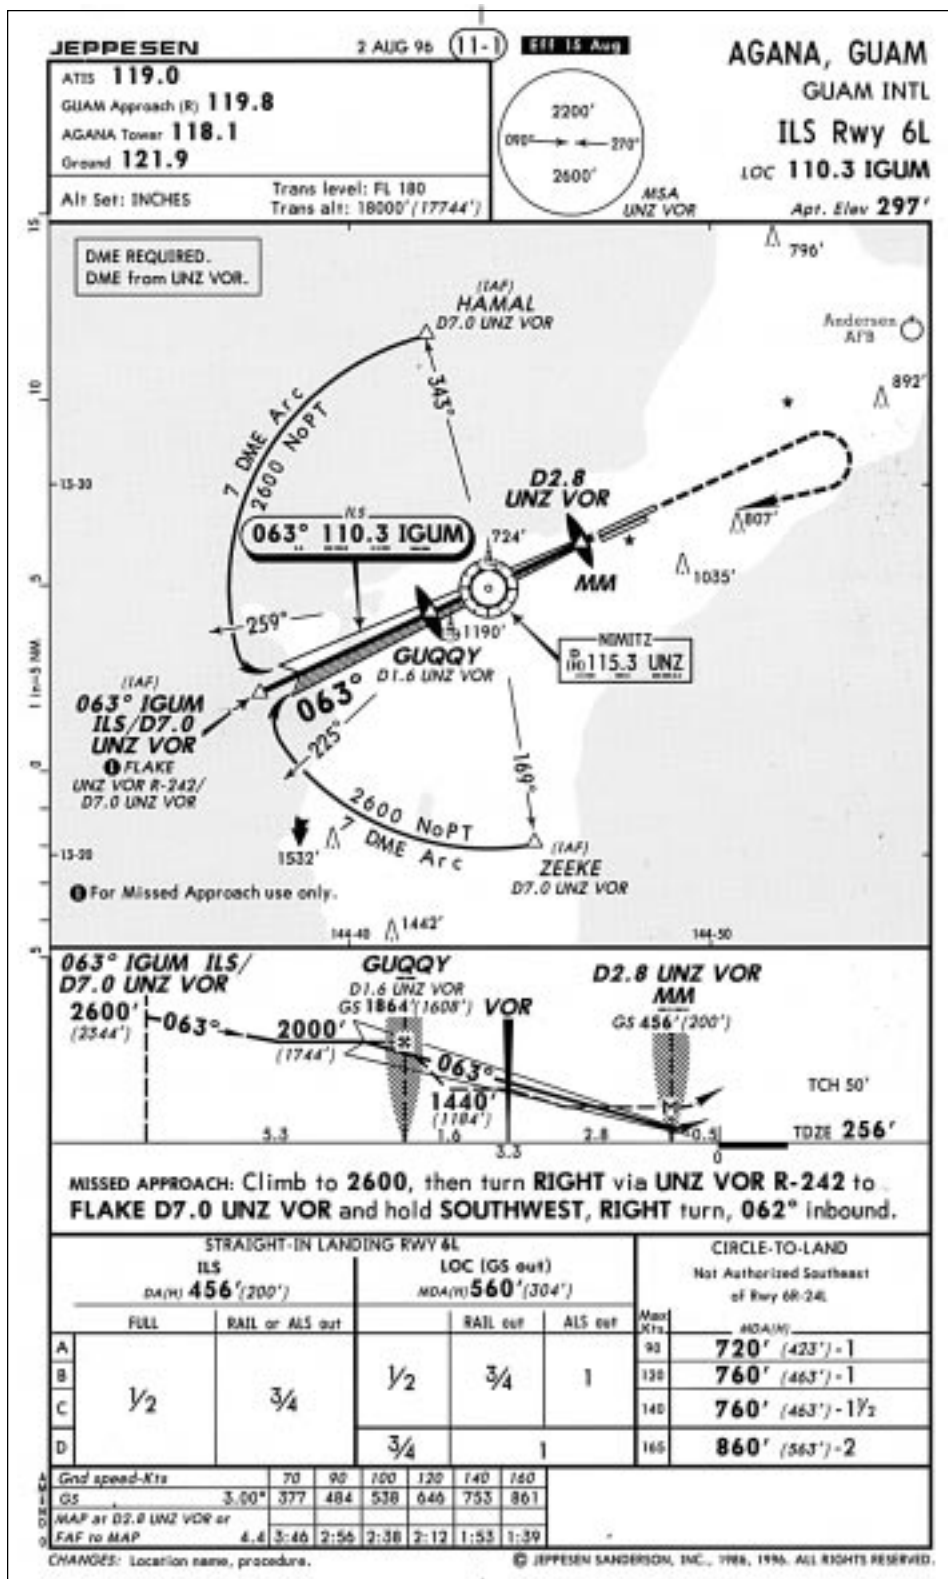
Figure 1. Instrument approach chart for the Guam International Airport runway 6L ILS procedure.

The instrument approach charts for Guam International Airport in effect at the time of the accident were issued on August 2, 1996 (with an effective date of August 15, 1996). Changes incorporated in the August 2, 1996, 11-1, ILS runway 6L approach chart (shown in figure 1) included the location names, crossing altitudes, and the missed approach procedure. Table 2 [\* page 28] details the specific differences between the January and August 1996 instrument approach charts.

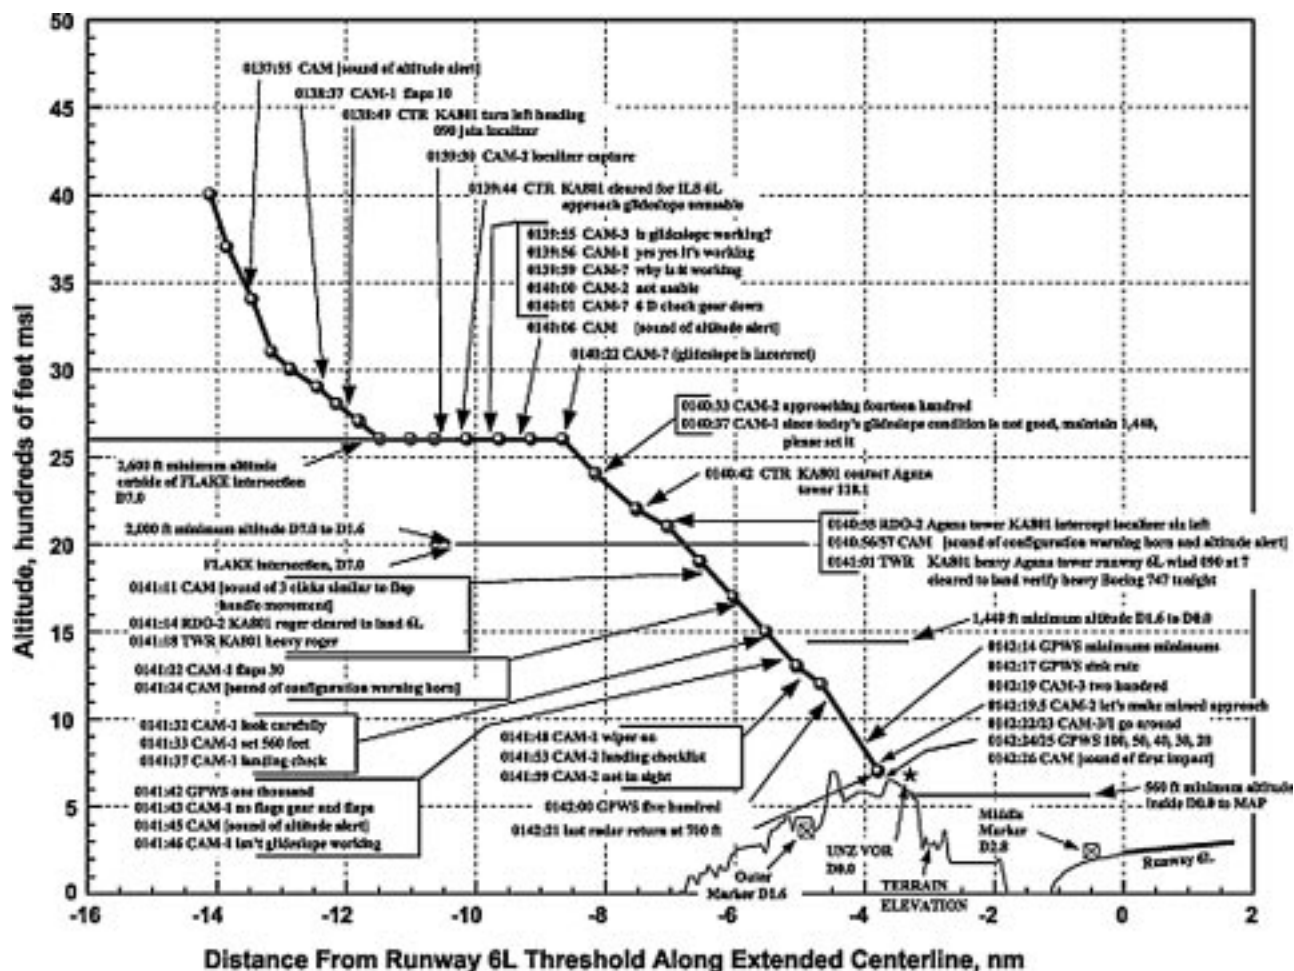
Figure 2. Side view of FAA radar data with selected ATC and CVR communication excerpts.

Figure 1 [\* page 12] shows the instrument approach chart for the Guam runway 6L ILS procedure that was in effect at the time of the accident. Figures 2 [\* page 13] and 3 [\* page 14] show FDR information for the last 5 1/2 minutes of flight, along with CVR comments and sounds and air traffic control (ATC) data.

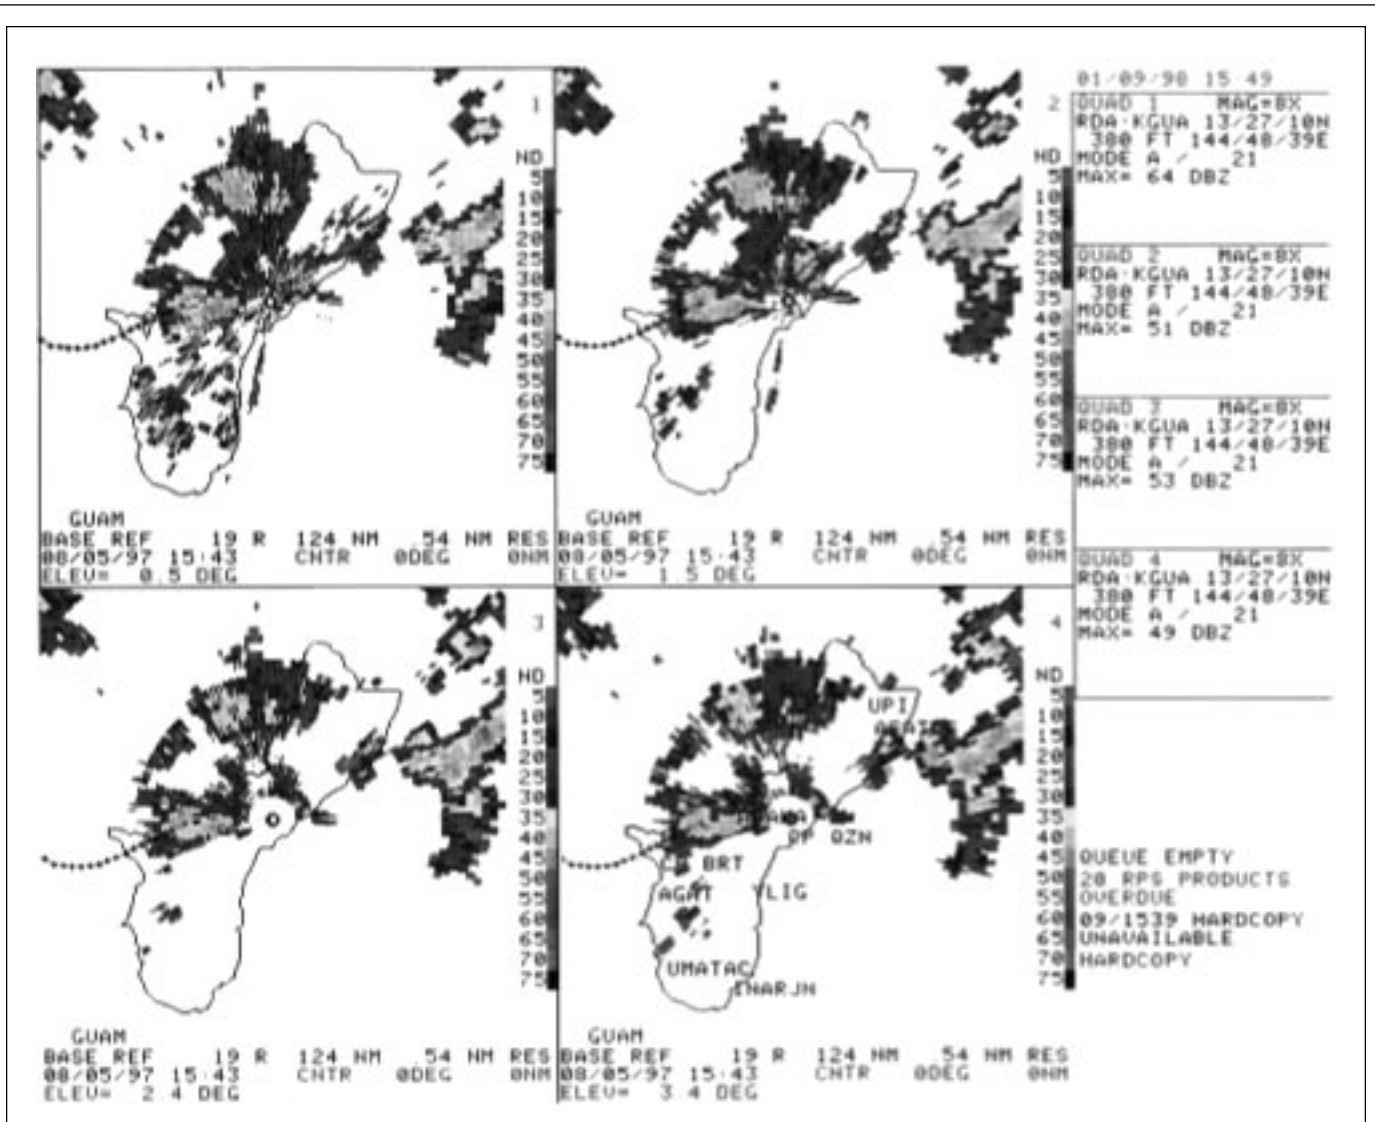
Figure 6. USR-88D four-panel base reflectivity product for Guam.

The radar antenna of the Guam Weather Surveillance Radar-1988, Doppler (WSR-88D) was located about 5 nm east of the accident site. Data recorded about 0143 on August 6 (1543 UTC time on August 5, 1997) indicated an area of precipitation over higher terrain about 4 nm southwest of the airport, including Nimitz Hill. The precipitation was oriented east to west, about 7 to 8 nm long and 3 to 4 nm wide, and was moving toward the west. Figure 6 [\* page 21] shows the WSR-88D four-panel base reflectivity product for 0143.

The CERAP controller stated that he did not advise the flight crew or the Agana tower controller that he had observed the precipitation on radar while flight 801 was on the approach course to the airport. The controller said that he had assumed that the flight crew was using cockpit radar because they had asked him twice for deviations around weather. The controller stated that the airplane’s cockpit radar was more accurate and more precise than the radar he was using at the CERAP. The controller further stated that he did not observe (on radar) the airplane entering the precipitation.

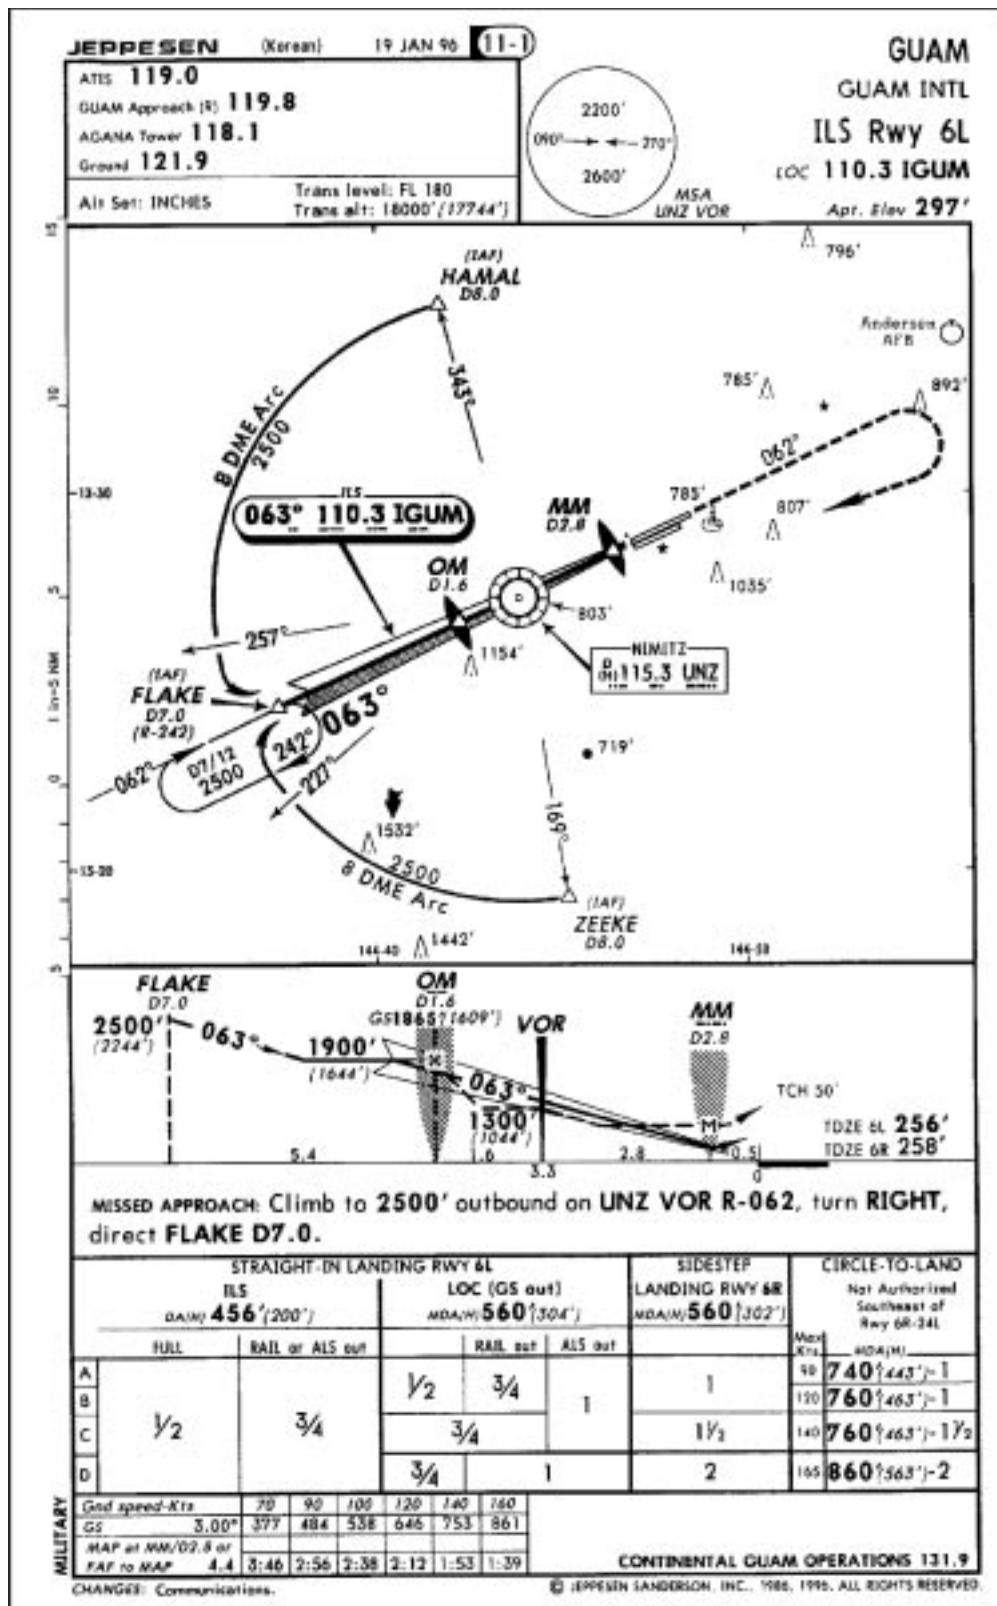
Figure 7. The January 19, 1996, 11-1 ILS runway 6L instrument approach chart.

Charts 11-1 and 13-2 were found side by side and were visible through one face of the plastic sleeve. Chart 16-1 and the blank side of an approach plate were visible through the opposite face of the plastic sleeve. Chart 11-1, which is shown in figure 7 [\* page 27], had the following items highlighted with a green fluorescent tint:<sup>62</sup>

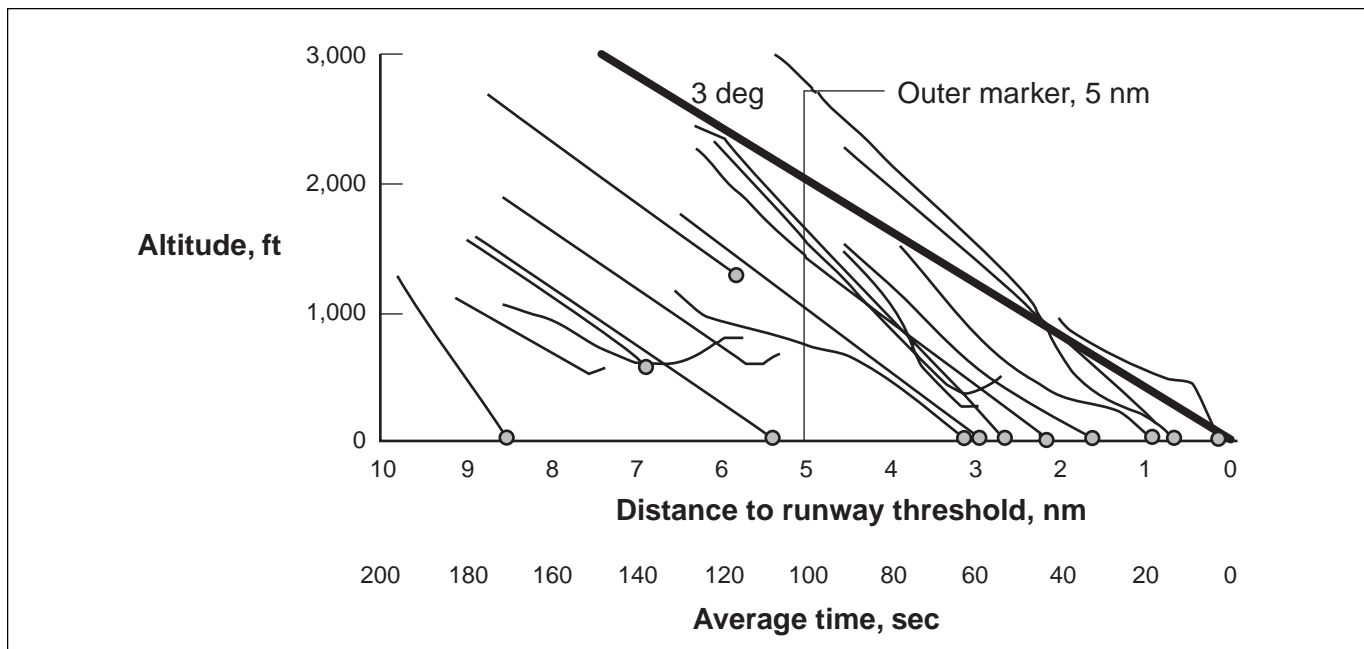
**Figure 10.** Vertical profile information from the 40 CFIT accidents and incidents between 1986 and 1990.

The captain stated that 70 percent of the CFIT accidents occurred on final approach and that most of these aircraft were "... in line with the runway." The captain also stated that "... many accident aircraft [were] underneath the three-degree glideslope [of a precision approach]." Figure 10 shows vertical profile information that was available from the 40 CFIT accidents and incidents that occurred between 1986 and 1990, as prepared by Boeing and provided by the FSF's CFIT Awareness Task Force.
