Descent Below Normal Surveillance Altitude Ends in Fatal Wire Strike

While flying over a frozen river in search of illegal fishing operations, the Canadian Coast Guard helicopter struck an unmarked power line. The pilot was killed and three passengers were injured in the accident.

Editorial note: This article is based on the official accident investigation report, *Wirestrike — Government of Canada, Canadian Coast Guard, Bell 206L, C-GCHN, Margaree River, Nova Scotia, 25 February 1995*, by the Transportation Safety Board of Canada, Report no. A95A0040. The report includes figures and appendices.

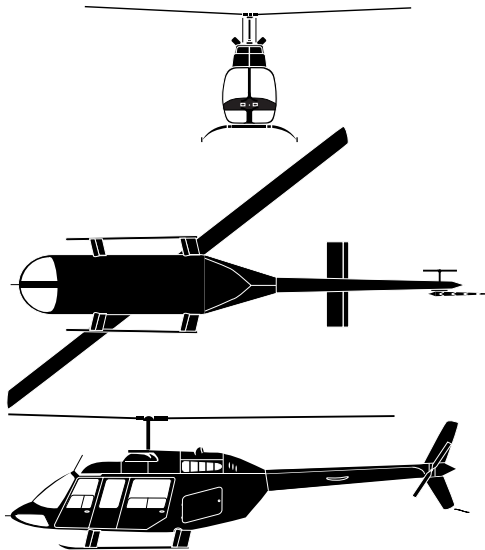
The Bell 206L LongRanger first flew in 1974. Developed from the 206B JetRanger, it has a longer fuselage that can accommodate seven seats. The 206L has a maximum takeoff weight of 1,882 kilograms (4,150 pounds) and a maximum cruising speed at 5,000 feet (1,525 meters) of 110 knots (204 kilometers per hour). It has a service ceiling of 20,000 feet (6,100 meters) and a range of 360 nautical miles (666 kilometers) at an altitude of 5,000 feet with no reserves.
