Helicopter Strikes Water on Approach After Pilots Lose Altitude Awareness

The controlled-flight-into-terrain (CFIT) accident, which killed a passenger and necessitated an underwater escape by the pilots, was also attributed to flight crew failure to set their altimeters correctly.

—
FSF Editorial Staff

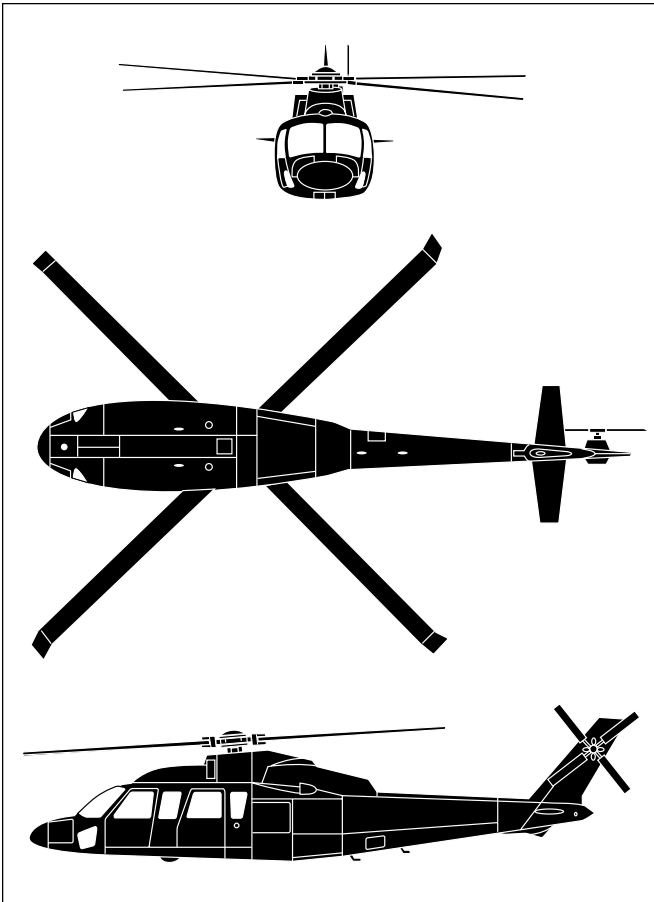
Sikorsky S-76

The PIC's next sensation was of being upside down, under water, in pitch-black conditions, with no idea where he was.³ He described unsuccessfully attempting to open his [right] door (Figure 1). The S-76A has a door lock-pin mechanism that must be released before the door handle will open from the inside. The PIC said that he did not remember attempting to release the locking pin. Nor did he attempt to use the emergency exit handle to jettison the door.
