External Loads, Powerplant Problems And Obstacles Challenge Pilots During Aerial Fire Fighting Operations

U.S. accident reports from 1974–1998 show that diversion of attention was a major factor in accidents during external-load operations, which accounted for more than half of the accidents. Powerplant malfunctions and powerplant failures were involved in more than a third of the accidents. More than a quarter of the accidents occurred when helicopters struck obstacles, such as trees and wires, during fire fighting missions.

—
Patrick R. Veillette, Ph.D.

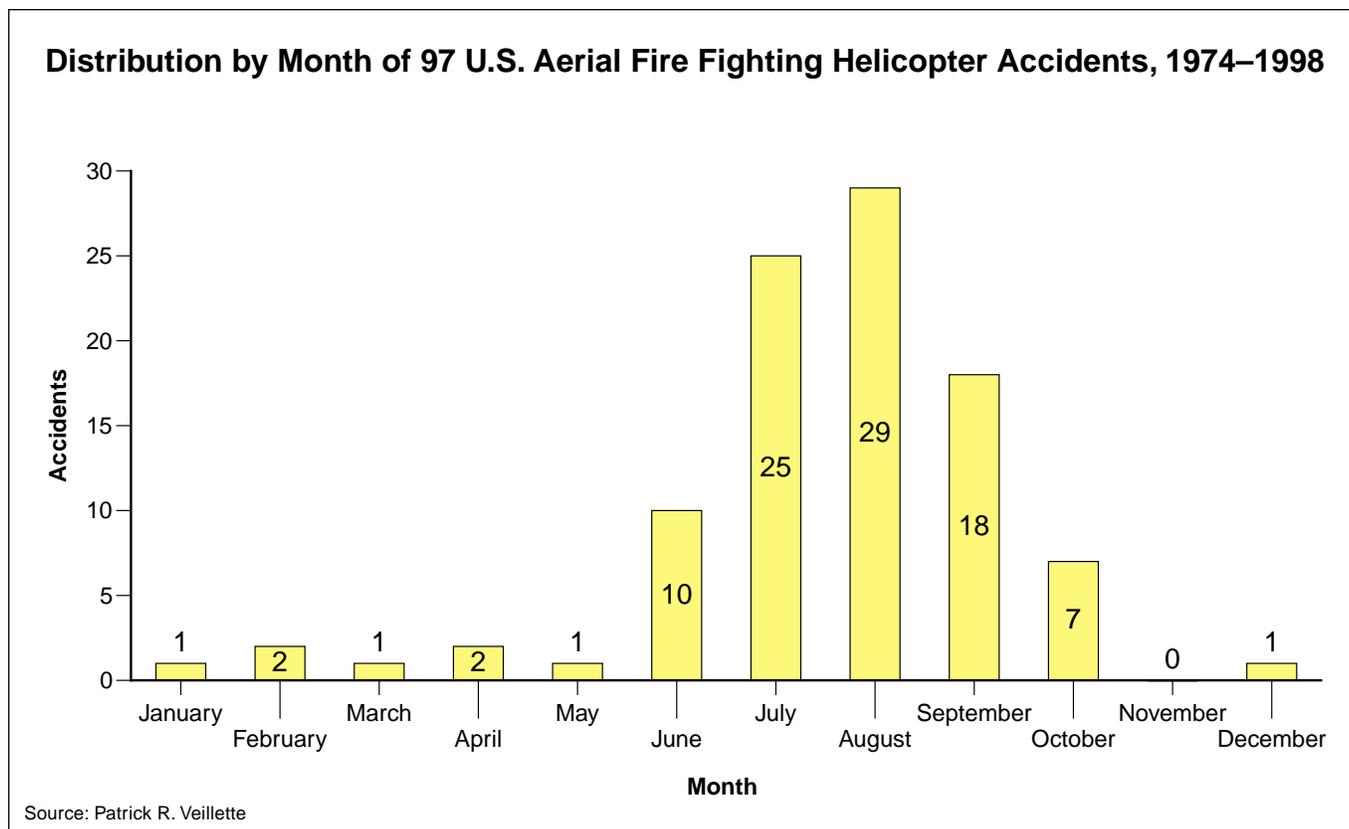
Figure 3 shows that 82 accidents occurred in the months of June, July, August and September. This is the period in which
