Federal Democratic Republic of Ethiopia
Ministry of Transport
Aircraft Accident Investigation Bureau

Aircraft Accident Investigation Preliminary Report
Ethiopian Airlines Group
B737-8 (MAX) Registered ET-AVJ
28 NM South East of Addis Ababa, Bole International Airport
March 10, 2019

Report No. AI-01/19

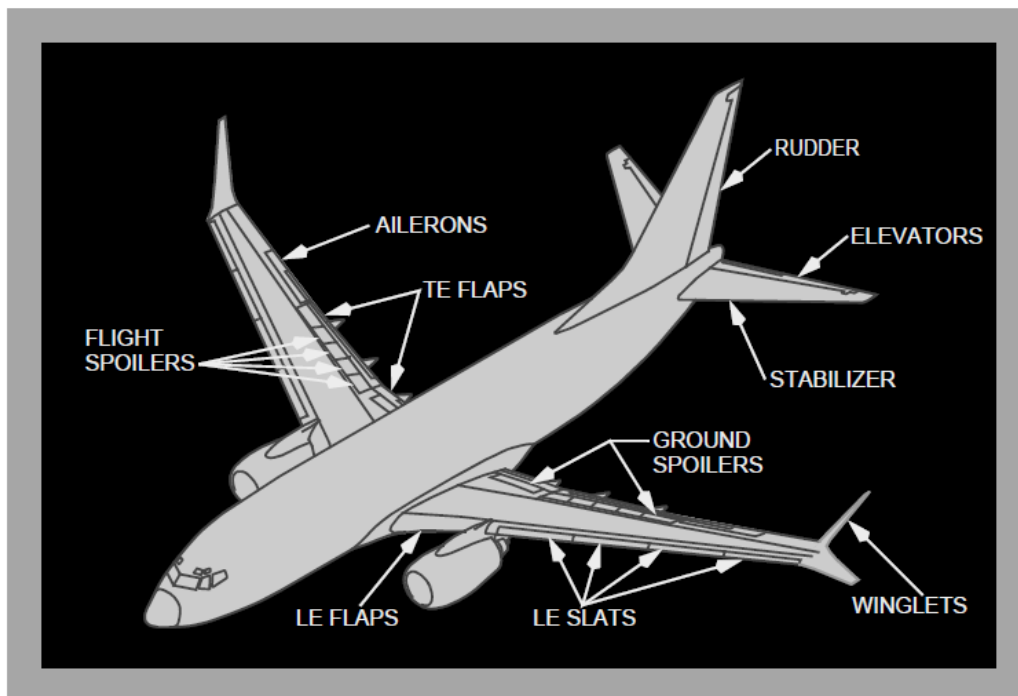
Flight Control Surfaces Location

The primary flight control system uses conventional control wheel, column and pedals linked mechanically to hydraulic power control units which command the primary flight control surfaces; ailerons, elevators and rudder. The flight controls are powered by redundant hydraulic sources; system A and system B.
