# SKIDDING OFF A CLIFF

BY MARK LACAGNINA

Unnecessary engagement of the emergency brakes locked the BAe 146's wheels, reducing deceleration on a damp runway.

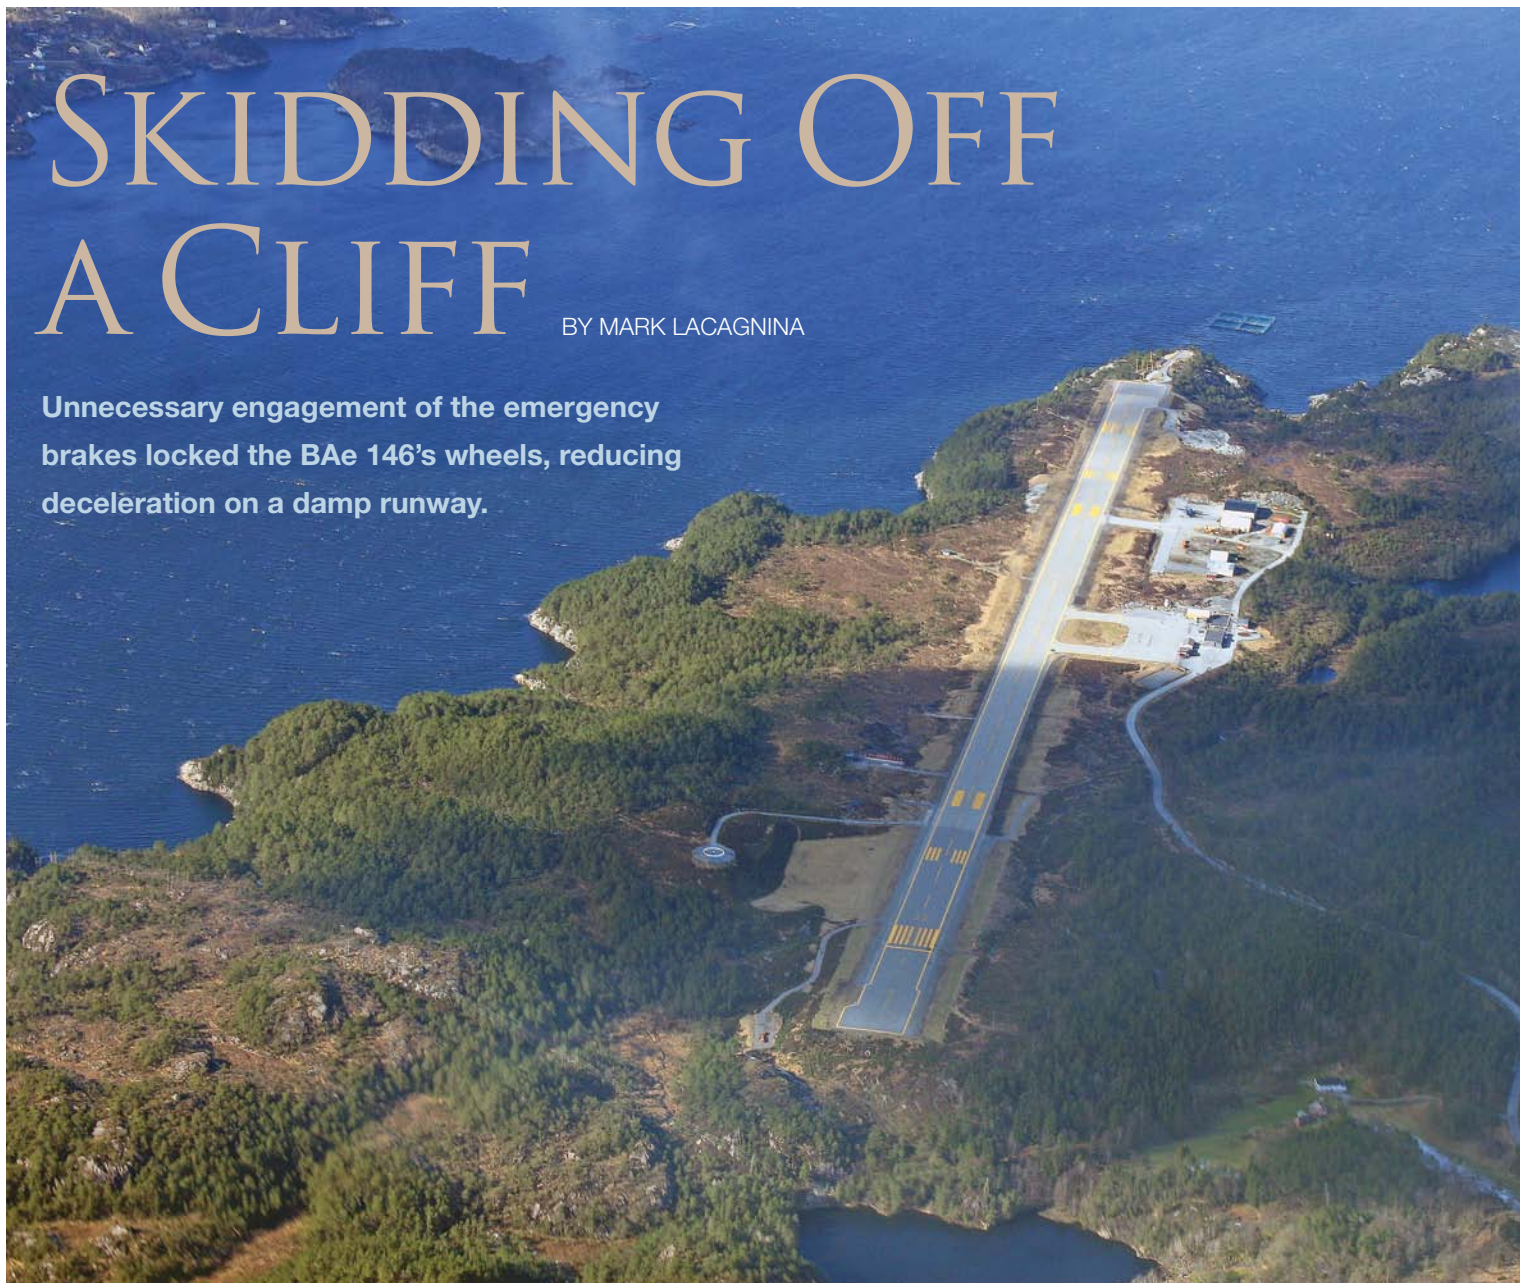
In a final report issued in April, the AIBN said that the aircraft's spoilers failed to deploy after touchdown, and the flight crew misinterpreted the consequent absence of expected deceleration as a fault in the wheel brake system. They responded, according to procedure, by applying the emergency brakes, which, without anti-skid capability, locked the four main wheels. There were no grooves in the runway

to decrease its surface slickness, and friction between the motionless tires and the pavement heated the thin layer of moisture into steam, melting the rubber in a process called *reverted rubber hydroplaning*. The aircraft skidded sideways off the end of the runway at 15 to 20 kt. The exit speed might have been slow enough to bring the aircraft to a halt *if* the paved safety area between the runway and the precipice had been just 50 m (164 ft) longer — in conformance with new Norwegian standards. The aircraft caught fire when it came to an abrupt stop at the bottom of the cliff. “The fire spread so fast that there was not enough time for everybody to evacuate the aircraft,” the report said.
