# Absence of Reasonableness

**A 100-tonne takeoff weight error eluded several checks.**

*This article is based on ATSB Transport Safety Report AO-2009-012, “Tailstrike and Runway Overrun; Melbourne Airport, Victoria; 20 March 2009; A6-ERG, Airbus A340-541,” Dec. 16, 2011. The report is available at <atsb.gov.au>.*

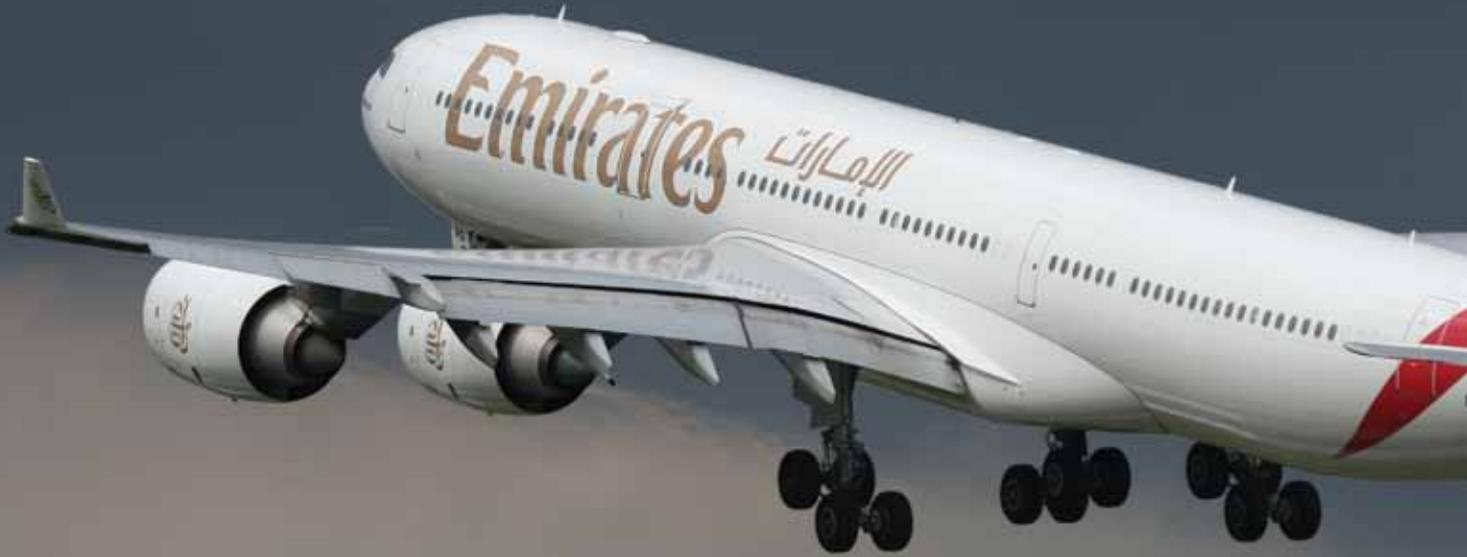
**This A340 was substantially damaged in a tail strike and overrun at Melbourne Airport.**

The A340 was landed on Runway 34 at 2336 and, after a brief inspection by aircraft rescue and fire fighting personnel, was taxied to the terminal, where the passengers disembarked normally. Examination of the aircraft revealed severe abrasion of skin panels on the bottom of the rear fuselage, deformation of fuselage frames and stringers in the area, and a cracked rear pressure bulkhead.
