Fractured Gear

A metallic particle was the only sign of the impending fatal failure of the AS332's main rotor gearbox.

The U.K. Air Accidents Investigation Branch (AAIB), in its final report, said the crash followed the catastrophic failure of the main rotor gearbox,

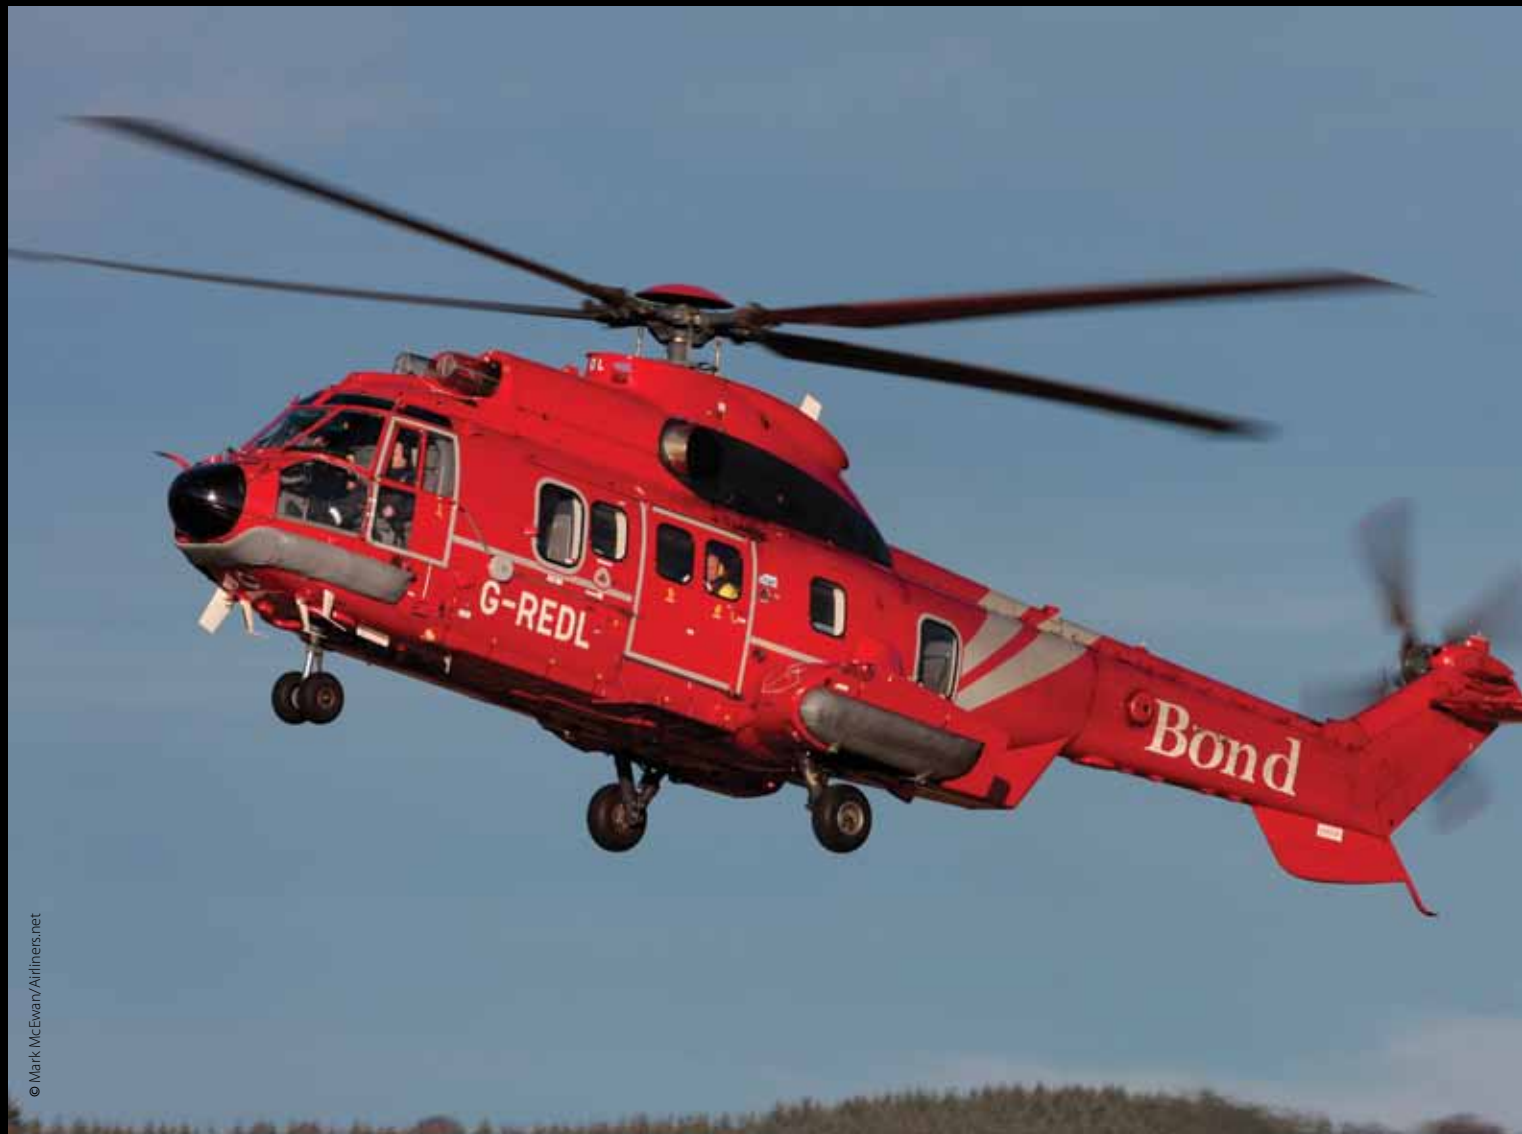
The main rotor blades separated from the helicopter before impact and were pulled from the North Sea during the recovery effort.
