# No Decision at DECISION HEIGHT

**Citation pilots were taken off guard by a fast-moving fog bank.**

BY MARK LACAGNINA

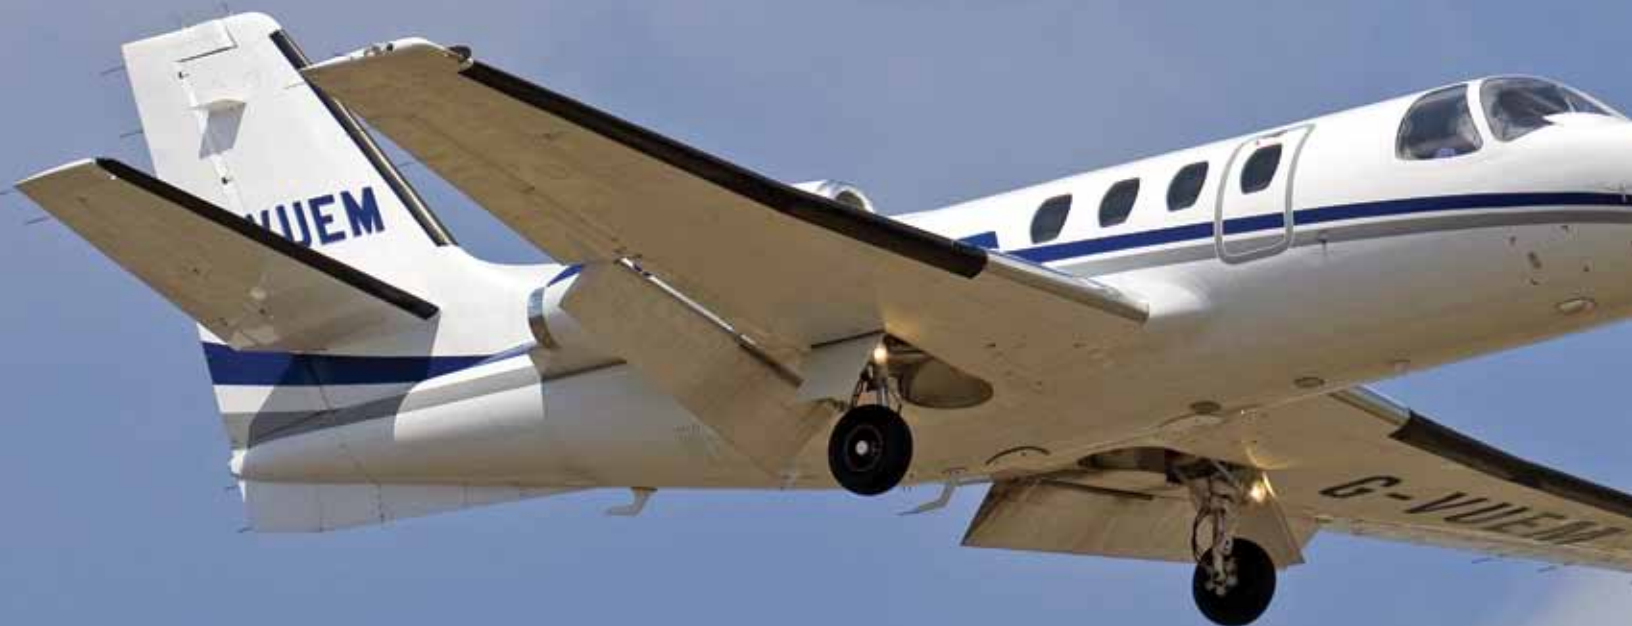
The copilot, the pilot flying, became confused, and the Citation continued descending until it struck the glideslope antenna and then terrain off the right side of the runway. The commander was seriously injured, the copilot sustained minor injuries, and the aircraft was destroyed by the impact and a fire.

runway touchdown zone when it deviated slightly to the right of the localizer centerline on a heading of 152 degrees. About 30 seconds later, at 1536, the leading edge of the left wing struck the top of the glideslope antenna, which was 15 m (49 ft) tall and adjacent to the runway touchdown zone. The impact ruptured the aircraft's left fuel tank and separated a position light from the top of the antenna, exposing live electrical cables that likely ignited fuel vapors.
