START-UP PROBLEMS

An in-flight engine fire followed maintenance technicians' use of an inappropriate procedure to manually start a balky engine on an MD-82.

BY LINDA WERFELMAN

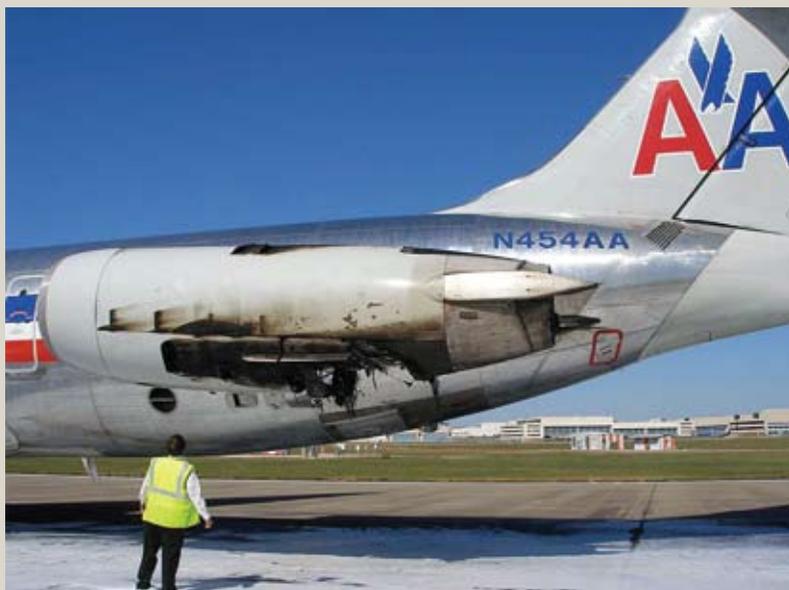
The accident investigation found that the mesh in the accident ATSV air filter “had

disintegrated and that about 70 percent of the material was missing,” the report said.

The post-accident examination of the ATSV air filter also revealed that the deterioration of the filter mesh had allowed the end cap to separate and to move into a position where it “could block the airflow from the ATSV air filter to the ATSV ... and prevent airflow to the ATS, causing an intermittent engine no-start condition,” the report said.
