A buildup of ice came loose during final approach.

SNOWBALLS

in the Fuel System

BY MARK LACAGNINA

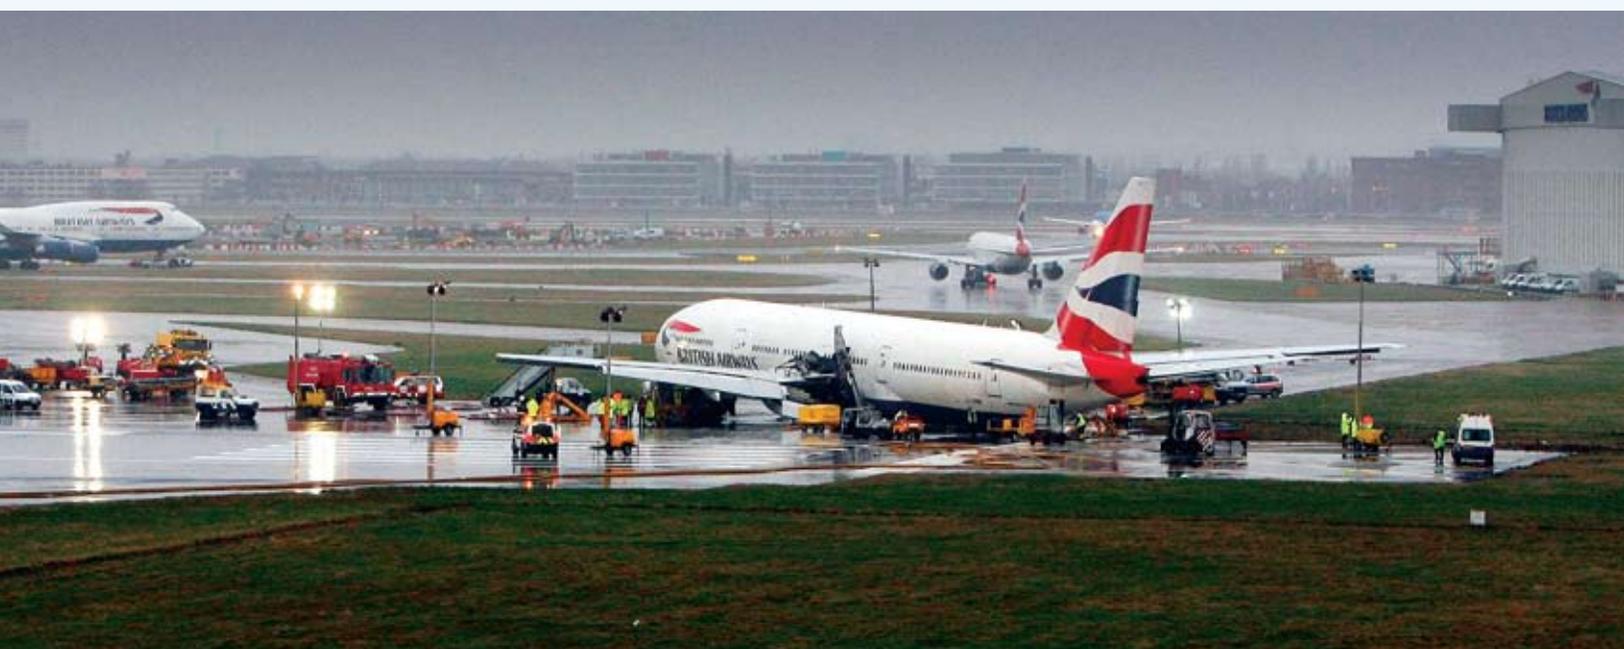
Despite fuel and oxygen leaks, there was no fire.

Descent rate was about 1,400 fpm and peak vertical acceleration was 2.9 g when the aircraft touched down in a grassy area about 330 m (1,083 ft) short of the runway threshold at 1242 UTC. The landing gear collapsed, and the 777 slid, turned right and came to a stop off the side of the runway threshold. Significant leakages of fuel and oxygen occurred, but there was no fire.
