BY WAYNE ROSENKRANS

SURVIVAL ON THE HUDSON

Inattention to safety briefings, life vests and life lines increased risks after US Airways Flight 1549 touched down.

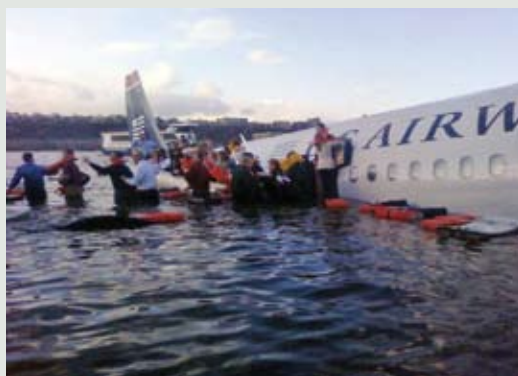
Top, one passenger jumped into the 41° F (5° C) Hudson River from door 1L before the slide/raft was deployed manually; bottom, overwing-exit life line-attachment points were unused, and nine passengers fell into the water.
