# FRACTURED BLADE

Accident investigators traced the fatal crash of an AS 350D to a fatigue fracture in a power turbine blade.

BY LINDA WERFELMAN

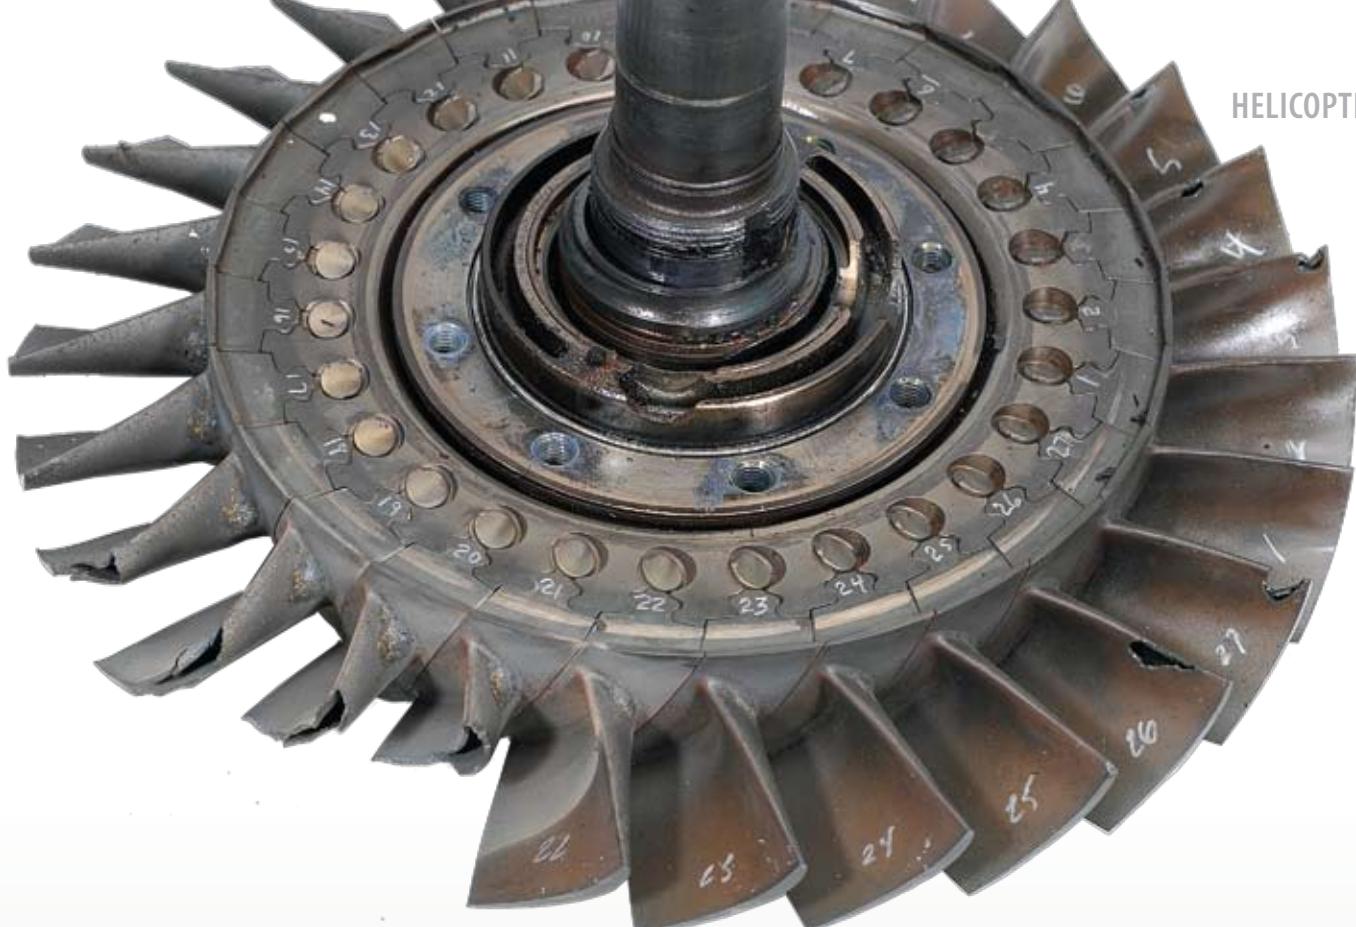
Investigators observed localized damage of four consecutive power turbine blades, two of which were fractured transversely, “across the airfoil above the blade root platform, and two were fractured high up their respective airfoils near the blade tips,” the report said. The other power turbine blades had generalized damage. All blades were in place and securely attached to the power turbine wheel.

A metallurgical examination, conducted with a scanning electron microscope, found “striation features typical of fatigue cracking on the pressure (concave) side” of one of the blades with a transverse fracture.
