THRUST INTO

Tire debris disabled sensors, causing a Learjet 60 to accelerate during a high-speed rejected takeoff.

AN OVERRUN

This article is based on NTSB Accident Report AAR-10/02: "Runway Overrun During Rejected Takeoff; Global Exec Aviation; Bombardier Learjet 60, N999LJ; Columbia, South Carolina; September 19, 2008." The full report is available at <ntsb.gov/Publictn/A_Acc1.htm>.

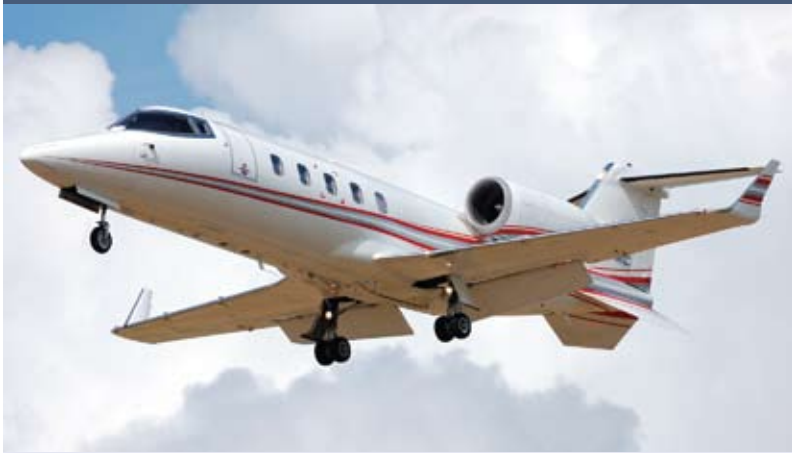
Bombardier Learjet 60

The thrust reverser doors deployed, as shown here, but then were inadvertently stowed, and the engines produced nearly full forward thrust.
