A small child's fall reminds adults of the need for close supervision and reveals inadequate updates to operators.

Airstair Vigilance

A 3-year-old girl's fall from the forward integral airstair of a Ryanair Boeing 737-800 — an approximate height of 8.5 to 9.0 ft (2.6 to 2.7 m) — has prompted the U.K. Air Accidents Investigation Branch (AAIB) to issue several safety recommendations, including one for airstair modification. She was released from a hospital after a 24-hour assessment and treatment of minor injuries.

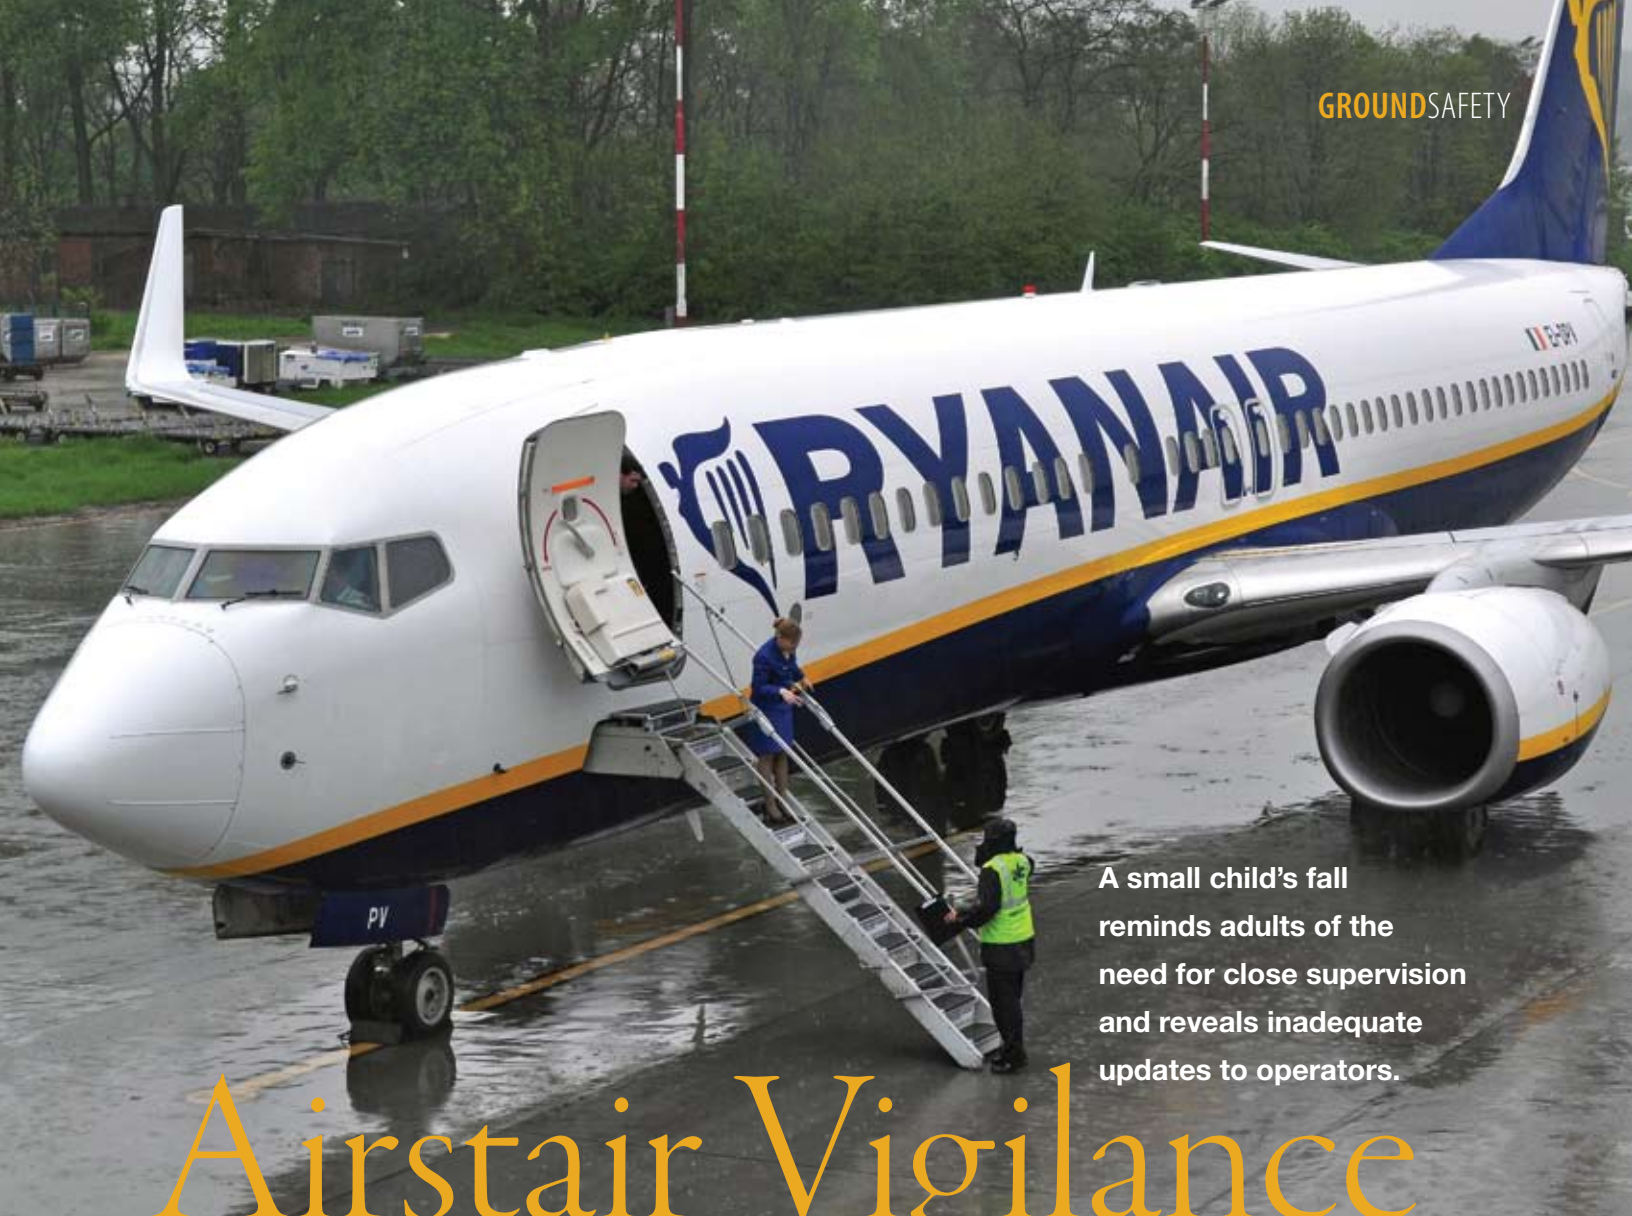
she held onto the lower handrail,” the report said. “When [the girl] reached the top of the stairs, she turned towards her mother, leaned backwards and fell through the gap between the extendable handrail and the top of the airstair, onto the hardstanding [ramp pavement] below.” Other passengers also were on the airstair at the time.

This integral airstair (Figure 1, p. 38) primarily was used to facilitate routine

boarding and disembarkation in place of portable ground-based steps or an airbridge, and safe operation depended on a combination of barriers, procedures and warnings on placards. “These airstairs include an integral two-rung handrail on either side,” the report said. “These [handrails] rise into position during deployment of the stairs, but due to the geometric restrictions imposed by the retraction mechanism design, they do not extend to the fuselage side.

Investigators concluded that the absence of a barrier that specifically protects small children also should be addressed. “The gap between the extendable handrail and the upper platform of the Boeing 737 airstair represents a hazard to small children boarding or disembarking the aircraft,” the report said. “Four previous events resulted in [amended guidance or safety bulletins that] do not provide physical protection against a child falling through the gap. The modification proposed by the operator provides a significant visual cue to the lack of a rigid barrier in this area, but provides only a limited physical protection against falling.”
