# FIRE in the HOLD

The DC-8 flight crew received little warning of the impending conflagration.

*This article is based on NTSB Accident Report NTSB/AAR-07/07: “Inflight Cargo Fire; United Parcel Service Company Flight 1307; McDonnell Douglas DC-8-71F, N748UP; Philadelphia, Pennsylvania; February 7, 2006.”*

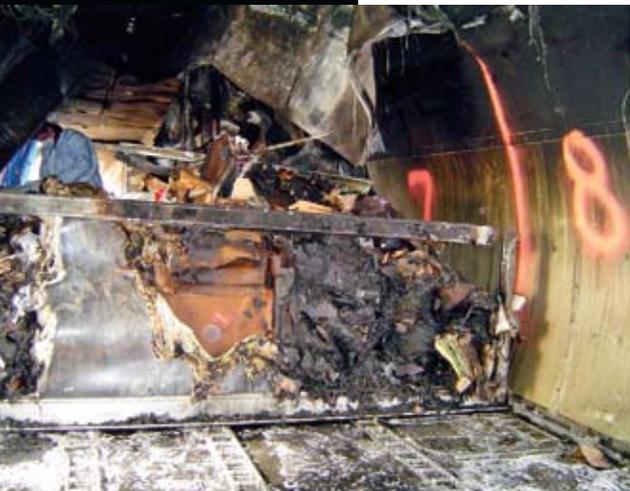
**Figure 1**

Investigators determined that the fire likely began inside cargo container 12, 13 or 14

(Figure 1). Among the items that had been shipped in these containers were electronic devices, including laptop computers, with rechargeable lithium batteries. Several lithium batteries of the same type also were found loose in the accident debris.

Noting that “testing and incident data indicate that lithium batteries can pose a fire hazard,” the report said there was no evidence that lithium batteries were the source of ignition aboard the DC-8.
