BLINDSIDED

The pilots of an Airbus A340 did not anticipate the 'severe deterioration' of weather as they approached the runway threshold at Toronto.

This article is based on TSB Aviation Investigation Report A05H0002, “Runway Overrun and Fire, Air France, Airbus A340-313 F-GLZQ, Toronto/Lester B. Pearson International Airport, Ontario, 02 August 2005.”

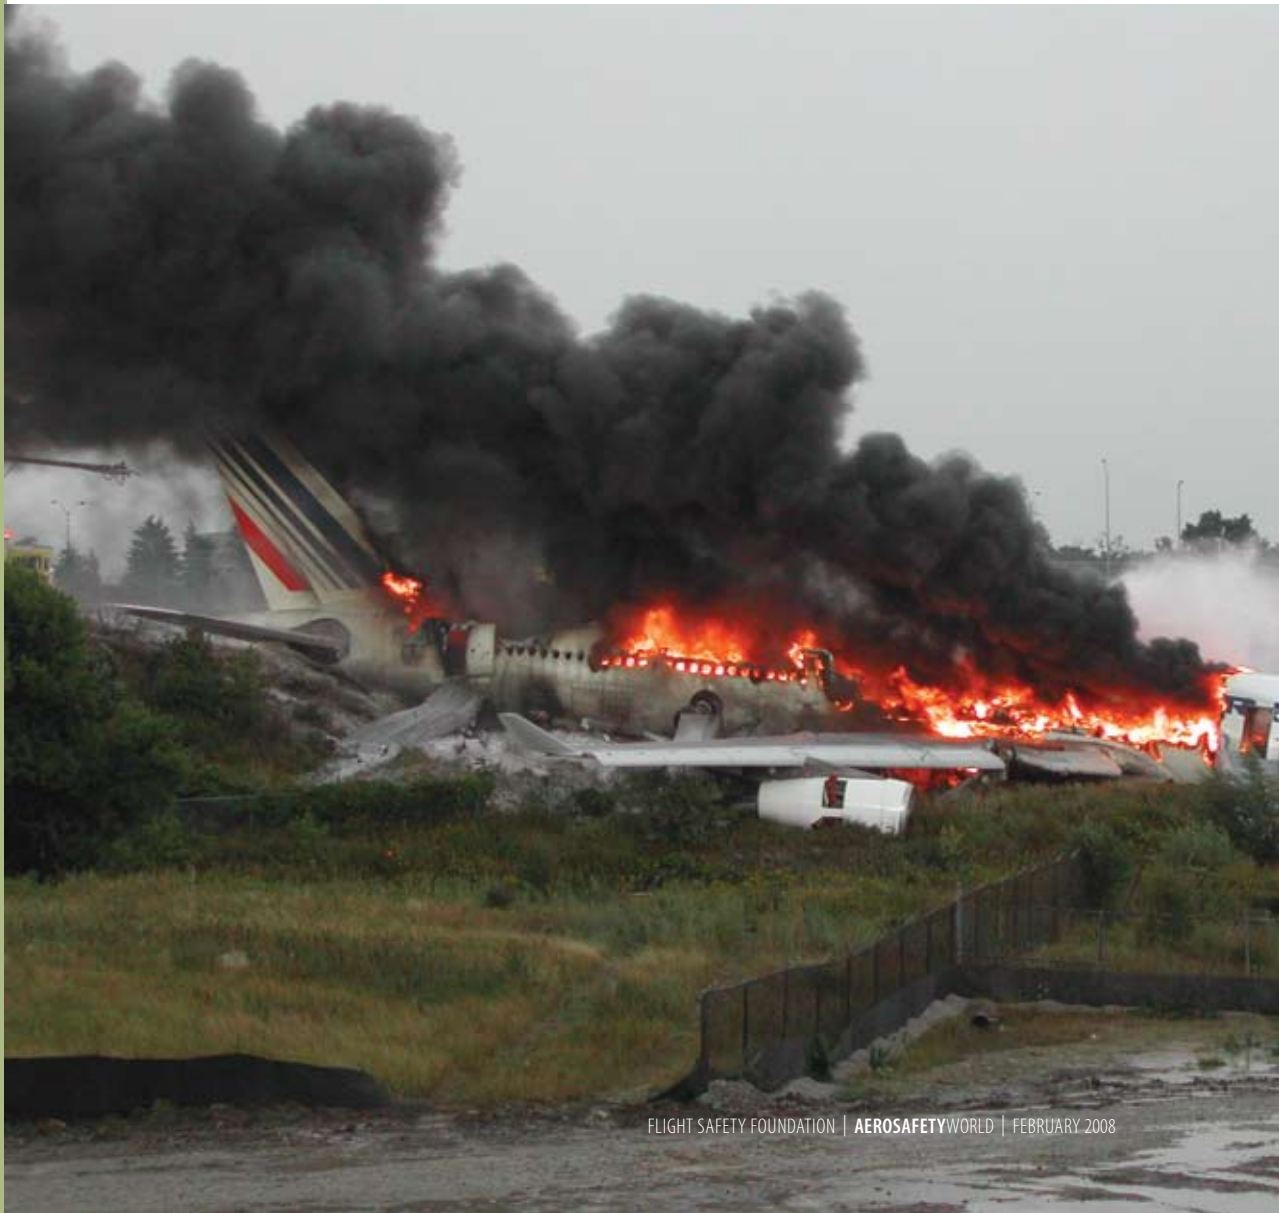
The Air France Airbus A340-300 was high and fast when it crossed the threshold of Runway 24L at Toronto/Lester B. Pearson International Airport during a thunderstorm, with heavy rain and lightning strikes that significantly reduced visibility before the touchdown 3,800 ft (1,159 m) down the 9,000-ft (2,745-m) runway. The crew selected reverse thrust 12.8 seconds after touchdown and full reverse 16.4 seconds after touchdown but was unable to stop the airplane before it departed the far end of the runway at 80 kt, crossed two roads, plowed into a ravine and burned.

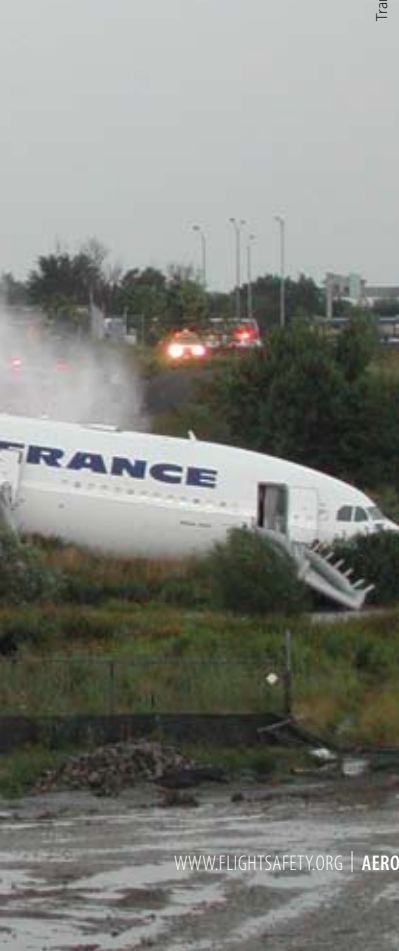
Figure 1

The crew did not calculate the landing distance required and “consequently, they were not aware of the margin of error available ... [or] that it was eliminated once the tailwind was experienced,” the TSB said. In addition, “there were no landing distances indicated on the operational flight plan for a contaminated runway condition” at the airport, and although the first 500 ft/150 m beyond the departure end of the runway complied with Transport Canada (TC) standards, “the topography of the terrain beyond this point, along the extended runway centerline, contributed to aircraft damage and to the injuries to crew and passengers,” the TSB said (Figure 1).

Runway 24L Safety Areas, Actual and Recommended

- A. Runway strip: Area extending 200 ft/60 m from end of runway, 500 ft/150 m from either side of centerline. Transport Canada standard, in place at Runway 24L.
- B. RESA: Area extending 300 ft/90 m from end of runway, twice runway width. ICAO standard, TC recommendation, not in place at Runway 24L.
- C. RESA: Area extending 1,000 ft/300 m from end of runway, twice runway width. ICAO recommendation, not in place at Runway 24L.
- D. RSA: Area extending 1,000 ft/300 m from end of runway, 250 ft/75 m either side of centerline. FAA standard, not in place at Runway 24L, not applicable outside U.S.

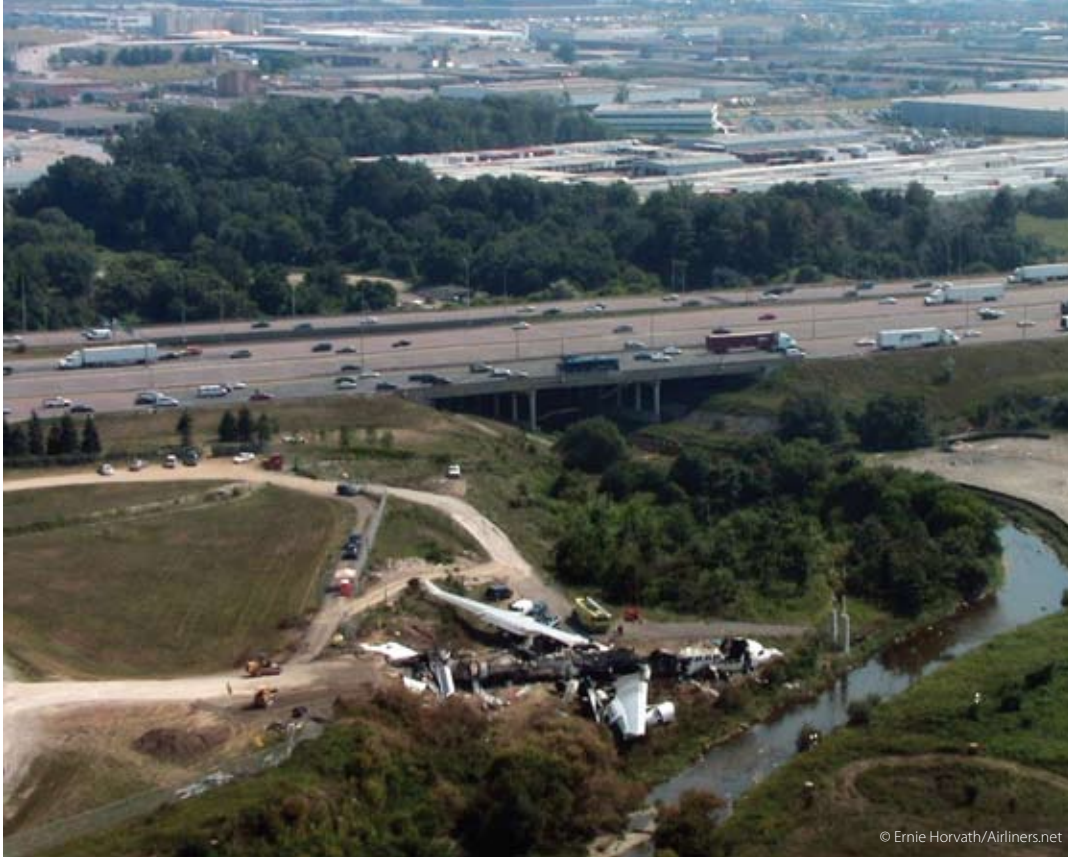
Figure 2

The airplane was 40 ft above the glideslope when it crossed the runway threshold and entered an area of heavy rain and lightning strikes; visual contact with the runway environment was “severely reduced,” the report said. The PF began the flare when the airplane was 40 ft above the runway (Figure 2).
