# HIGH, HOT and FIXATED

Despite several warnings, the Garuda 737 pilot stayed focused on landing.

*This article is based on NTSC Aircraft Accident Investigation Report KNKT/07.06/07.02.35: “Boeing 737-497, PK-GZC, Adi Sucipto Airport, Yogyakarta, Indonesia, 7 March 2007.”*

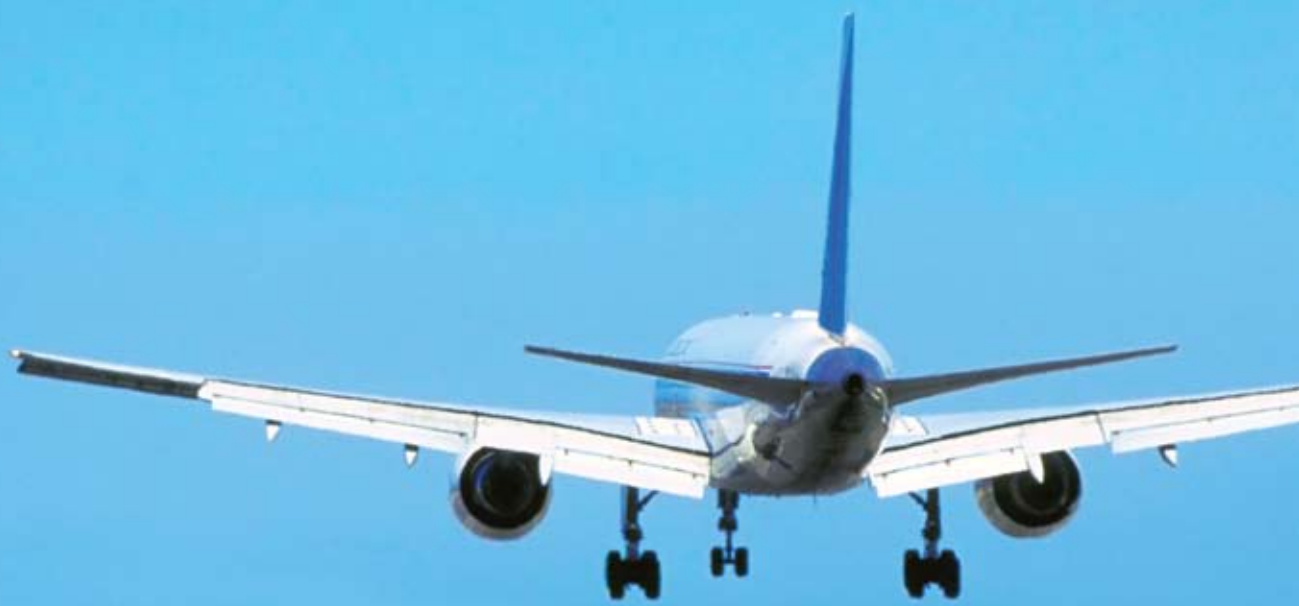
The copilot called twice for a go-around, and the ground-proximity warning system (GPWS) aboard the Garuda Indonesia Boeing 737-400 provided 15 alerts and warnings during the approach. But the pilot-in-command (PIC) was intent on landing the aircraft on the runway at Yogyakarta, Indonesia, and either did not hear or did not heed the warnings. He continued the steep and excessively fast approach, which resulted in an overrun,

several fatalities and serious injuries, and the destruction of the aircraft.

The Indonesian National Transportation Safety Committee (NTSC) said, in its final report, that the causes of the March 7, 2007, accident were ineffective flight crew communication and coordination; the crew's failure to reject the approach when stabilized approach criteria were not met; the PIC's failure to act on the warnings from the copilot and the GPWS; the copilot's failure to take control of the aircraft;

and the absence of pilot training by the airline on required responses to GPWS alerts and warnings.
