BY MARK LACAGNINA

**A relayed company message distracted the crew during an autoland approach.**

# Bad CALL

*This article is based on AAIB report no. 5/2008: “Report on the Accident to Boeing 737-300, Registration OO-TND, at Nottingham East Midlands Airport on 15 June 2006.”*

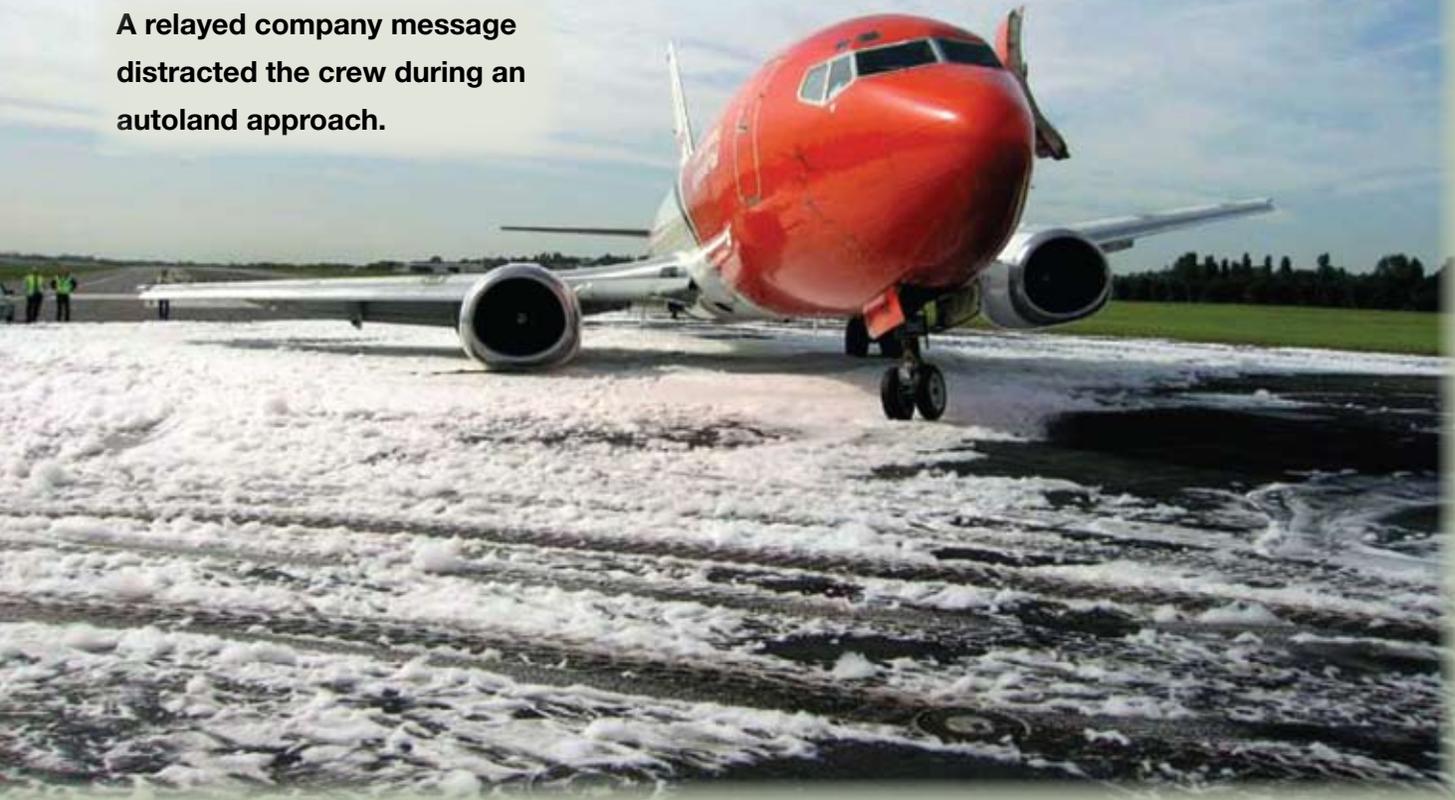
The fuse pins in the right main landing gear failed, as designed, on contact, preventing structural damage to the wing.

The impact occurred at 0439. After breaking off at its fuse pin attachment points, the right main gear struck the inboard flap assembly and the rear fuselage, and came close to striking the horizontal stabilizer. The bottom of the right engine nacelle and right wing tip also were damaged.
