Pilots at several airports have reported navigation problems that involve erroneous heading information. Authorities blame magnetic anomalies in areas on the ground.

AIRPORT MAGNETISM

This article is based on U.K. AAIB Aircraft Incident Report No. 1/2008 (EW/C2006/10/10).

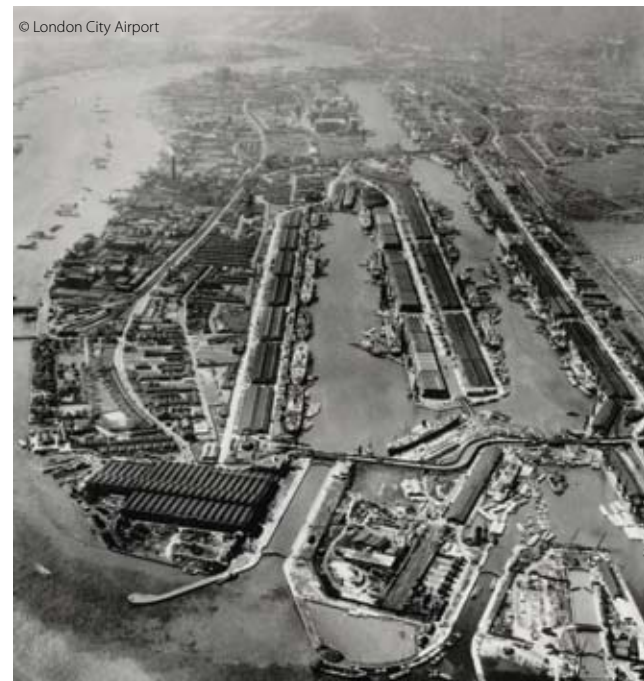
Figure 1

found compass deviations of as much as 97 degrees (Figure 1, p. 19).

The surveys concluded that the compass deviation problems at LCY are “caused by several ferrous magnetic signature anomalies, primarily emitted as a vertical component from the 68 piled-beam structures situated under [the] Runway 28 holding area.”
