The NTSB says an operating radio altimeter likely could have prevented the fatal crash of a Eurocopter EC 135P2 on an EMS repositioning flight.

Dark-Night EMS

This article is based on NTSB Aviation Accident Brief NYC05MA039.

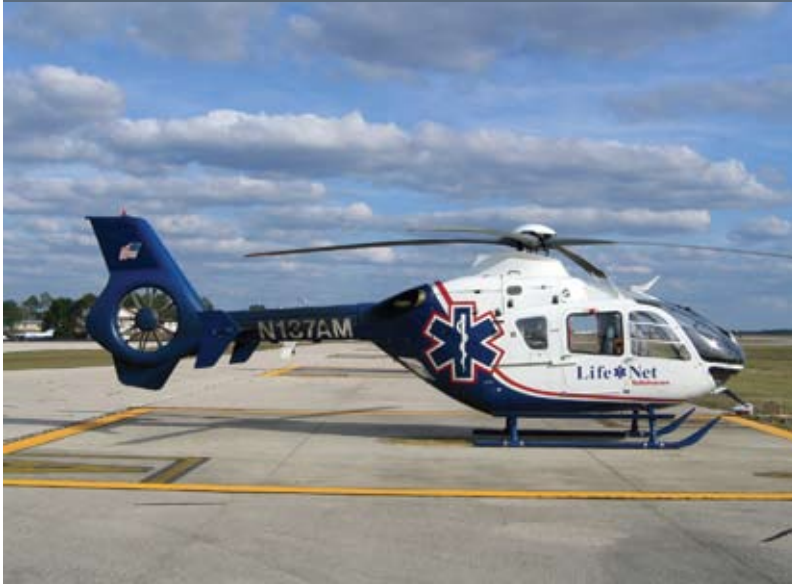
The Eurocopter EC 135 is a light utility helicopter. Its first prototype was flown in 1988 and was known then as a BO 108; the first two production EC 135s were delivered in 1996.

The EC 135P2 was introduced in 2001, with two Pratt & Whitney PW 206B2 engines, each capable of 463 kw (621 shp) at takeoff and 419 kw (562 shp) maximum continuous.
