Easy Does It

TCAS resolution advisories require rapid — but not radical — response.

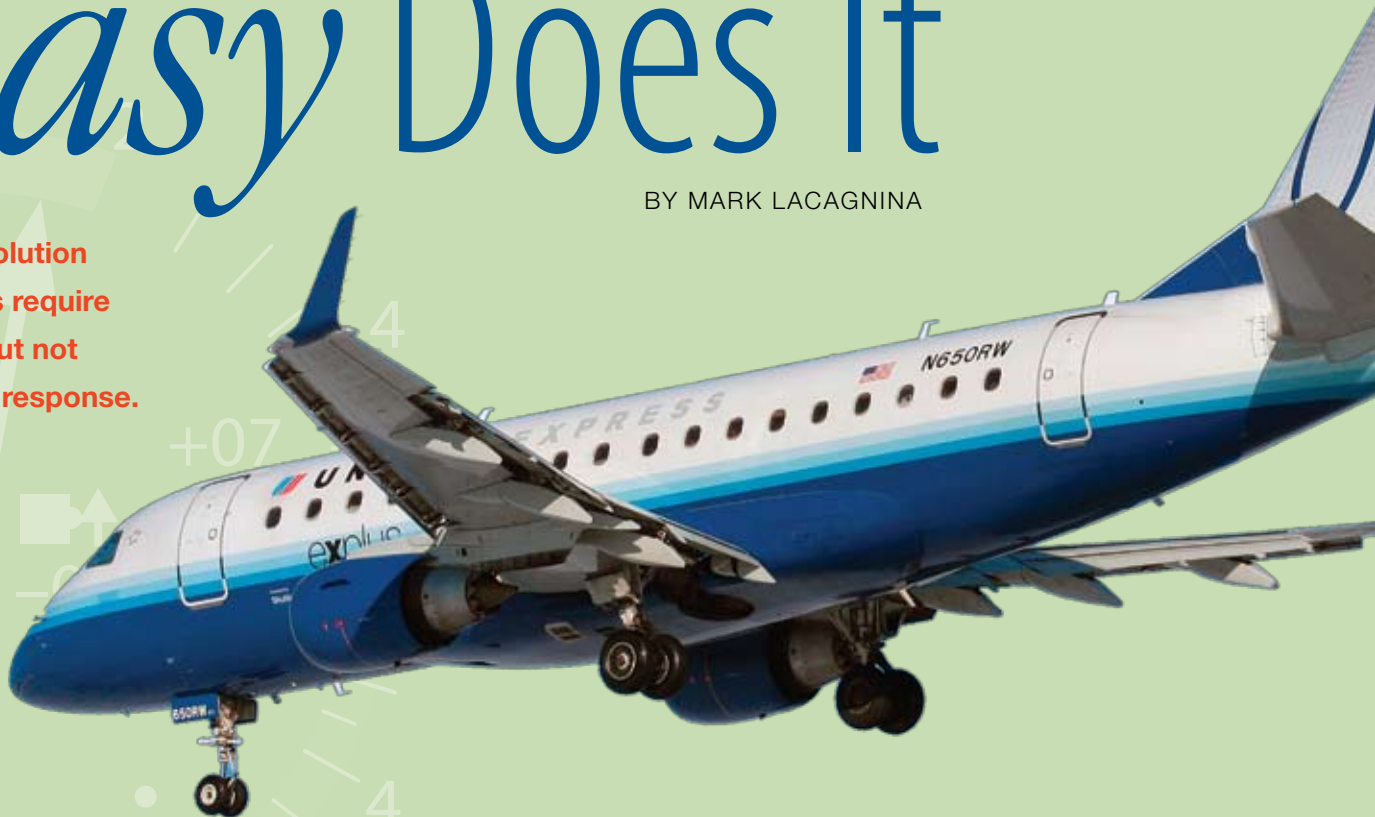
Recorded flight data indicate that the first officer increased the pitch attitude to 14 degrees nose-up, resulting in a peak vertical acceleration of +2.0 g — that is 2.0 times standard gravitational acceleration. NTSB said that the “excessive maneuver” was the probable cause of serious injuries, including a broken leg, sustained by a cabin crewmember. The 170 was not damaged.

A flight attendant suffered a broken leg when this Embraer 170 pulled 2 g during an excessive RA maneuver.
