Learning From Experience
Incident No. 3

Delayed

Pull-Up

Third in a series focusing on approach-and-landing incidents that might have resulted in controlled flight into terrain but for timely warnings by TAWS.

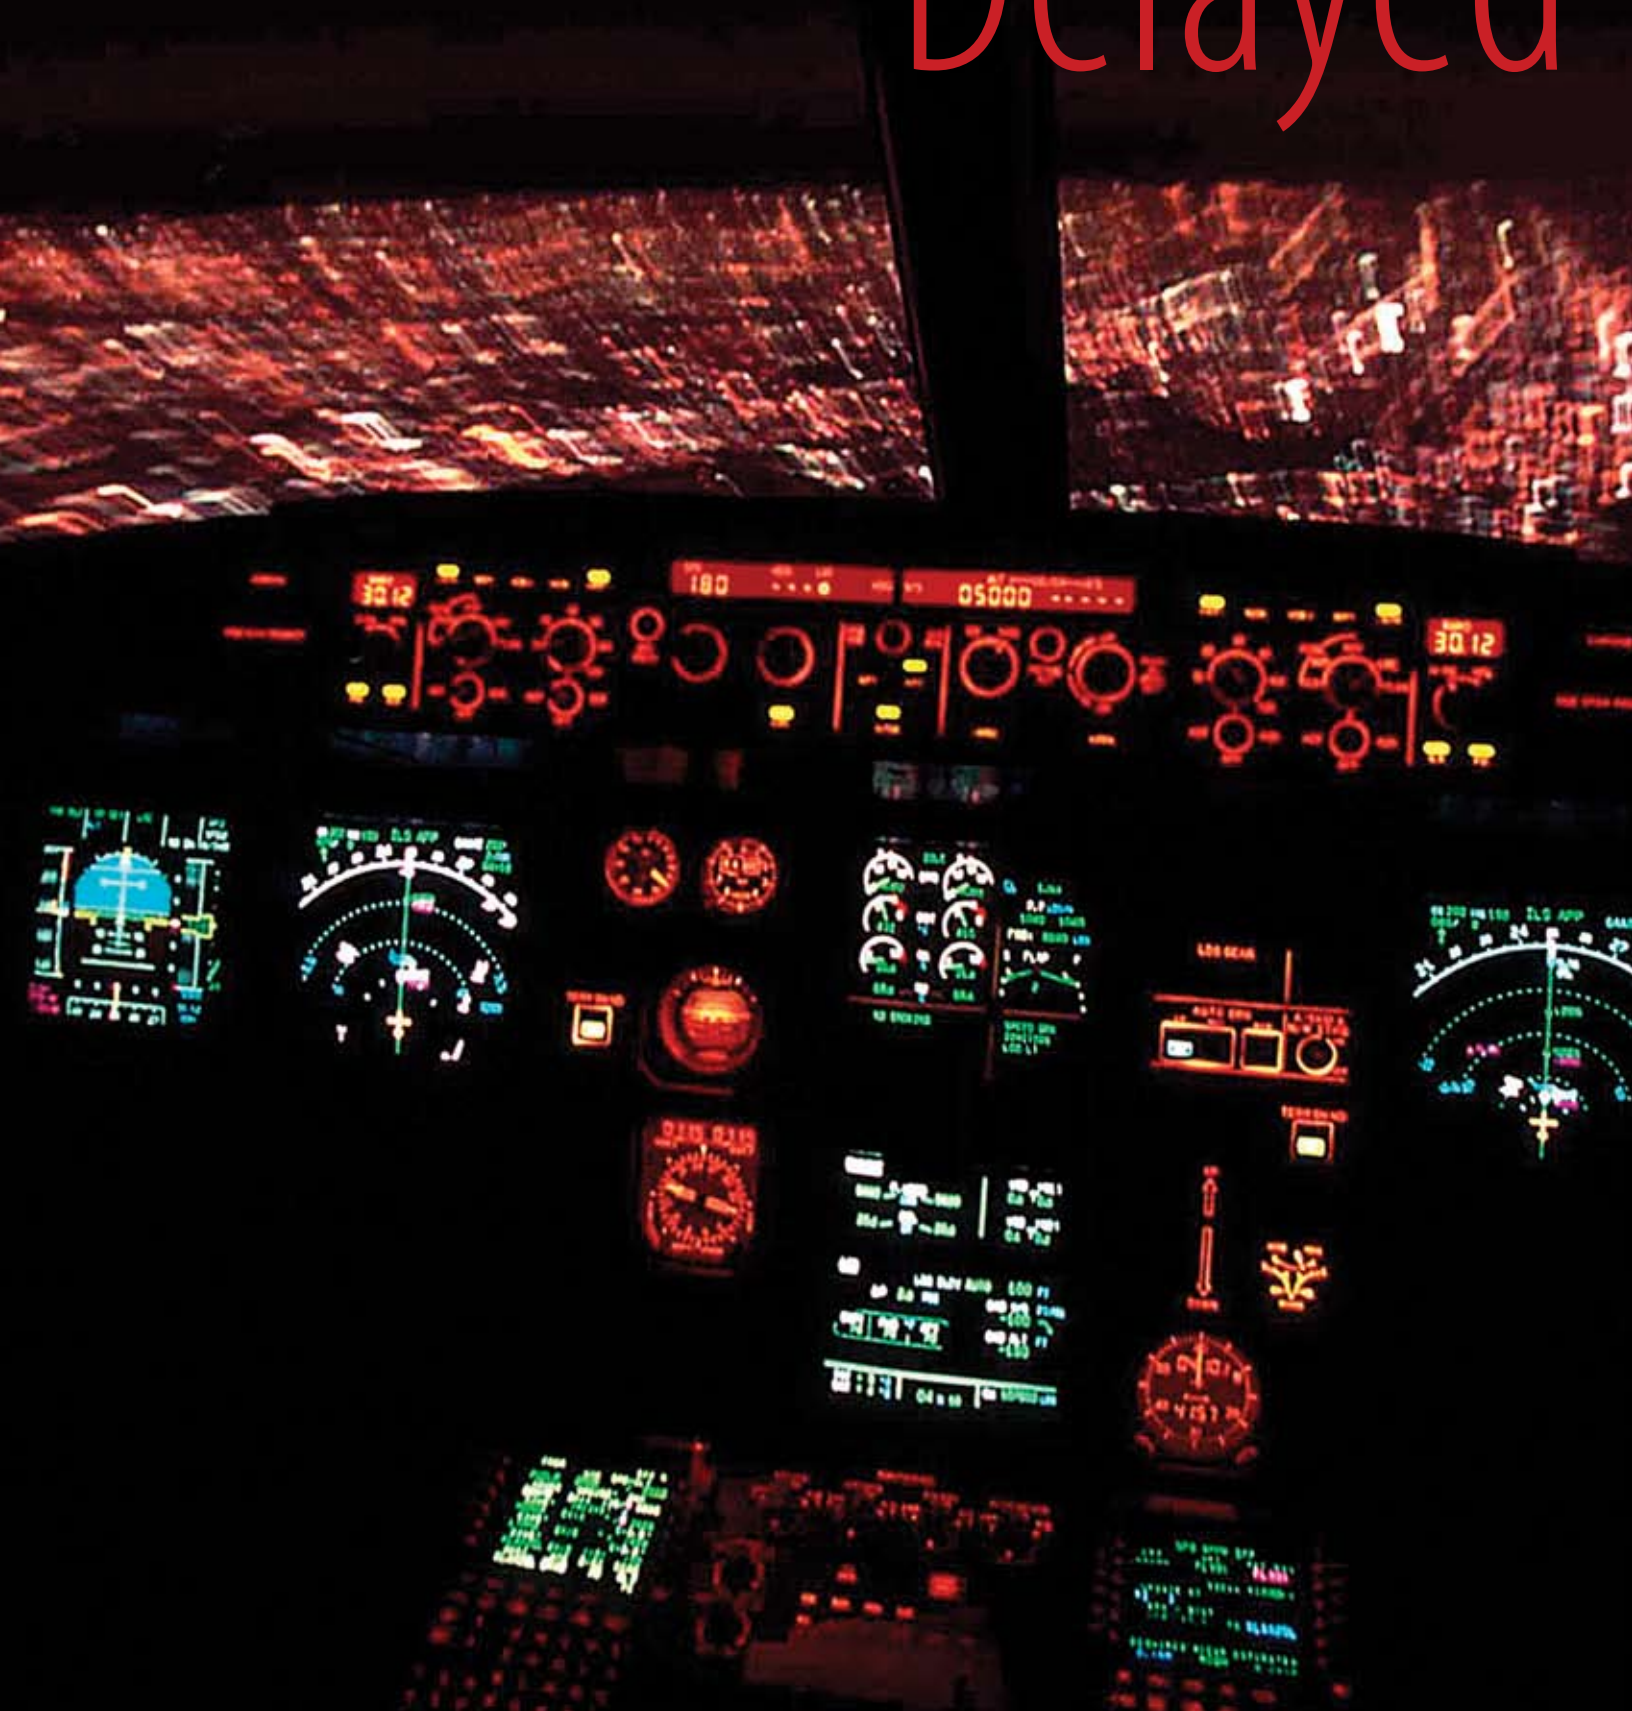
The chart for the VOR/DME (VHF omnidirectional radio/distance measuring equipment) approach, which the crew apparently was conducting in nighttime visual meteorological conditions (VMC) with visibility restricted by haze, shows that a minimum altitude of 4,600 ft should have been maintained until reaching the final approach fix (FAF), 7.0 nm DME from the station. However, the crew began the descent for the final segment of the approach two nm before reaching the FAF, from there flying a three-degree descent path (Figure 1).

The aircraft was about 1,300 ft too low when it crossed the FAF. The descent was continued below the minimum descent altitude (MDA) for the VOR/DME approach, 3,300 ft, likely because the flight crew had the ground environment in sight and was continuing the flight by reference to external visual cues. The crew received a “TERRAIN, PULL UP” warning from the TAWS

when the aircraft was 250 ft above ground level — a city in this case — and 6.7 nm from the station (about 6.0 nm from the runway threshold). The crew stopped the descent and began a climb, but leveled the aircraft at the MDA. Not having reached the charted step-down fix for descent to the MDA, 4.0 nm, the aircraft was 380 ft below the appropriate minimum altitude and about 100 ft below the top of a nearby obstacle.

The aircraft was in level flight at the MDA for about 1.5 nm before the TAWS generated a “TOO LOW, TERRAIN” warning, which apparently prompted the crew to conduct a missed approach.
