# Lessons Learned From Recent Incident

Singapore Aviation Safety Seminar 2019

Air turn back due to fuel discrepancy

# **LESSONS LEARNED FROM A RECENT INCIDENT**

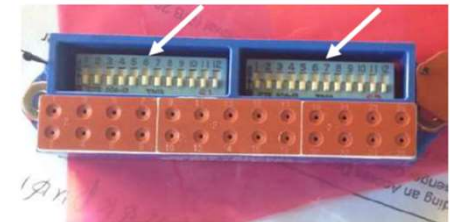
- B777 aircraft has different fuel tanks arrangement for B777-200 and B777-200ER (extended range)
- Centre tank of -200ER is bigger than -200, the difference is 40.5 tons

(In tonnes)	Boeing 777-200	Boeing 777-200ER
Center tank	36.612	77.063
Left tank	27.460	28.227
Right tank	27.460	28.227

- The Program Switch Module (PSM) setting dictates the fuel tank variant
- PSM communicates with fuel quantity processing unit (FQPU) the type of fuel tanks arrangement

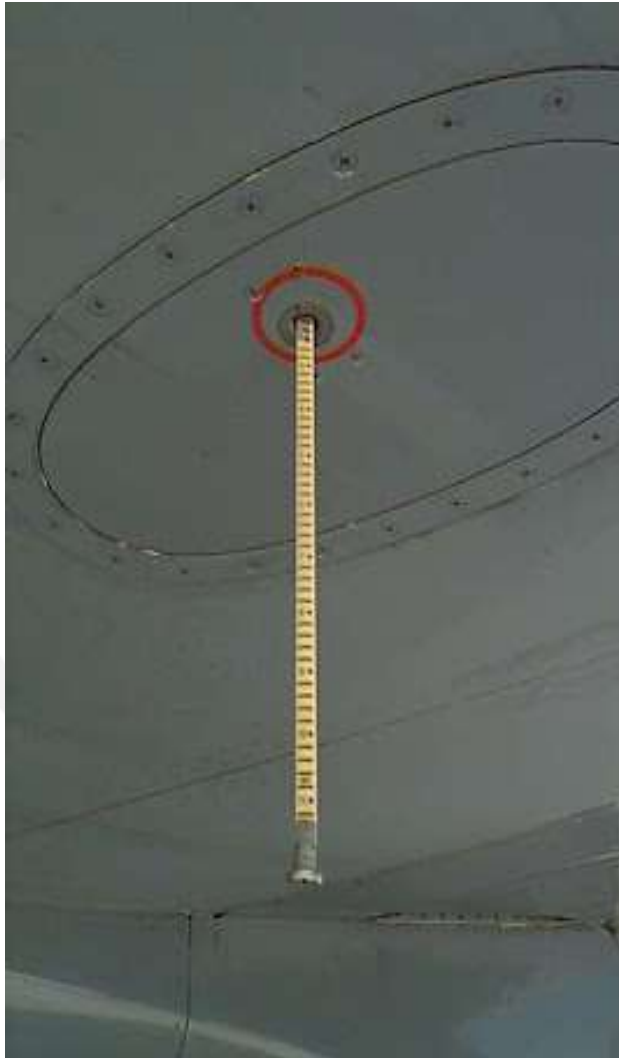
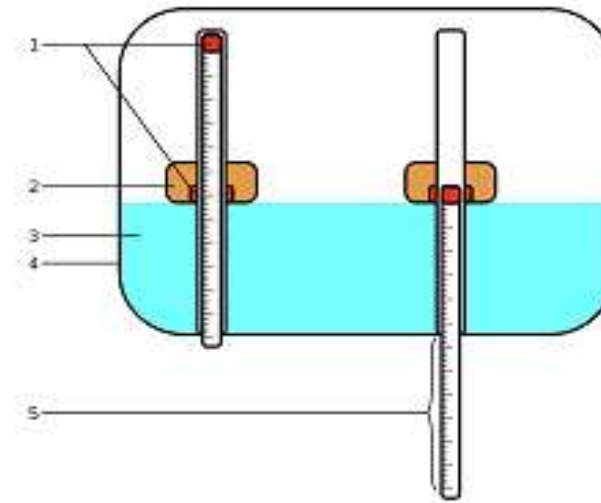
# Example of magnastick in fuel tank

- Magnastick check was performed and the fuel quantity was found tallied with FQIS, i.e., 86 tons
- Bowser operator was convinced that he might have forgotten to reset the fuel counter before the start of refueling and adjusted his fuel uplifted
  - Note: It was found out later that the bowser system would prevent the start of refueling if the fuel counter is not reset to zero
