## Failure to Comply With Nonprecision Approach Procedure Sets Stage for Regional Jet CFIT at Zürich

*The flight crew did not have visual contact with the runway or with the approach lights when they continued descent below the published minimum descent altitude. The airplane struck terrain soon after the crew began a missed approach.*

—  
FSF Editorial Staff

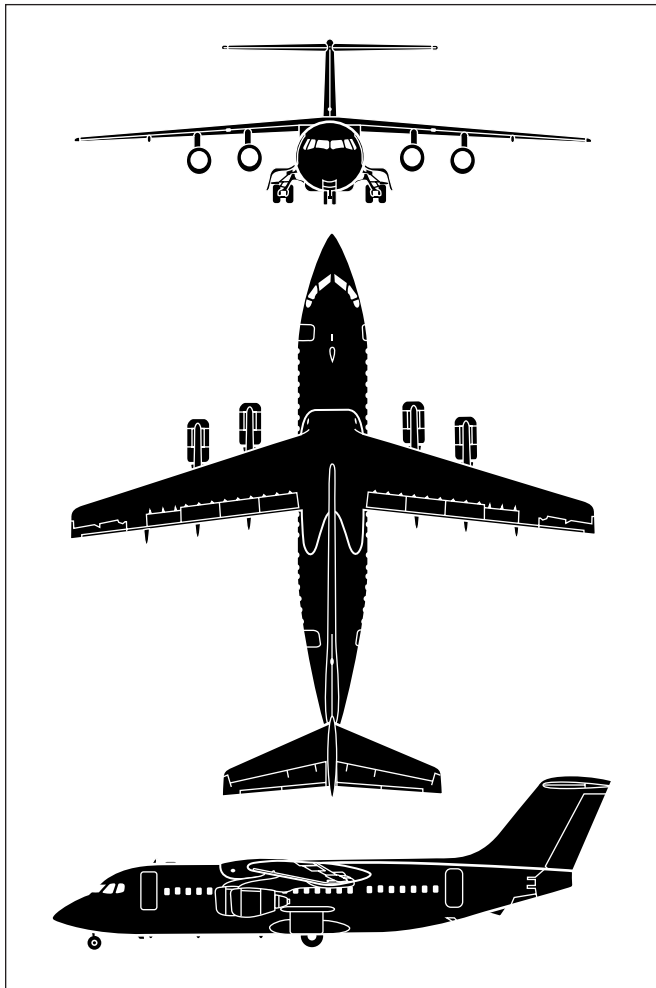
### British Aerospace Avro 146-RJ100

British Aerospace (BAe) Regional Aircraft (now part of BAE Systems) introduced the BAe 146 short-range transport airplane in 1983. The Avro 146-RJ100, a lengthened version of the airplane assembled by Avro International Aerospace, has four AlliedSignal (now Honeywell) LF507 turbofan engines, each producing 31.14 kilonewtons (7,000 pounds static thrust).
