Erroneous Airspeed Indications Cited in Boeing 757 Control Loss

Investigators concluded that the airplane had a blocked pitot tube and that, during departure, the flight crew became confused by false indications of increasing airspeed and did not respond to a stall warning. All the occupants were killed when the airplane struck the Caribbean Sea off the northern coast of the Dominican Republic.

—
FSF Editorial Staff

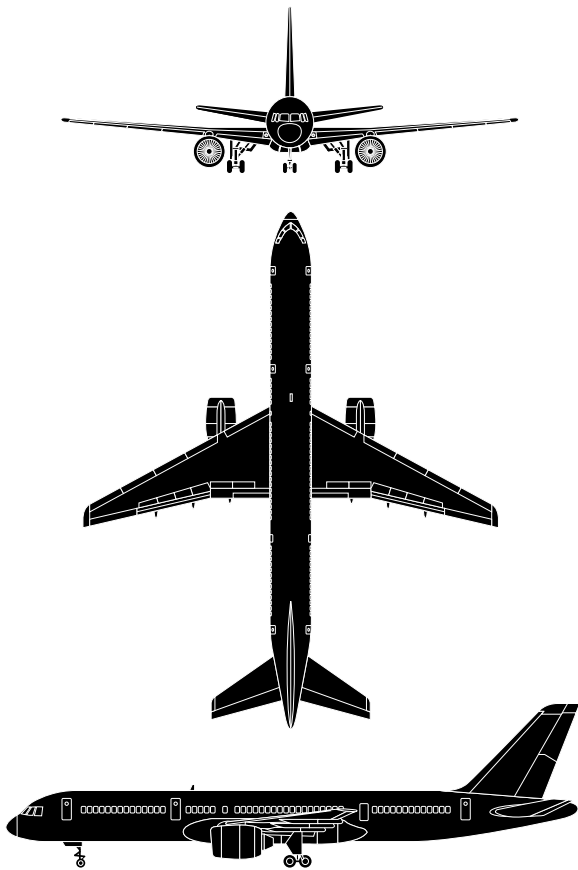
Boeing 757

The Boeing 757-200 series is a medium-range airliner designed to carry 186 passengers in a typical mixed-class configuration. The B-757 can accommodate up to 239 passengers in charter service, putting its capacity between that of the Boeing 737-400 and the Boeing 767. A longer range version and a freighter configuration of the B-757 are also available.
