Aero Safety WORLD

contents

December 2009–January 2010

Vol 4 Issue 12

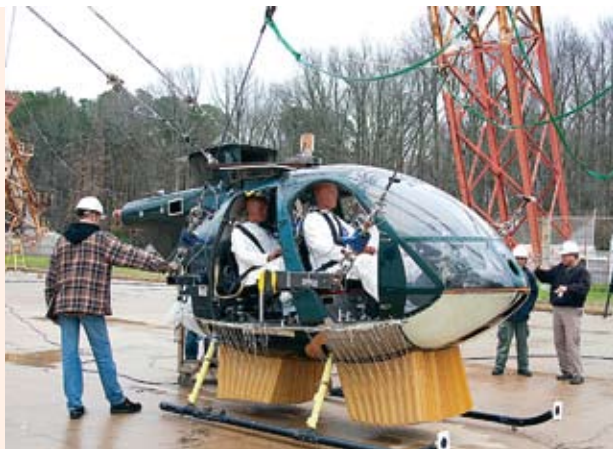
NASA said the drop test “imitated what would be a relatively severe helicopter crash,” with a flight path angle of about 33 degrees and combined forward and vertical speeds of about 48 ft (15 m) per second, or 30 mph (48 kph).

The MD-500 survived the crash “relatively intact,” NASA said. In a future experiment, the helicopter will be dropped again, without the deployable energy absorber.

Researchers at the U.S. National Aeronautics and Space Administration (NASA) are looking for ways to reduce the destructive forces of aviation crashes. Recent efforts have focused on determining whether a “deployable energy absorber” — an expandable honeycomb cushion attached to the belly of a helicopter — can ward off damage to a helicopter in a crash.

The honeycomb cushion, developed by Sotiris Kellas, a Langley engineer, is made of Kevlar and includes a flexible hinge that enables the cushion to be packaged and lie flat until it is needed.

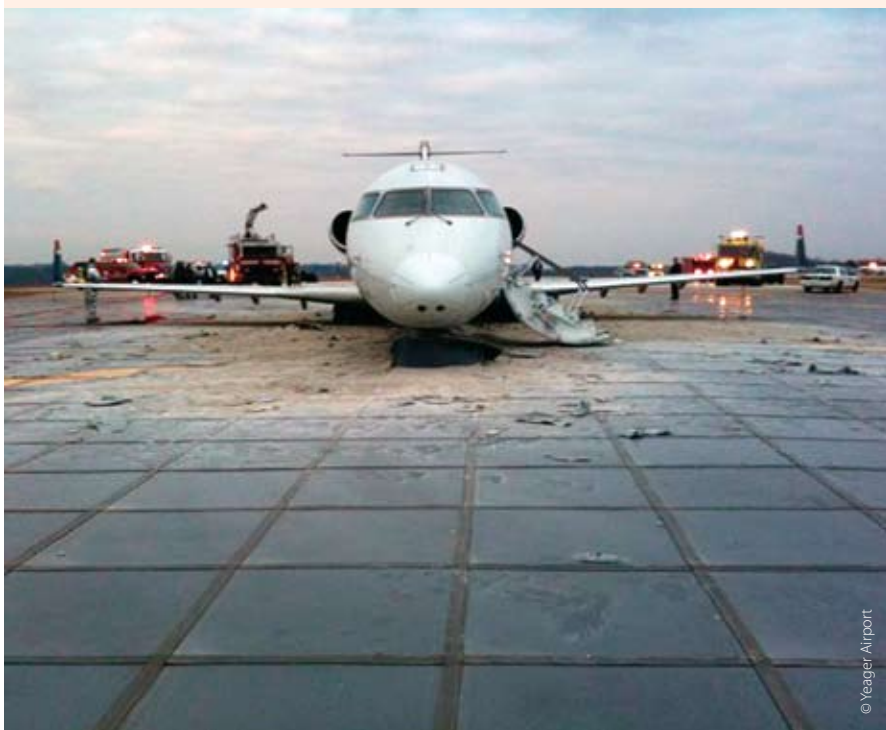
Emergency vehicles surround a US Airways Express CRJ200 that stopped in the engineered material arresting system (EMAS) area of a runway at Yeager Airport in Charleston, West Virginia, U.S., following a rejected takeoff. No one in the airplane was injured. The U.S. Federal Aviation Administration said the Jan. 19 incident was the fifth incident in the United States in which EMAS stopped an airplane after a runway overrun.

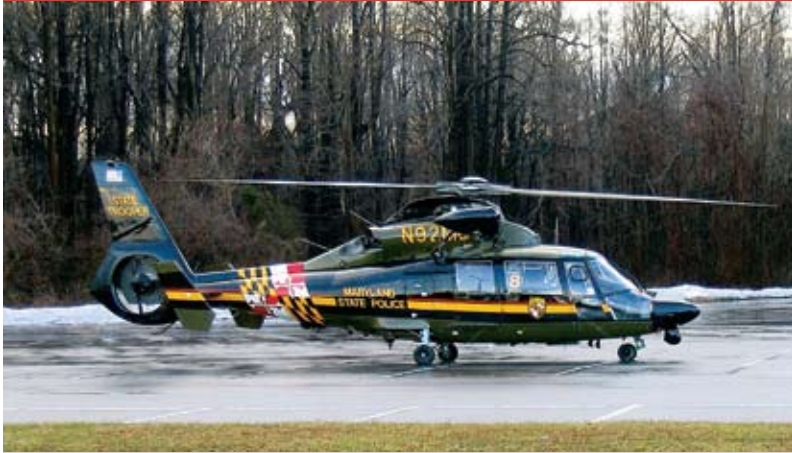
The Aerospatiale (now Eurocopter) SA 365N, first flown in 1979, is a twin-engine helicopter designed to carry two pilots and up to eight passengers. The accident helicopter had two front seats with dual controls and an aeromedical interior with four seats and two litters.

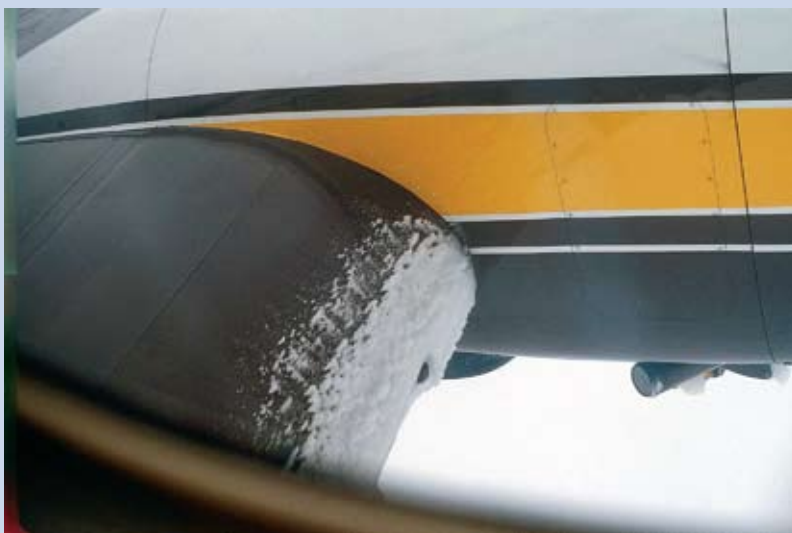
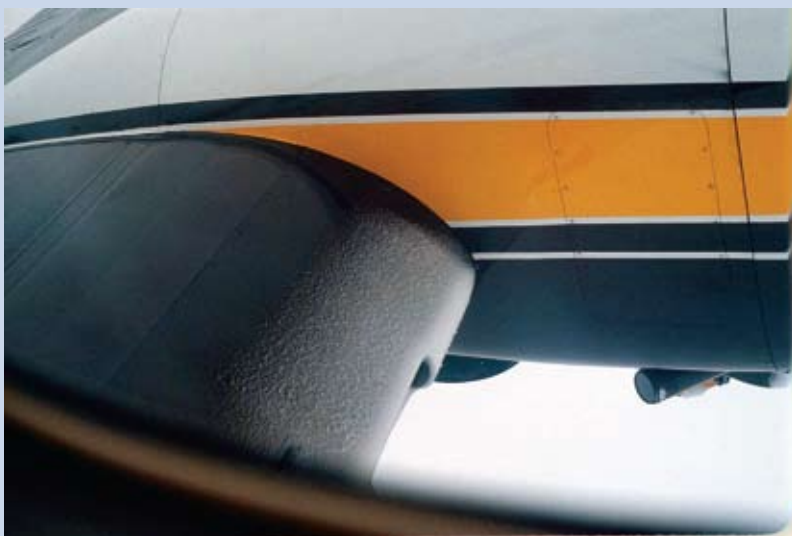
Two views of distributed-roughness icing, showing the thin layers involved.

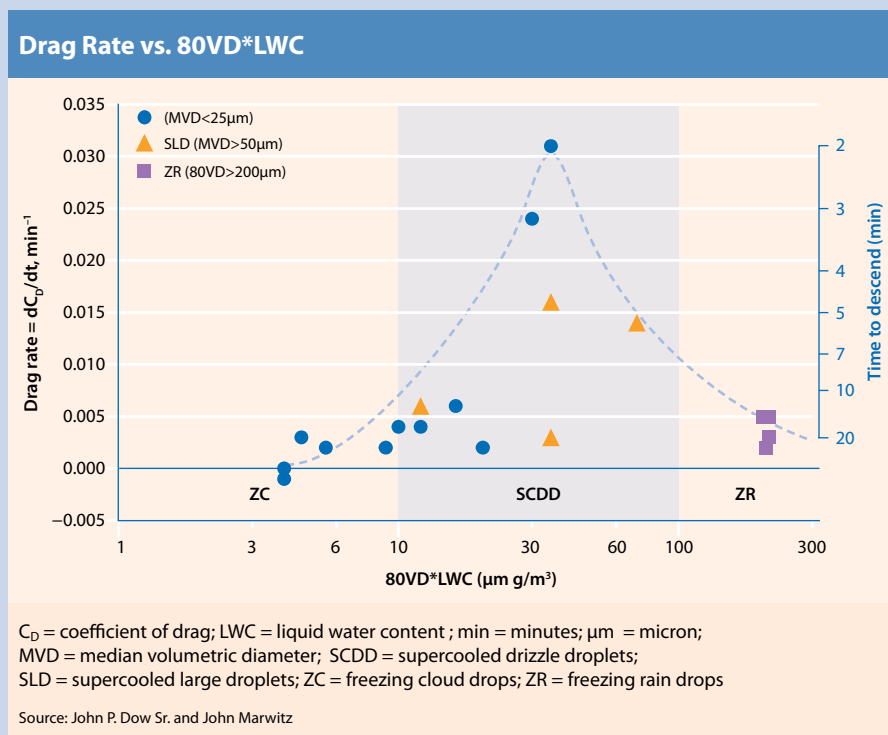
Figure 1

The problem was to identify a specific environment that would represent these mass and thermal inertial regulating processes. The parameter selected was the product of 80VD and total LWC. This product was abbreviated as 80VD*LWC and the accompanying graph was produced (Figure 1). Notably, the peak in the curve near 40 would be the same if 80VD on the Y axis was 400 microns and LWC on the X axis was 0.1 g per cu m, or if the Y axis was 100 microns and the X axis was 0.4 g per cu m.
