Aero Safety WORLD

December 2010–January 2011

Vol 5 Issue 11

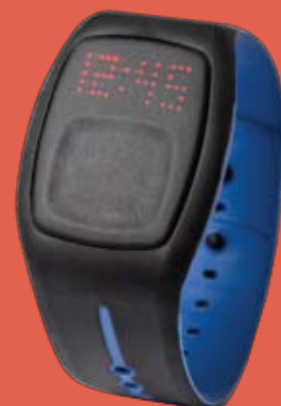
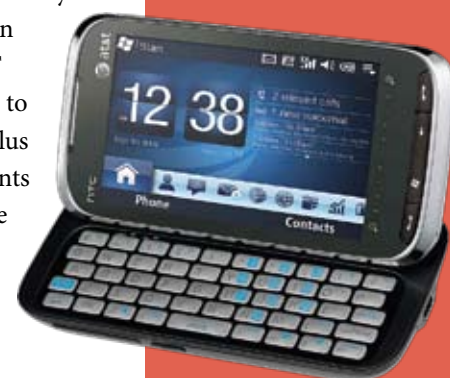
Flight attendants wore a Fatigue Science Readiband (previous generation) and performed tests on an AT&T Tilt.

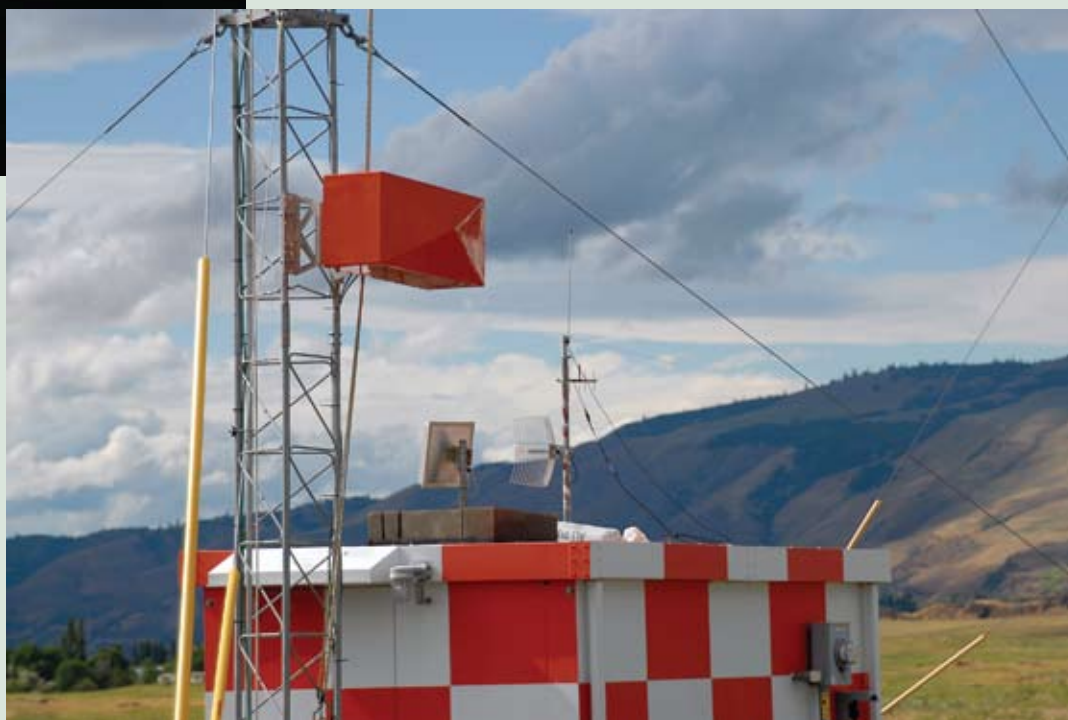
Ground equipment for a transponder landing system, below, is designed to occupy less space than equipment for a traditional ILS.

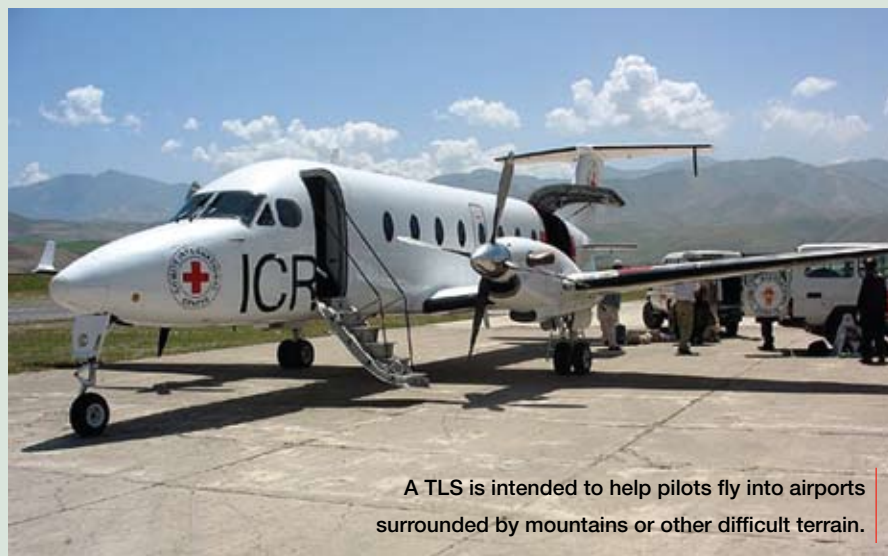
A TLS is intended to help pilots fly into airports surrounded by mountains or other difficult terrain.

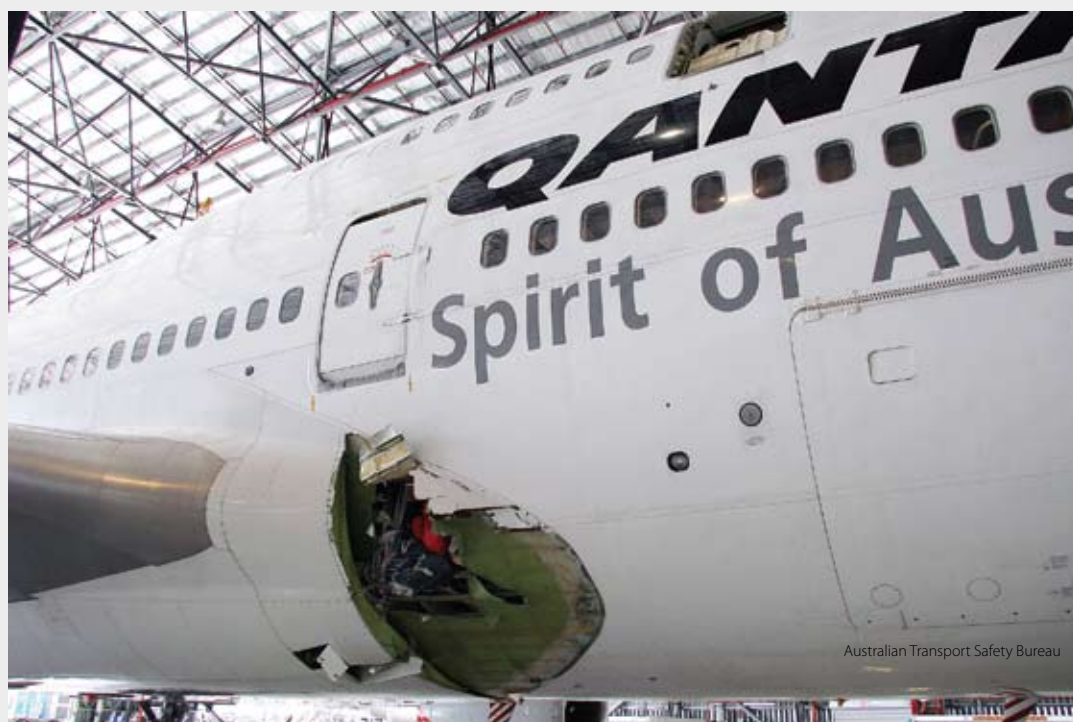
The accident aircraft (above) received substantial damage to its fuselage and other exterior and interior components when the cylinder burst.

The explosion ripped open the forward cargo hold and propelled the cylinder upward through the cabin floor, where it struck the door latch and overhead cabinets.

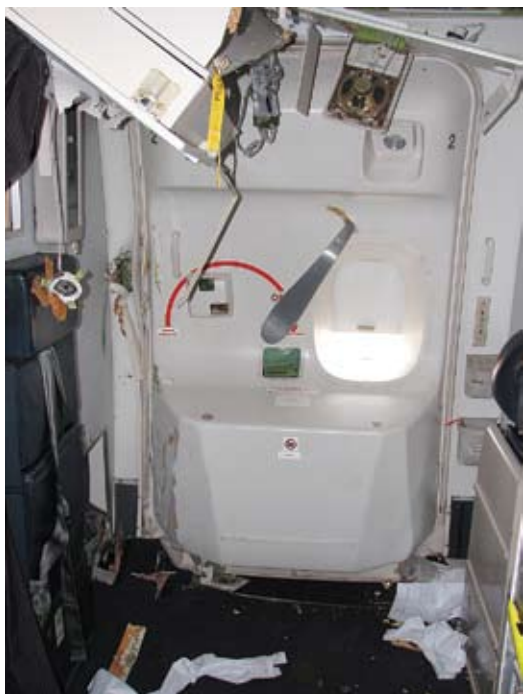
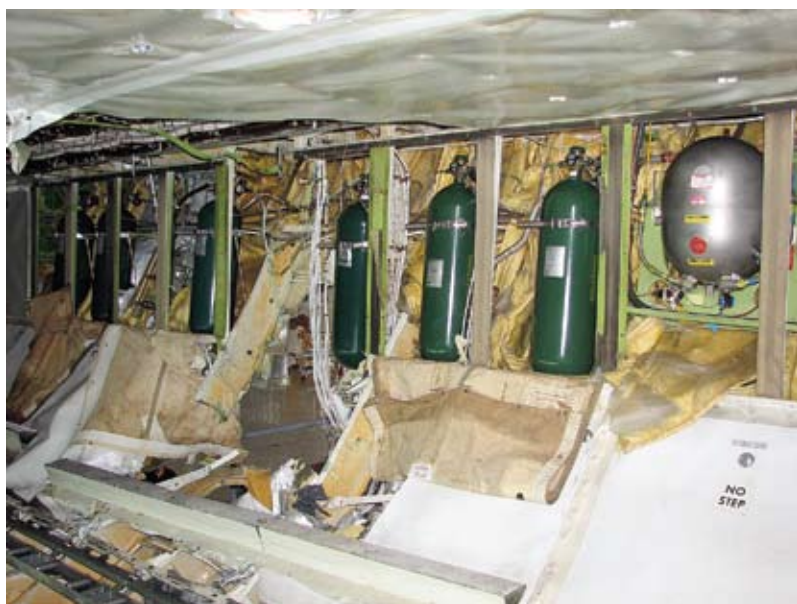
Big Hole

when the cylinder burst had torn a hole about 2.0 m (6.6 ft) high and 1.5 m (4.9 ft) wide, just forward of the right wing root. “Fuselage materials, wiring and cargo from the aircraft’s forward hold were protruding from the rupture,” the report said. The excess pressure created when the cylinder burst also opened the two pressure relief valve blowout doors on the left side of the cargo hold.

Although the cylinder itself was not recovered, the damage it caused enabled investigators to assemble a likely failure scenario. “It was evident that the cylinder had failed by bursting through or around the base, allowing the release of pressurized contents to project it vertically upward,” the report said. The cylinder severed 85 electrical wires and the first officer’s aileron control cables¹ before it penetrated the cabin floor, struck the R2 door frame and smashed the overhead paneling and storage cabinets. Investigators believe the cylinder then dropped back through the hole in the cabin floor and was swept out of the aircraft through the tear in the fuselage.

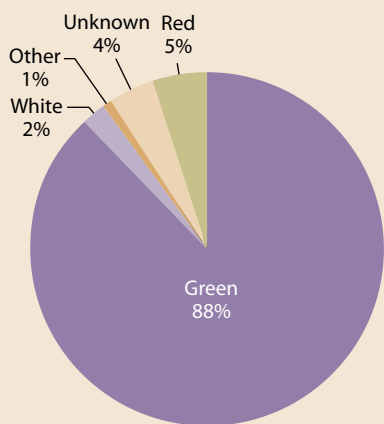
Figure 3

Percentage of Cockpit Illuminations, by Color, 2004–2008

technology has become more affordable. Green lasers were used in the great majority of illuminations during the study period (Figure 3).
