# AeroSafety WORLD

THE JOURNAL OF FLIGHT SAFETY FOUNDATION

FEBRUARY 2012

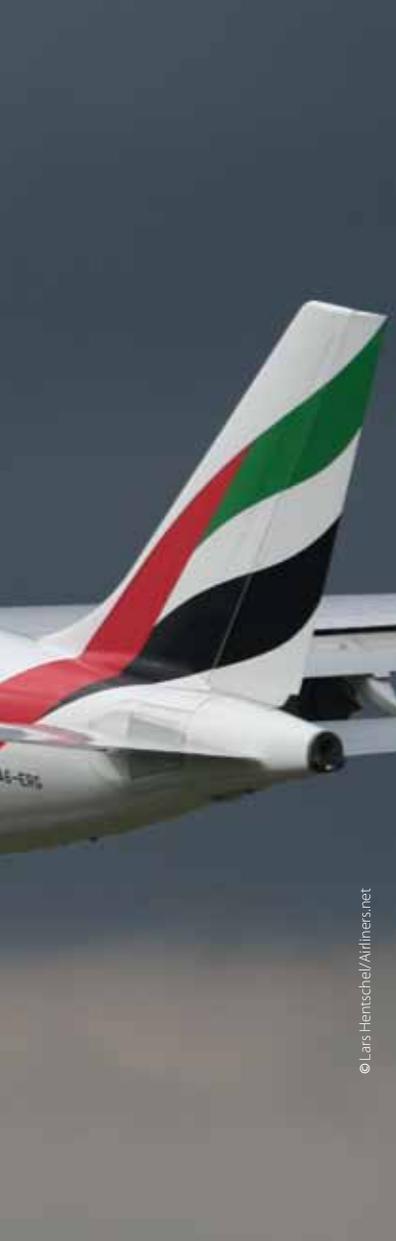
**This A340 was substantially damaged in a tail strike and overrun at Melbourne Airport.**

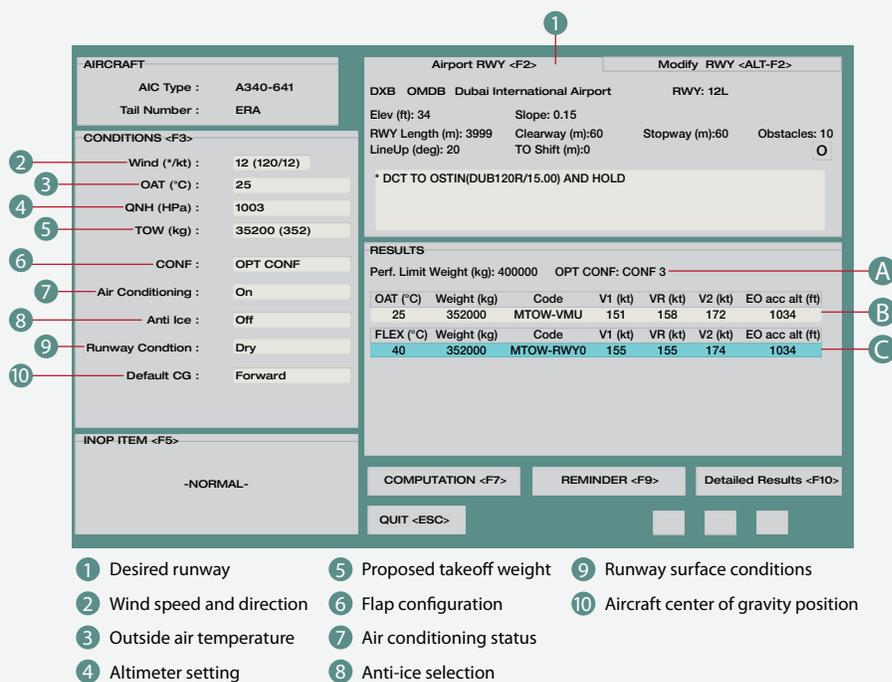
**Figure 1**

**EFB Takeoff Performance Screen (example)**

EFB = electronic flight bag

**Note:** Selection of the COMPUTATION button calculated the takeoff performance data and displayed **A** performance-limited takeoff weight and optimum flap configuration for the selected runway and entered conditions; **B** takeoff speeds and the engine-out acceleration altitude for the proposed takeoff weight using full takeoff thrust at the actual outside air temperature; and **C** takeoff speeds and engine-out acceleration altitude for the proposed takeoff weight using less than full takeoff thrust based on a computed flex takeoff thrust temperature value.

parameters (takeoff reference speeds and flap and engine settings) for the takeoff from Runway 16,” the report said. Among the data required to be entered into the EFB were wind speed and direction, outside air temperature and takeoff weight (Figure 1, p. 14).

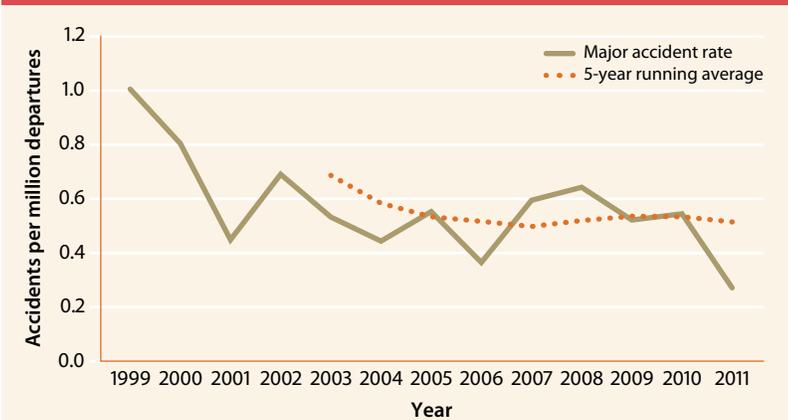
**Figure 1**

**Table 1**

**Western-Built Commercial Jet Major Accident Rates, 1999–2011**

**Note:** Total departure data are not available for Eastern-built aircraft.

decade, but the rate again has an encouraging downward trend (Figure 1). This accident rate is only for Western-built aircraft because, even though we know the number of major accidents for Eastern-built aircraft, we do not have reliable worldwide exposure data to calculate rates for them.

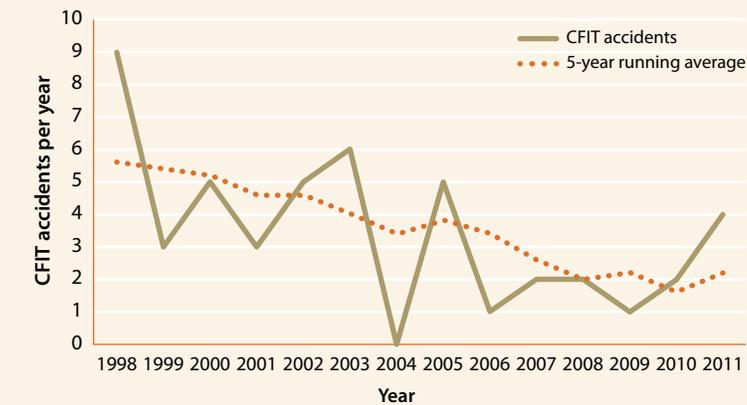
### Table 3

## CFIT Accidents, Worldwide Commercial Jets, 1998–2011

CFIT = controlled flight into terrain

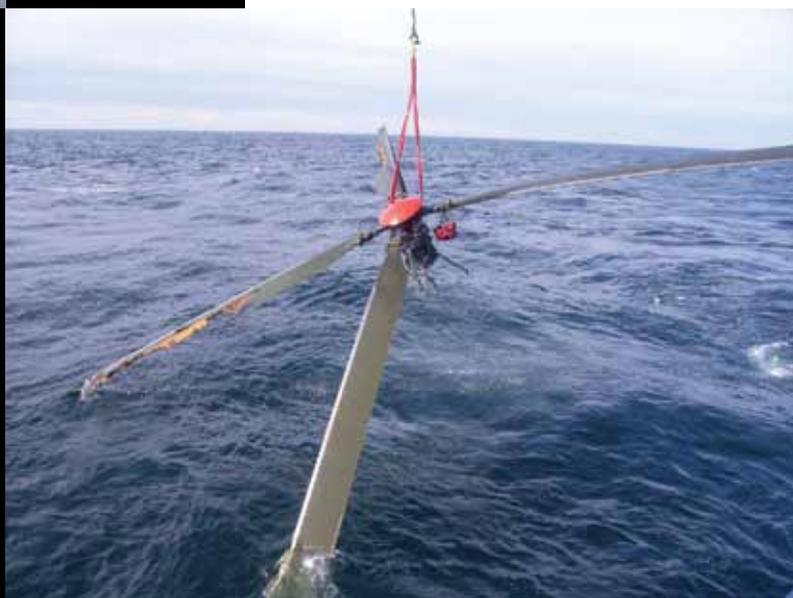
The main rotor blades separated from the helicopter before impact and were pulled from the North Sea during the recovery effort.

Two nm (4 km) away, a worker on the vessel Normand Aurora heard the helicopter and then saw it in a rapid descent to the water. He told investigators that the main rotor blades had separated from the helicopter before it fell

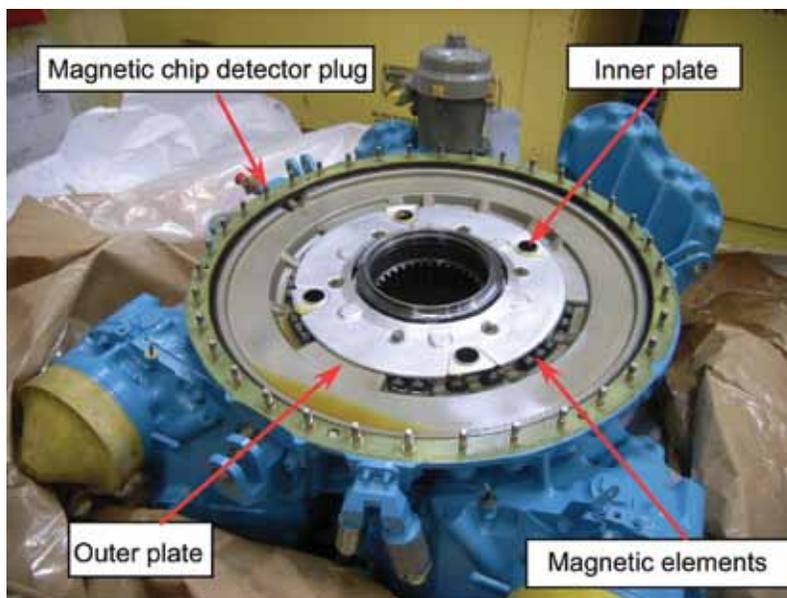
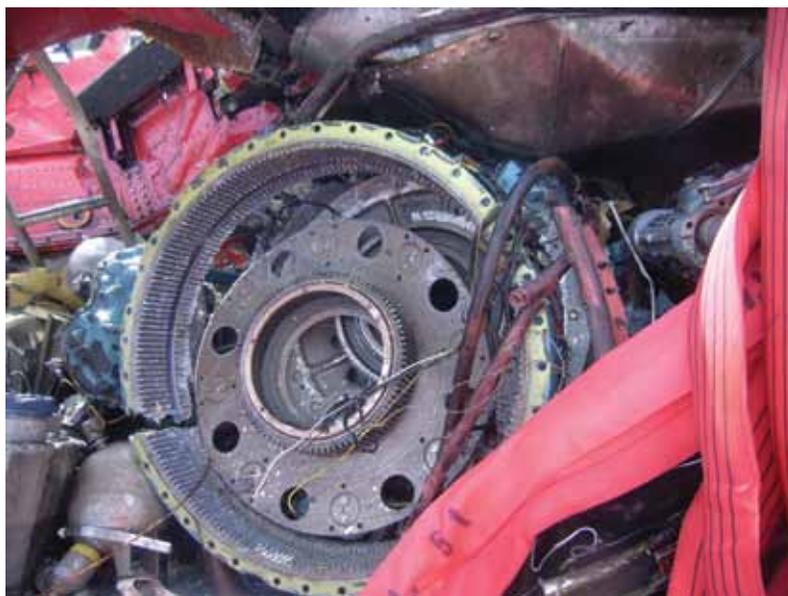
Photographs from the accident report show the main module of an AS332 L2’s main rotor gearbox, with the epicyclic module removed, above, and the epicyclic module ring gear from the accident helicopter, soon after it was recovered from the sea, below.

The accident investigation focused on the failure of the gearbox epicyclic module. Investigators found considerable damage throughout the epicyclic module, “consistent with it operating for a period of time whilst contaminated with debris,” the report said.

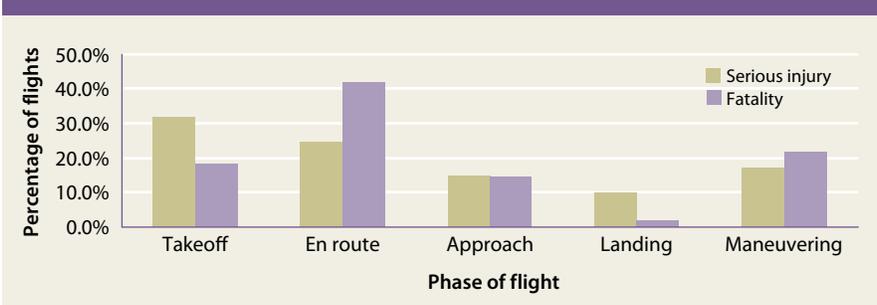
Figure 2

Alaska Fatal and Serious Injury Accidents, by Severity, 2004–2009

Note: Accident aircraft were operating under U.S. Federal Aviation Regulations Part 91 and Part 135.

Source: U.S. Federal Aviation Administration

Some differences in severity — fatality versus serious injury — were also noted (Figure 2, p. 52). The report says, “If the accident occurred during takeoff or landing, it was more likely to involve a serious injury, but no fatality. Most likely this was because of the lower energies associated with those phases of flight. However, if the accident occurred during the en route phase, it was more likely to involve a fatality. Approach accidents were divided equally, while maneuvering accidents slightly favored fatalities.”

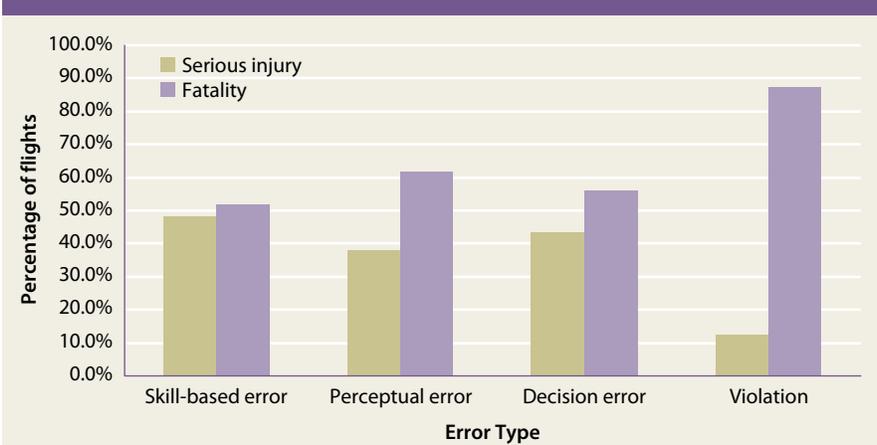
Alaska Fatal and Serious Injury Accidents, by HFACS Category, 2004–2009

HFACS = Human Factors Analysis and Classification System

Note: Accident aircraft were operating under U.S. Federal Aviation Regulations Part 91 and Part 135. An accident could be categorized as having more than one error type.

Only 10 of the 97 accidents, or slightly more than 10 percent, were not associated with flight crew error.<sup>2</sup> The researchers categorized each of the remaining accidents according to HFACS categories:
