# AeroSafety WORLD

THE JOURNAL OF FLIGHT SAFETY FOUNDATION

NOVEMBER 2010

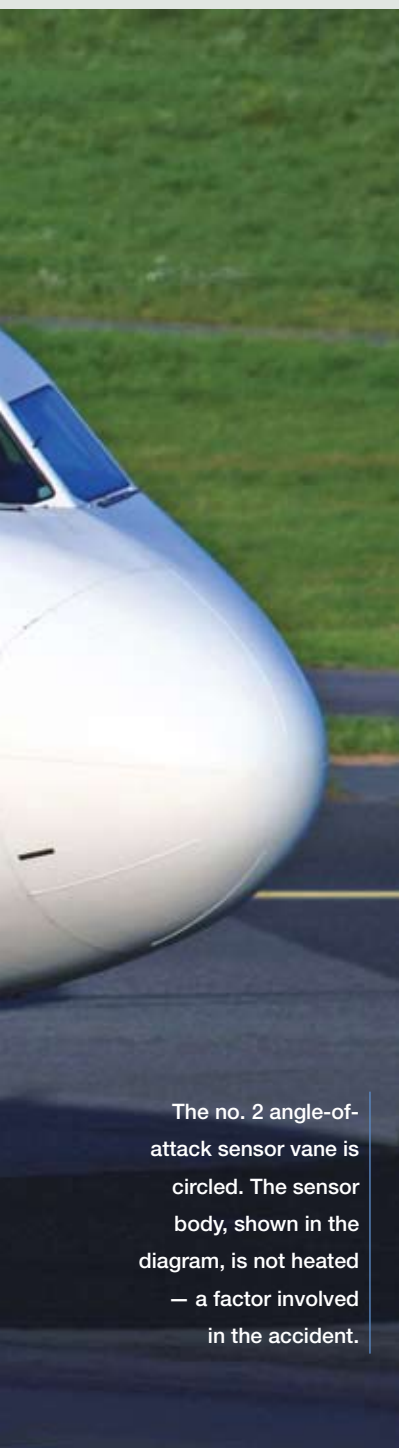
The no. 2 angle-of-attack sensor vane is circled. The sensor body, shown in the diagram, is not heated — a factor involved in the accident.

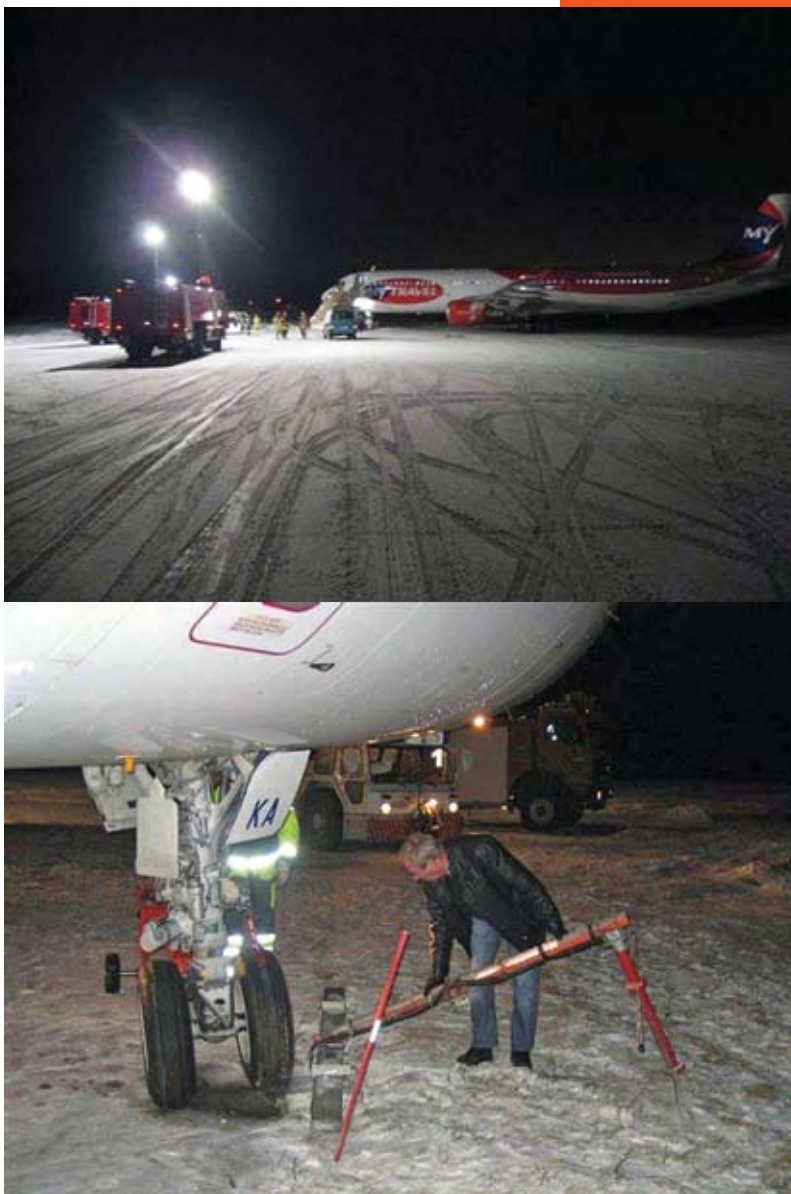
After landing on a snow-covered runway in Torp, Norway, the A321 stopped with its nosewheel against an antenna's concrete base.

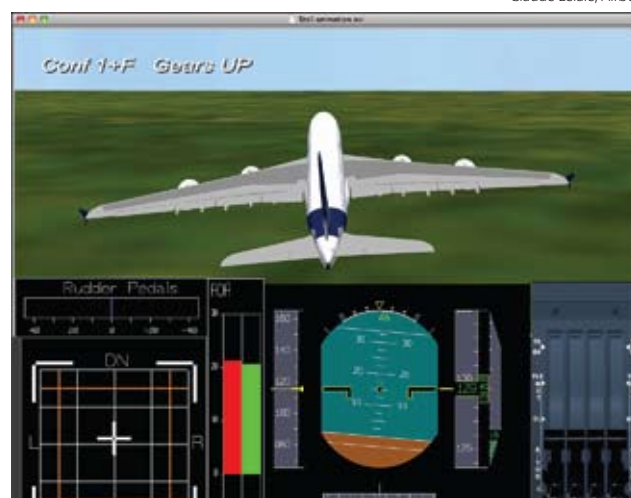
An animation from Airbus A380 test flight data showed stall recovery with pitch only.

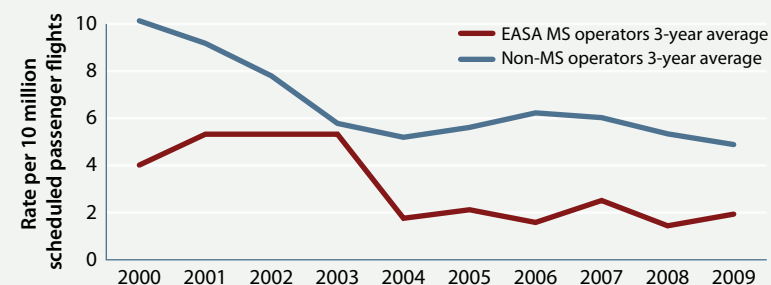
**Figure 1**

**Fatal Accident Rates, EASA Member States Vs. Non-Member States, 2000–2009**

EASA = European Aviation Safety Agency; MS = member state

Over a more recent decade, 2000–2009, both member and non-member state operators showed a declining fatal accident trend in scheduled passenger operations, but the trend line of member state rates was lower throughout the period (Figure 1). “Although the number of fatal accidents for aircraft operated by EASA member state airlines has remained the same in recent years (one accident), the decrease in the number of flights during the years of 2008 and 2009 has led to an increase in the rate of such accidents,” the review says. Traffic, and thus rates, for 2009 are estimates, however.

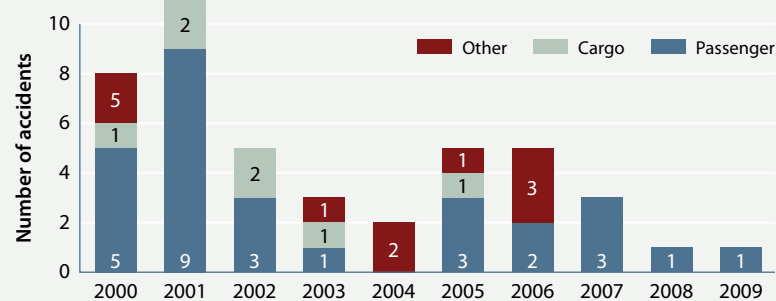
**Figure 2**

**Fatal Airplane Accidents by Operation Type, EASA Member States, 2000–2009**

EASA = European Aviation Safety Agency

For member states, the picture looks somewhat different. Throughout most of the decade, the majority of member state fatal accidents have occurred in passenger operations (Figure 2). But the report does not compare accident rates between operational categories, so numbers of accidents do not precisely measure relative risk.

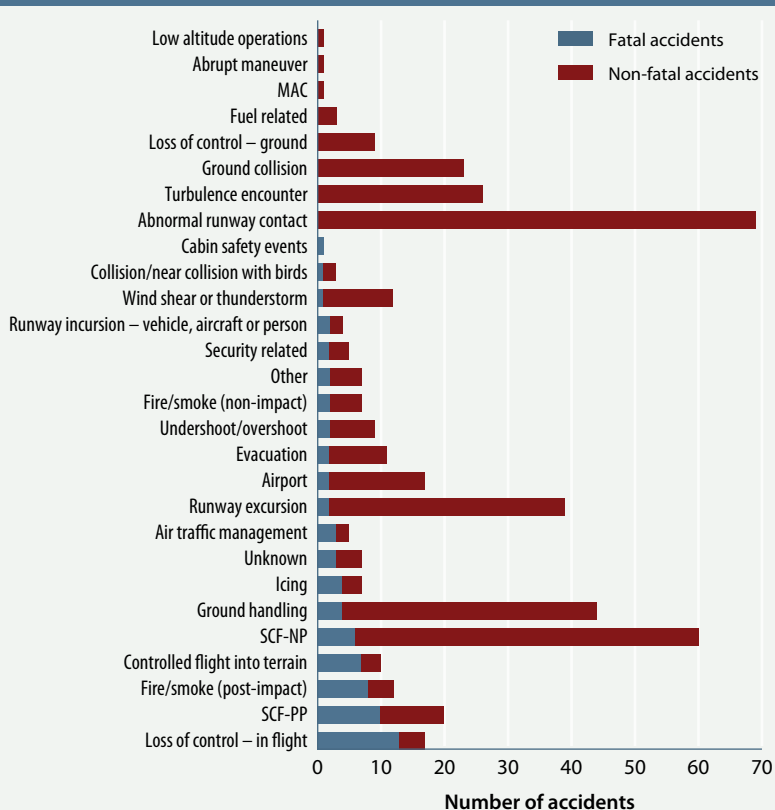
Figure 3

### Accident Categories, Fatal and Non-Fatal Accidents, EASA Member State Airplanes, 2000–2009

EASA = European Aviation Safety Agency; MAC = airprox/TCAS alert/loss of separation/near midair collision/midair collision; SCF-NP = system/component failure or malfunction (non-powerplant); SCF-PP = system component failure or malfunction (powerplant)

Accidents in member state commercial air transport operations were categorized according to the standardized definitions developed by the Commercial Aviation Safety Team-International Civil Aviation Organization (CAST-ICAO) Common Taxonomy Team.<sup>4</sup> For the 2000–2009 decade, “loss of control in flight” ranked highest among fatal accident categories, followed by “system or component failure — powerplant,” and “fire/smoke — post-impact” (Figure 3). Controlled flight into terrain, or CFIT, once the grimmest reaper of all in commercial aviation, has ranked fourth among fatal accident categories during the past 10 years.

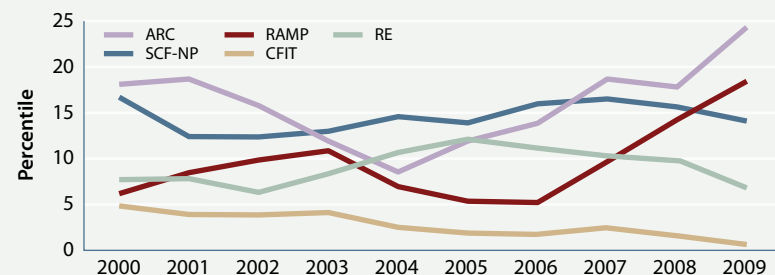
Figure 4

### Trends in Top Four Accident Categories and CFIT Category, EASA Member State Airplanes, 2000–2009

EASA = European Aviation Safety Agency; ARC = abnormal runway contact; RAMP = ground handling; RE = runway excursion; SCF-NP = system/component failure or malfunction (non-powerplant); SCF-PP = system component failure or malfunction (powerplant); CFIT = controlled flight into terrain

The proportions of the top four accident categories, as well as CFIT, have varied over the past 10 years (Figure 4). The review says, “In recent years, the proportion of accidents which included the categorization of ARC (abnormal runway contact) has increased. Such accidents usually involve long, fast or hard landings. ...

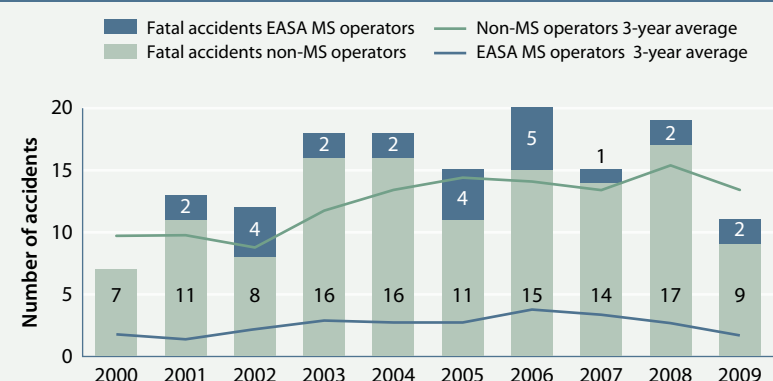
Figure 5

## Fatal Helicopter Accidents, EASA Member States and Non-Member States, 2000–2009

EASA = European Aviation Safety Agency; MS = member state

member state operators has remained more or less constant,” the review says (Figure 5).

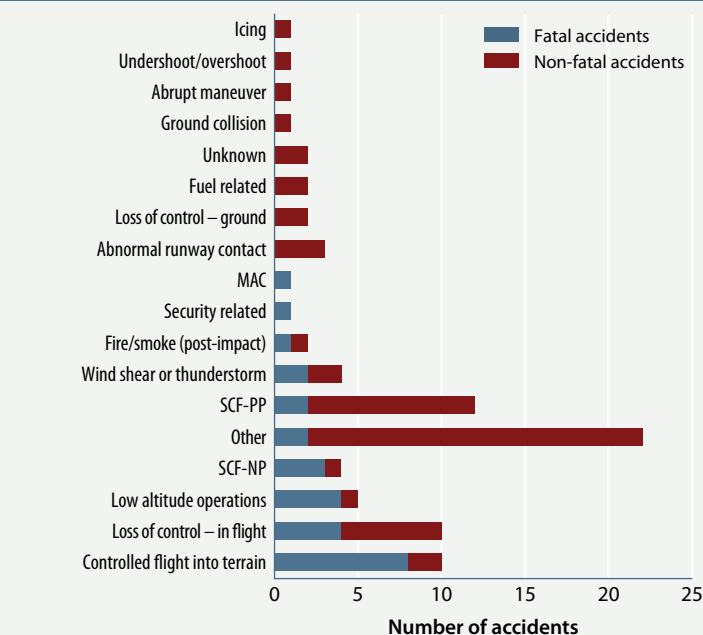
## Fatal and Non-Fatal Helicopter Accidents, EASA Member States, 2000–2009

EASA = European Aviation Safety Agency; MAC = airprox/TCAS alert/loss of separation/near midair collision/midair collision; SCF-NP = system/component failure or malfunction (non-powerplant); SCF-PP = system component failure or malfunction (powerplant)

There were five fatal helicopter accidents in 2009, compared with 10 in 2008 and eight as the 1998–2007 average. The 18 on-board fatalities in 2009, however, exceeded the four of 2008 and the 1998–2007 average of 11. The relatively high on-board fatality number for 2009 was attributable to the 16 occupants killed in a crash during a flight from an oil platform to Aberdeen, Scotland.
