The pilots of the Learjet air ambulance likely were affected by fatigue during the VFR departure; a controller failed to relay radar altitude warnings.

CFIT

on a dark night departure

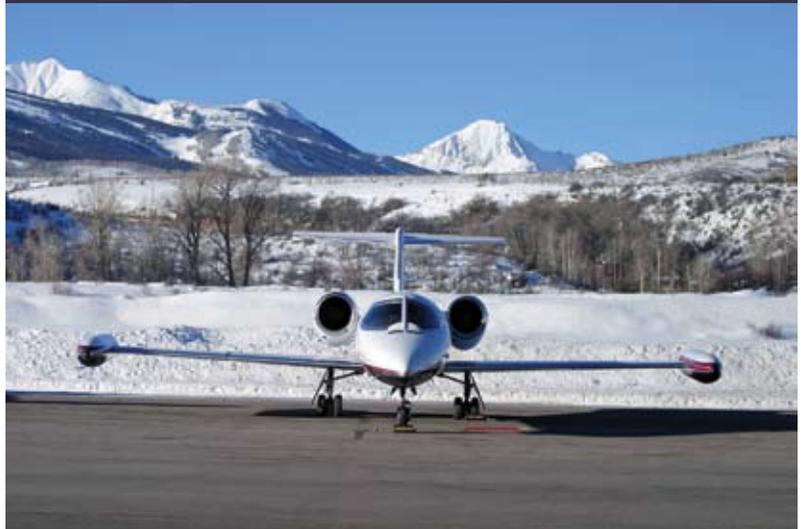
Learjet 35A

The Learjet 35, introduced in 1974, is similar to the Learjet 25 but has turbofan engines rather than turbojet engines, a longer fuselage and longer wings. The Learjet 35A, introduced in 1976, has wing modifications designed to reduce stall speeds and approach speeds, and improve takeoff performance. Maximum takeoff weight was increased to 18,300 lb (8,301 kg) from 17,000 lb (7,711 kg).
