AeroSafety WORLD

THE JOURNAL OF FLIGHT SAFETY FOUNDATION

SEPTEMBER 2010

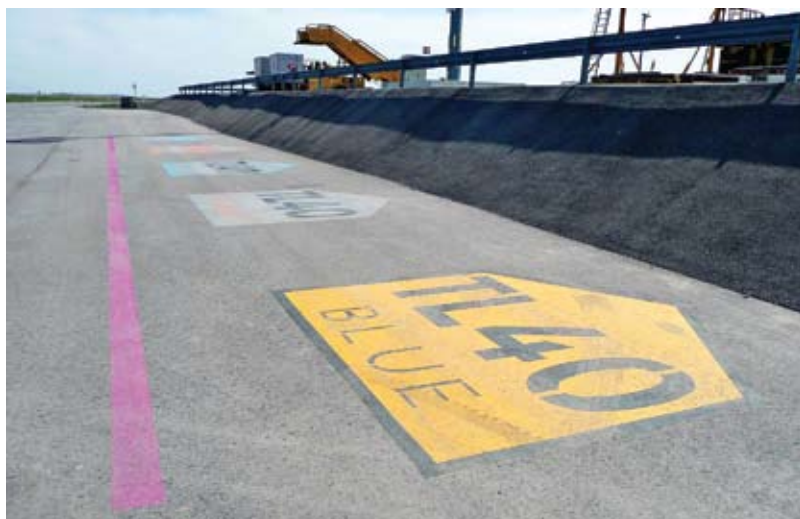
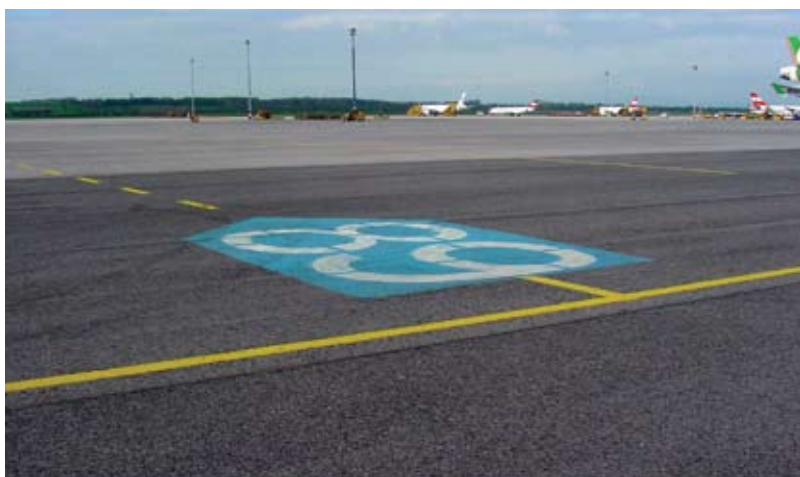
Above, new “alternative aircraft stand” taxi lane markings. Below, old “stand direction” marking.

It has been significantly improved compared to the first edition, now including more markings and their exact dimensions. It is also the first time that markings are shown in any worldwide publication for alternative aircraft stand taxi lanes. Such markings allow operations on an apron taxi lane by either two code-letter C airplanes or one code-letter E or F airplane.² This has been applied and found to be both effective and safe at a number of airports.

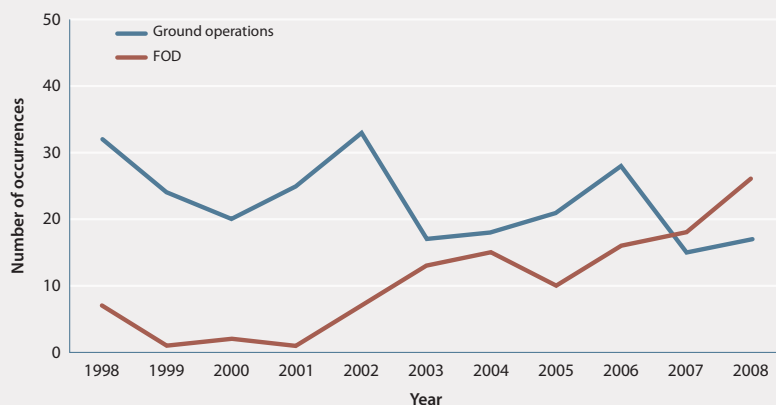
Figure 1

Occurrences, Australian Airports, 1998–2008

FOD = foreign object debris

Note: Airports are those serving high-capacity aircraft.

percent were associated with ground operations and the rest with foreign object debris (FOD), the report says. FOD occurrences increased notably during the study period (Figure 1). Ground operations occurrences trended slightly down, with peaks in 2002 and 2006; the report has no explanation for the increases in those years.
