AeroSafety WORLD

SHORT ON SPEED
ATR 42 stalls on final

CONVECTIONAL WISDOM

UNDERSTANDING MESOSCALE CONVECTIVE SYSTEMS

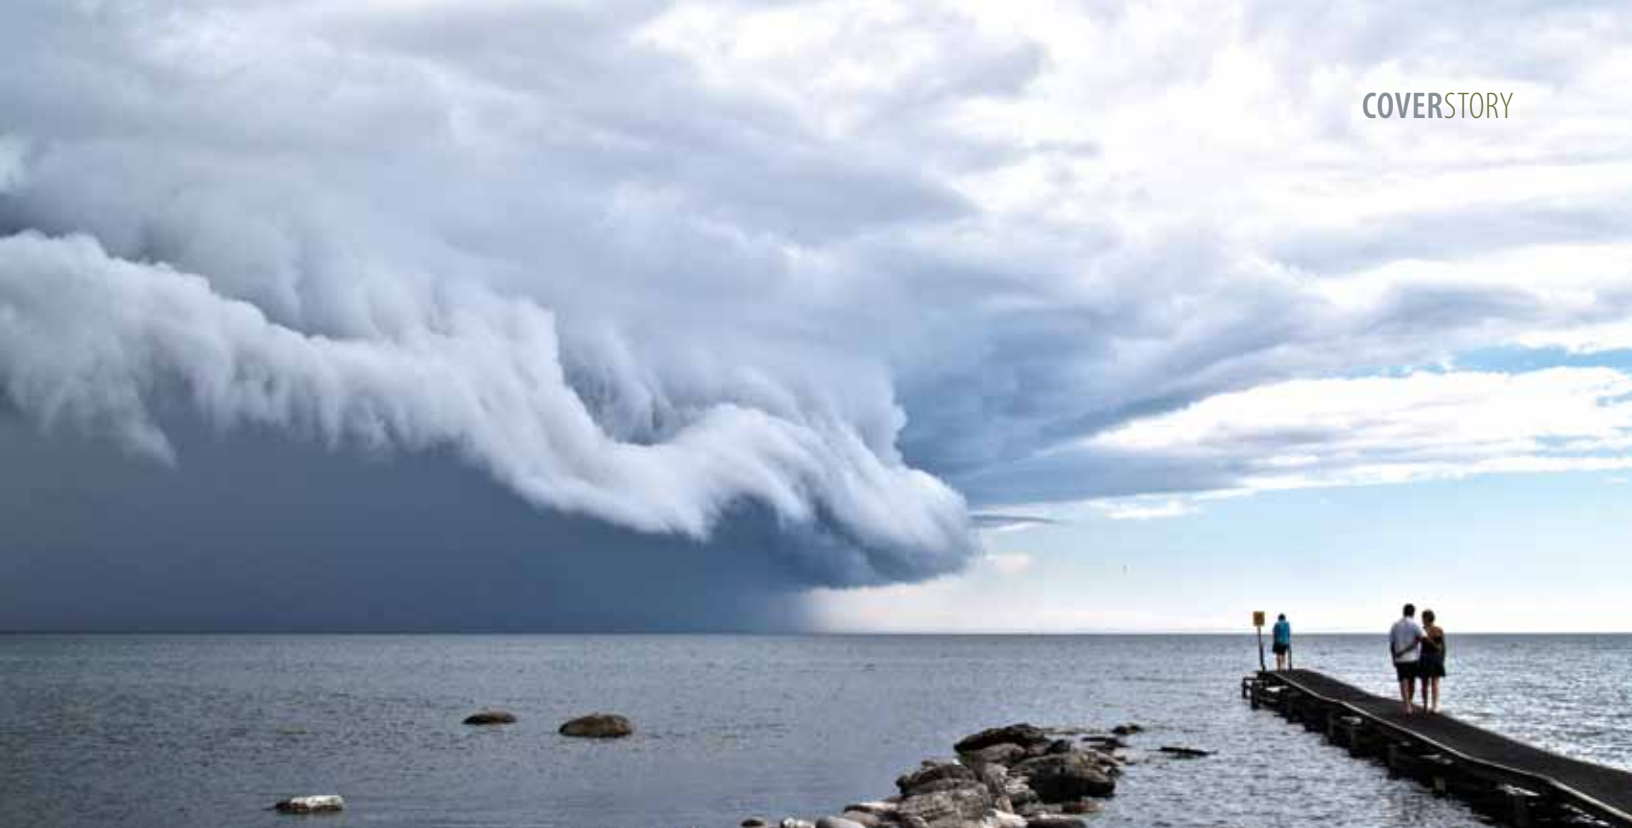
The bowing section of a squall line (left) can be accompanied by strong winds.

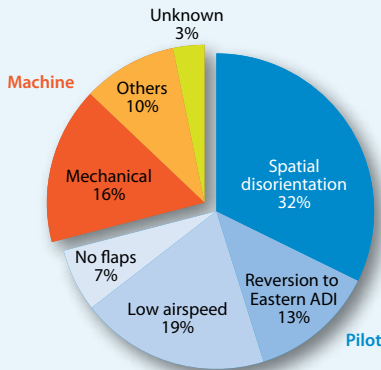
Figure 1

LOC/LAC Accident Factors

LOC = loss of control; LAC = lack of aircraft control; ADI = attitude director indicator

LOC and LAC currently are the leading causes of fatalities in commercial aviation. There were 34 accidents in the last 10 years that cost more than 3,100 lives and \$4 billion in financial losses. Spatial disorientation and suspected reversion or confusion between Western and Eastern (Soviet-era) attitude indicator formats accounted for nearly half of the losses (Figure 1). Undetected airspeed decreases leading to stalls were involved in about 20 percent of the losses.

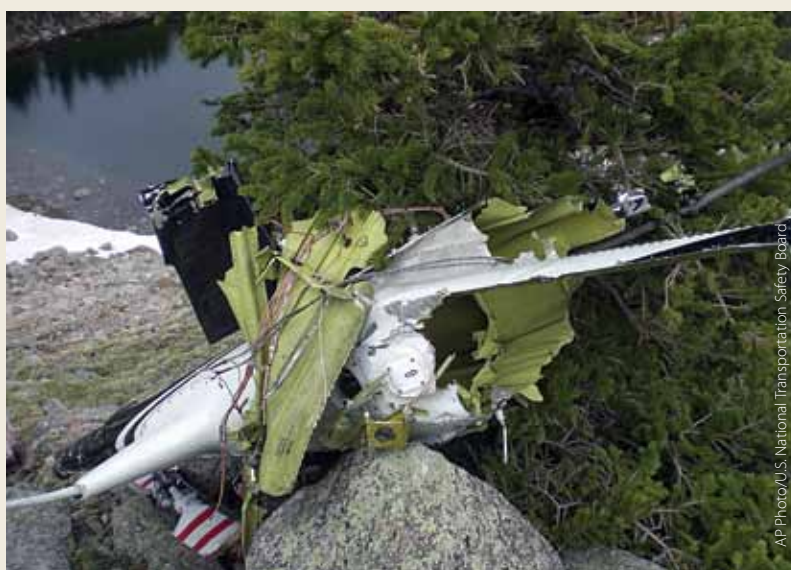
A tail strike occurred at an undetermined location before the Agusta crashed on a ridgeline. The highest piece of wreckage was found at point A, impact marks at B, the tail boom at C, and the main fuselage wreckage at D.
