AeroSafety WORLD

HAZARDS ACCOMPANY TAXIWAY PROJECTS

THE JOURNAL OF FLIGHT SAFETY FOUNDATION

AUGUST 2013

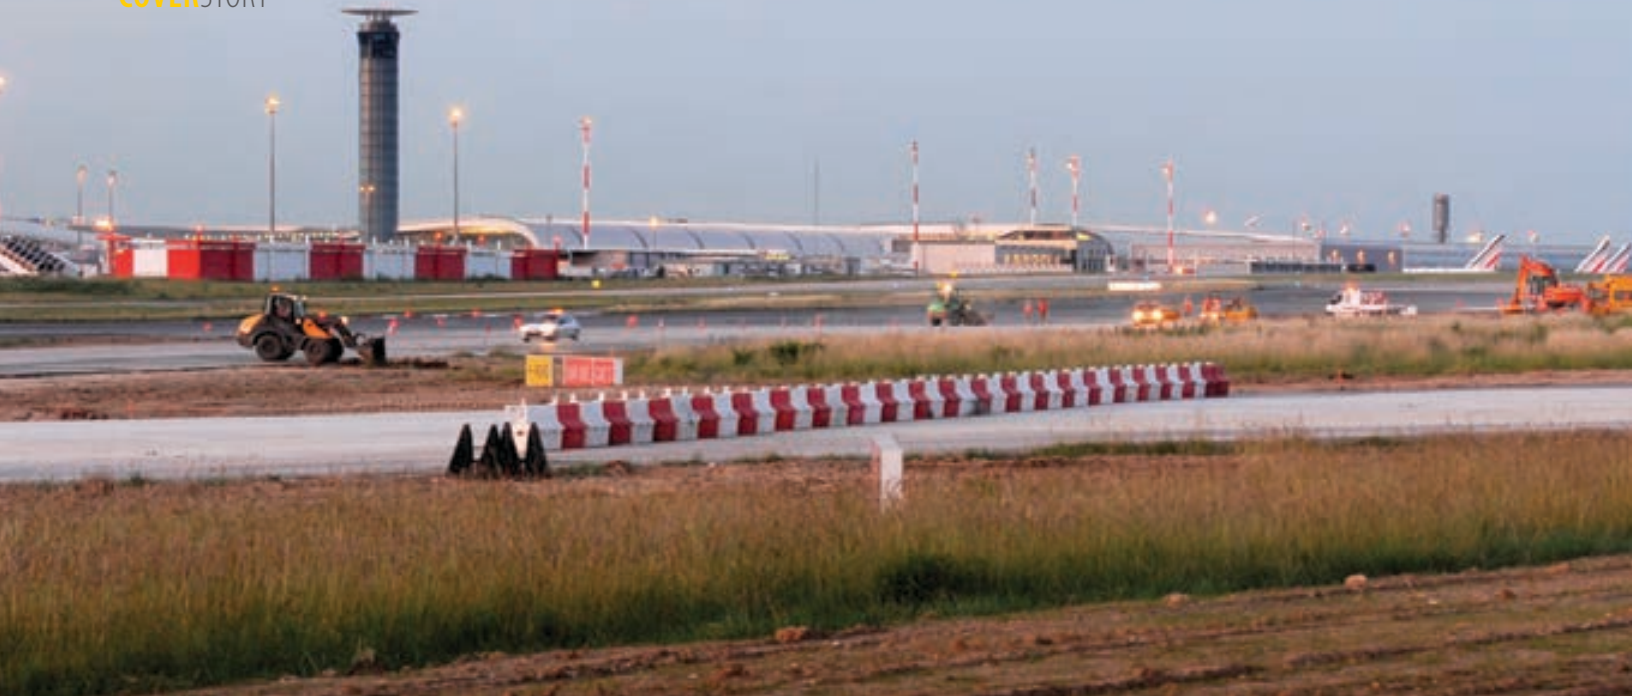
The possibility of an aircraft overrunning the RESA also was assessed. A history of excursions after landing or after a rejected takeoff revealed two extreme trajectories. The first was a longitudinal overrun of an Airbus A340-600 at Toronto Pearson International Airport in 2005 that stopped beyond a hypothetical ICAO RESA. The second, in 2000, was the trajectory of a lateral excursion by a Boeing 747-200 beyond the instrument landing system (ILS) Category I runway protections at CDG. The addition of the data from these two runway excursions revealed an area at risk that runs beyond the RESA of Runway 26R westward, and to the southern edge of the parallel Taxiway Tango northward.

Finally, the resulting countermeasures of the analysis for this critical risk were the implementation of a 787-ft (240-m) RESA at the temporary end of Runway 26R, banning of obstacles and human activity on the runway (including the closed section) when it was operational, and suspension of landings on Runway 08L/26R until the workers and mobile machines were moved beyond Taxiway Tango (in case an emergency situation necessitated a landing).

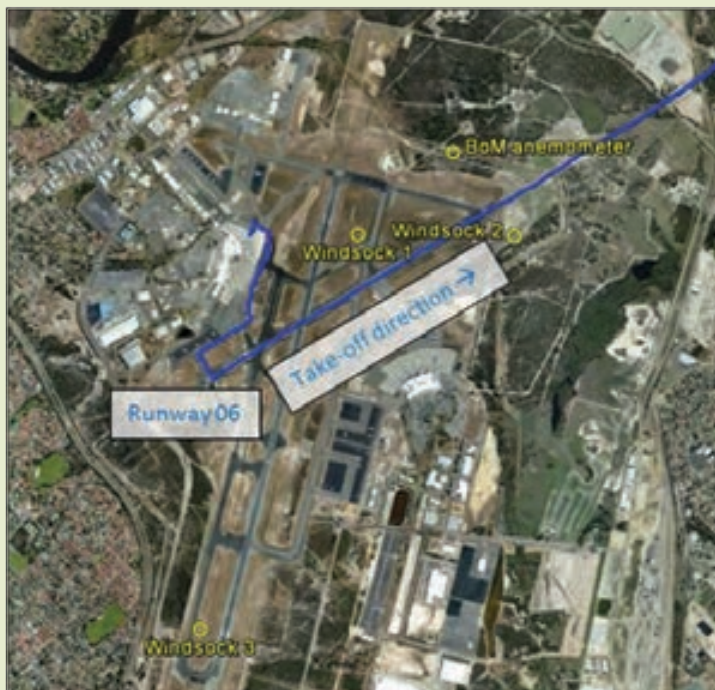
Figure 1

BoM = Australian Bureau of Meteorology

Note: None of the windssocks could be seen by the Boeing 737 flight crew from the Runway 06 threshold. The airfield anemometer at Perth Airport, Western Australia, registered a significant wind change during their takeoff run.

told investigators that windsock 2 also had indicated a headwind component. Neither pilot was able to observe any of the airport’s three windsocks from the Runway 06 threshold (Figure 1, p. 19).

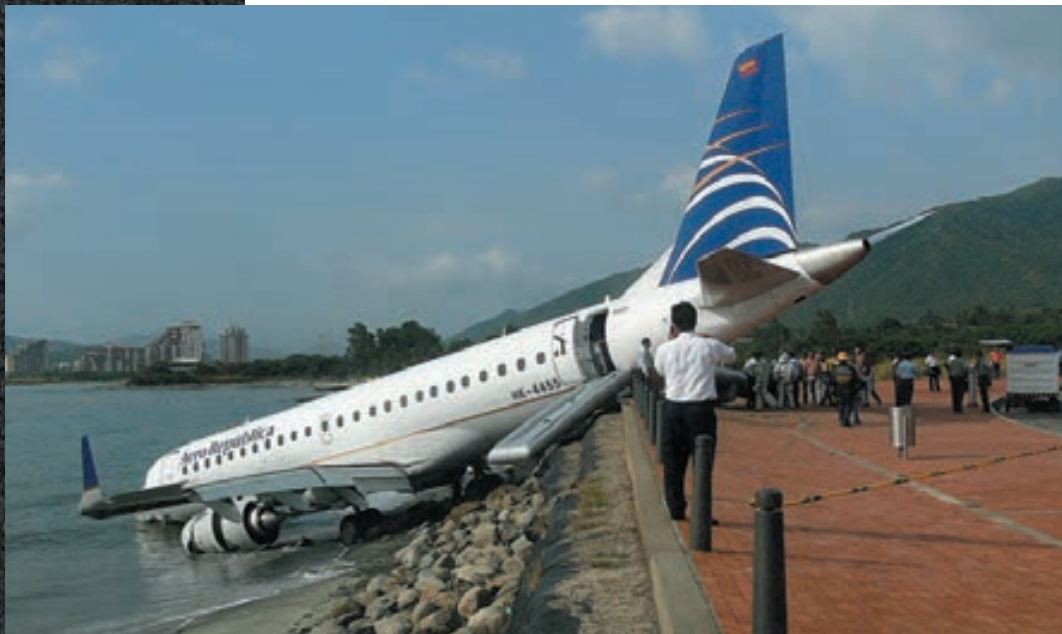
This Embraer 190 slid off a wet runway while landing at Santa María, Colombia, after a flight from Cali in July 2007.

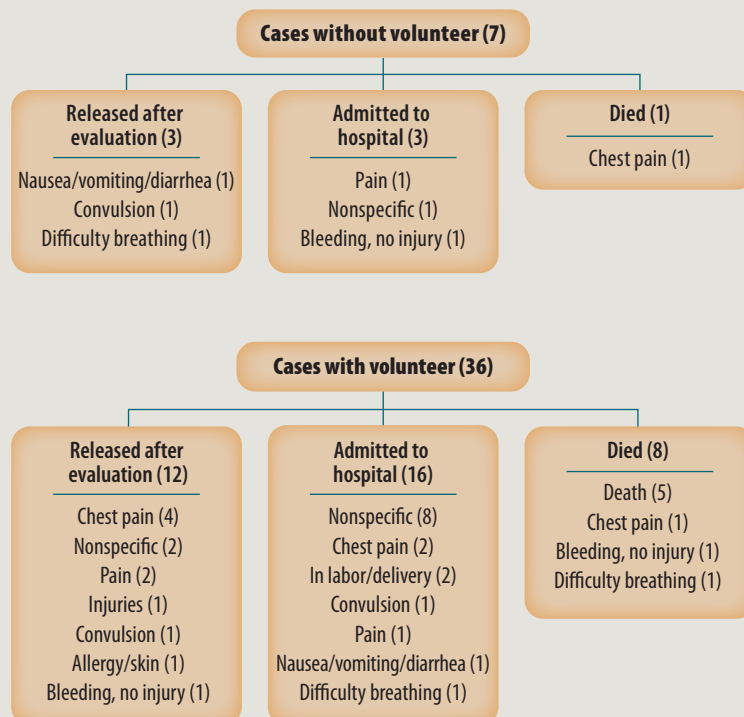
Figure 1

Symptom-Based Categorization of Diversions

Source: Hung, Kevin K.C.; Cocks, Robert A.; Poon, W.K. et al. “Medical Volunteers in Commercial Flight Medical Diversions.” *Aviation, Space, and Environmental Medicine* Volume 84 (May 2013): 491–497.

Records allowed for further review of 36 of the 39 diversions, and of that number, 12 passengers were released, 16 were hospitalized, and eight died during the flight (Figure 1). Of those who were hospitalized, half were suspected of having had a stroke, two had chest pain and two went into labor.

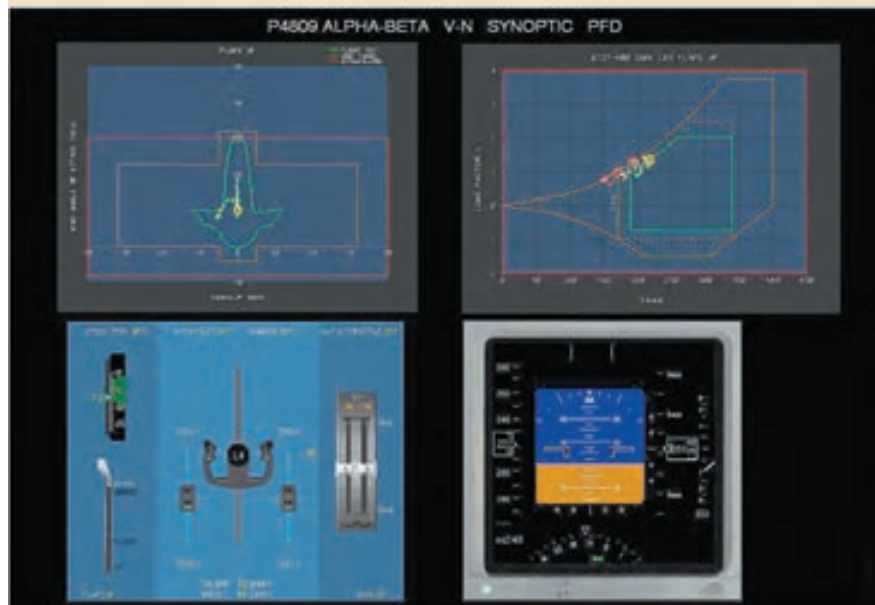
Figure 1

The FAA’s three minimum requirements for any FSTD used for this purpose (Figure 1) are a simulator validation envelope (the alpha/beta crossplot² on the IOS or equivalent alternate method); IOS display of flight control inputs while the student is performing maneuvers (especially any

CAE predicts that typically these IOS upgrade tools will replay and freeze moments or frame sequences during debriefing animations of flight crew maneuvers/aircraft performance, and help simulator students understand the safe/unsafe outcomes.

“When you are doing UPRT, there’s so much going on over a short period of time that you need to be able to stop and look at it almost frame-by-frame to understand and show pilot performance and properly debrief the student,” Németh said. “Recorded data may be replayed because it’s so rich, and it happens so fast. The instructor can stop at the IOS and retrace the dots across the screen to see what

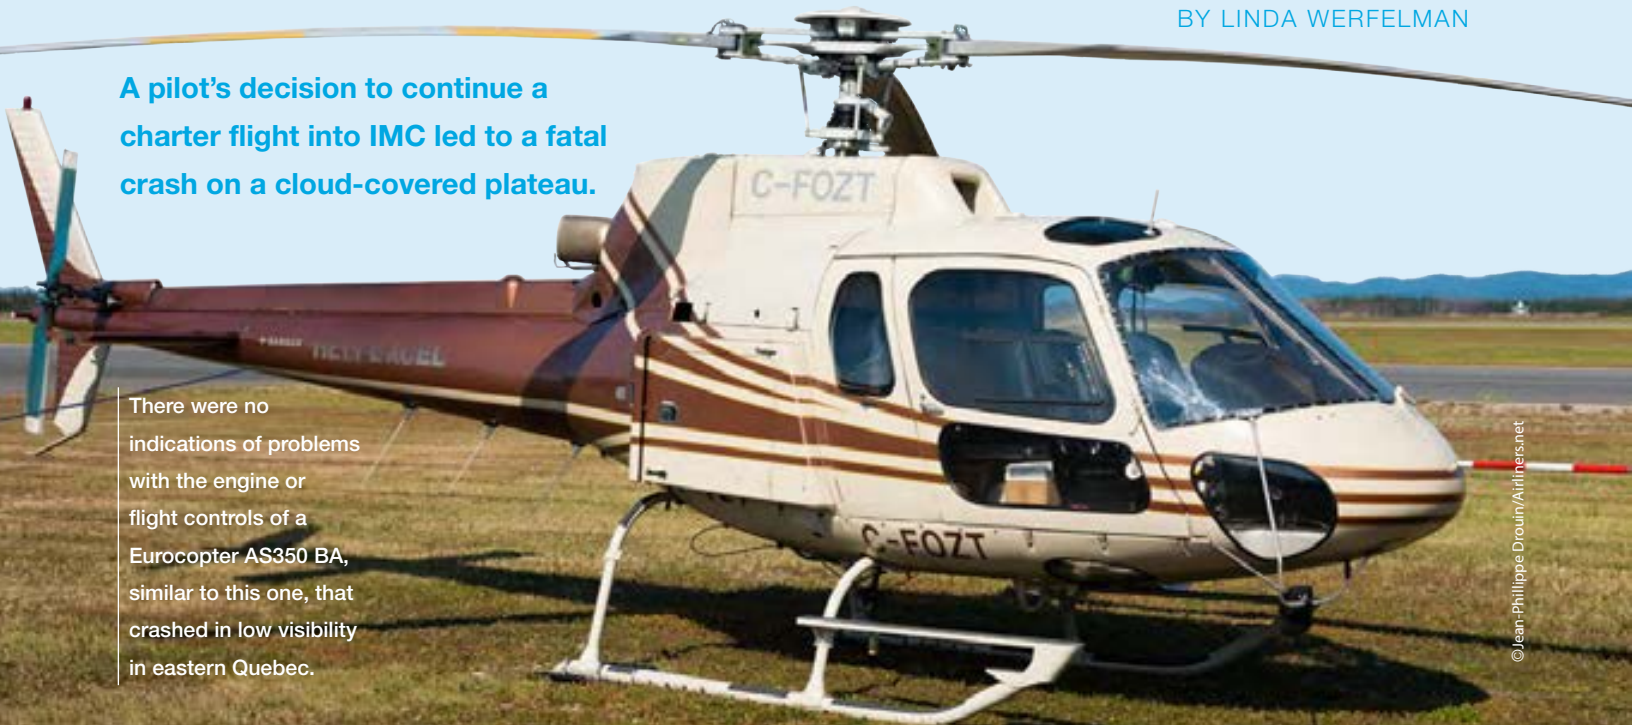
There were no indications of problems with the engine or flight controls of a Eurocopter AS350 BA, similar to this one, that crashed in low visibility in eastern Quebec.

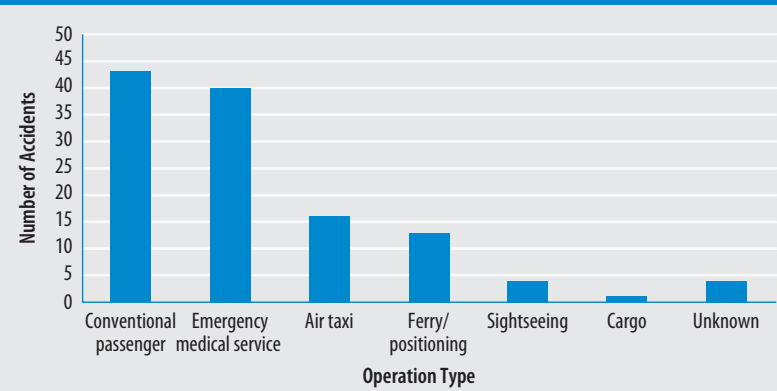
Figure 4

EASA MS-Operated CAT Helicopters By Operation Type, 2013

EASA = European Aviation Safety Agency; MS = member state; CAT = commercial air transport
 Note: Data are for all maximum takeoff mass categories.

When looking at type of operation for EASA MS-operated CAT helicopters in all mass categories for the 2003–2012 period, conventional passenger operations had the most accidents, followed closely by helicopter emergency medical services. Other types of operations analyzed by EASA included air taxi, ferry/positioning, sightseeing, cargo and unknown (Figure 4).
