Understanding the Stall-recovery Procedure For Turboprop Airplanes In Icing Conditions

Flight Safety Digest

Vol. 24 No. 4

April 2005

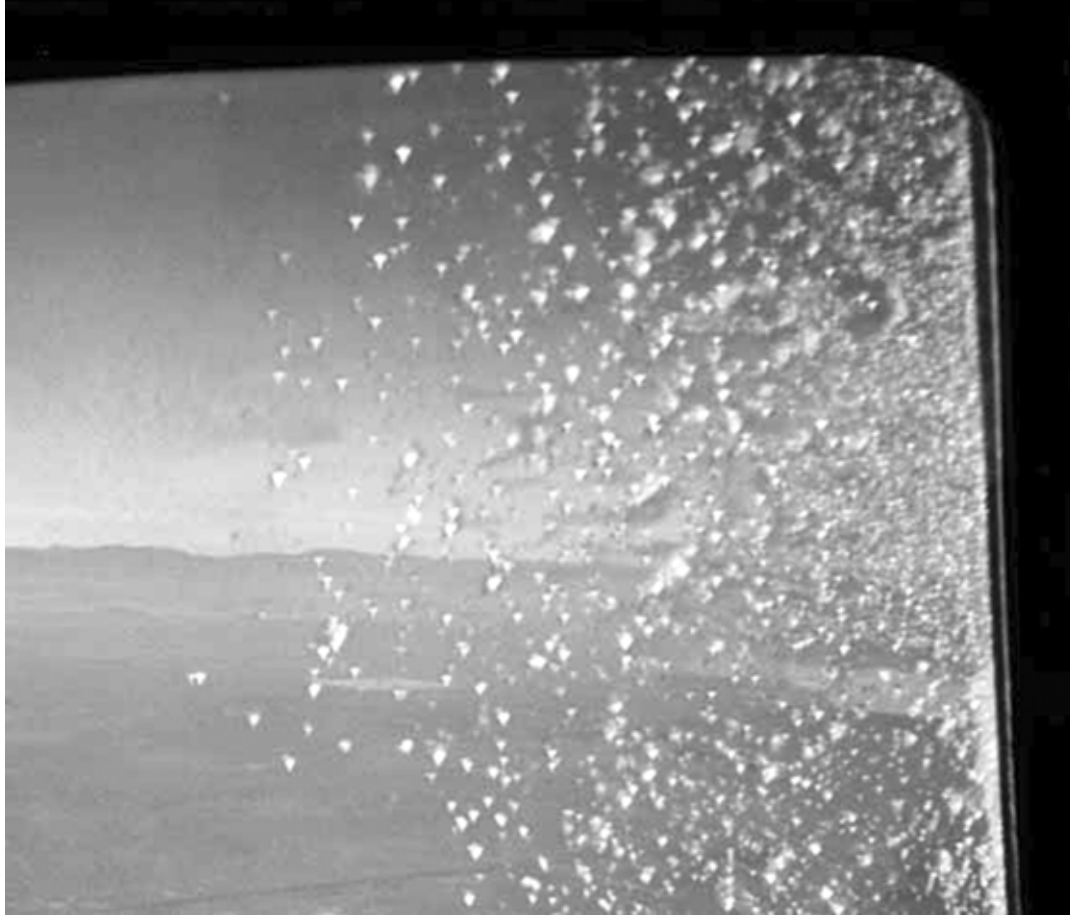
Supercooled large droplets froze instantly on contact with a side window in the airplane cockpit during an icing test flight.

Signs of SLD conditions include ice forming aft of normal ice accretions as observed on windshields, propeller spinners and engine nacelles. In certain lighting conditions, the large droplets may be observed splashing and freezing immediately on windshields. This would be a further indication of a Level 3 condition, as defined in Table 1.

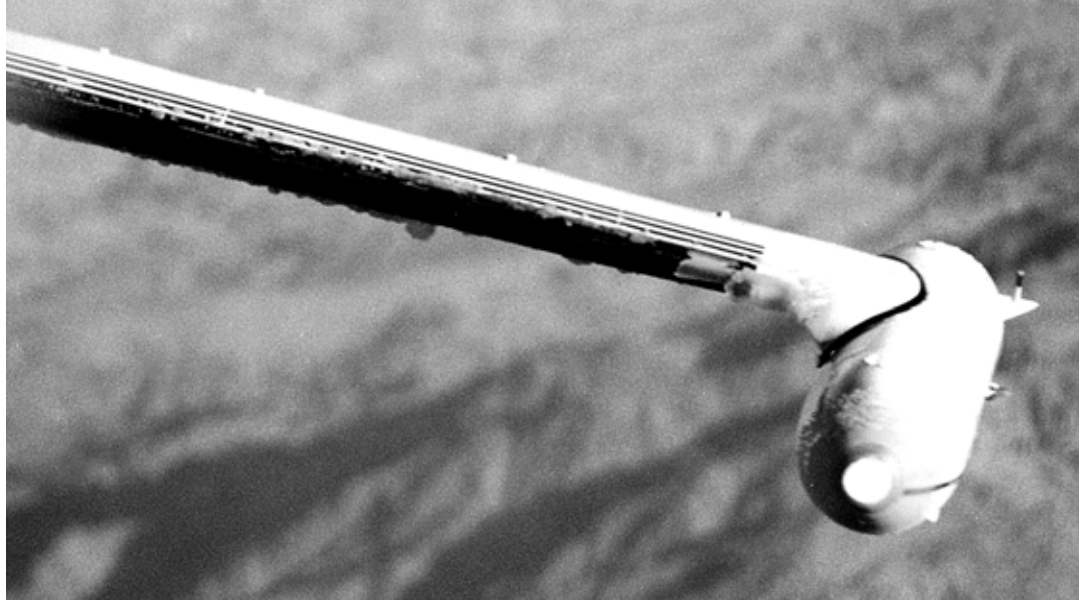
During an icing test flight, some ice remained after activation of the deice boots of a Mitsubishi MU-2 in addition to the uncleared ice on unprotected areas of the MU-2's wing-tip fuel tank and fairing.

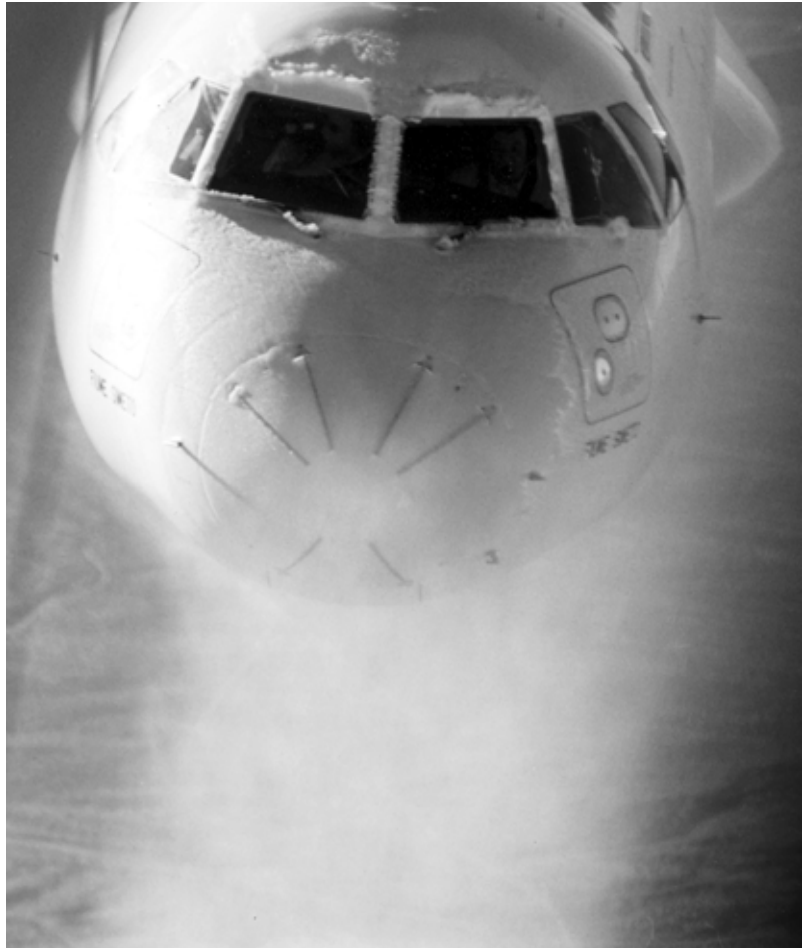
Ice accumulated on unprotected areas of an Avions de Transport Regional ATR 72 during an icing test flight. The airplane was flown behind a tanker to simulate an encounter with supercooled large droplets. (Photo: John P. Dow Sr.)

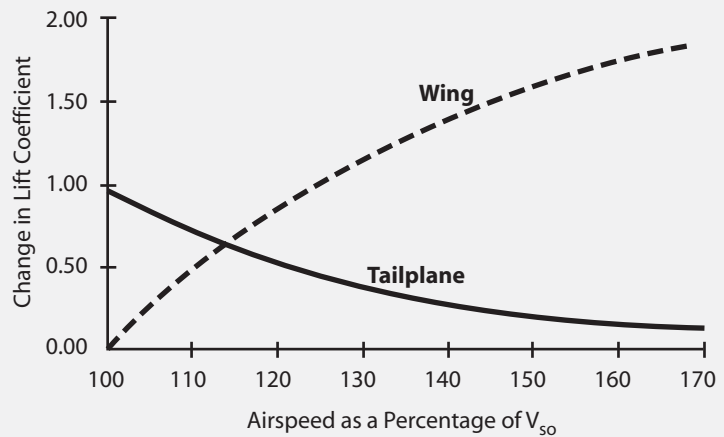
Figure 2
Typical Effect of Airspeed on Turboprop Airplane Wing and Tailplane Lift Coefficient

V_{so} = Stall speed or minimum steady flight speed in landing configuration

speed is increased, wing AOA is reduced but the tail's negative AOA increases, bringing it closer to stall AOA. Figure 2 (page 13) shows how increased airspeed changes the C_L of the wing and the C_L of the tailplane of an example turboprop airplane in landing configuration.
