# Workload in the Glass Cockpit

*Increasing sophistication in electronic flight instrumentation and systems has redefined the role of the pilot.*

*Alan H. Roscoe, M.D.  
Aviation Medical Consultant  
Britannia Airways*

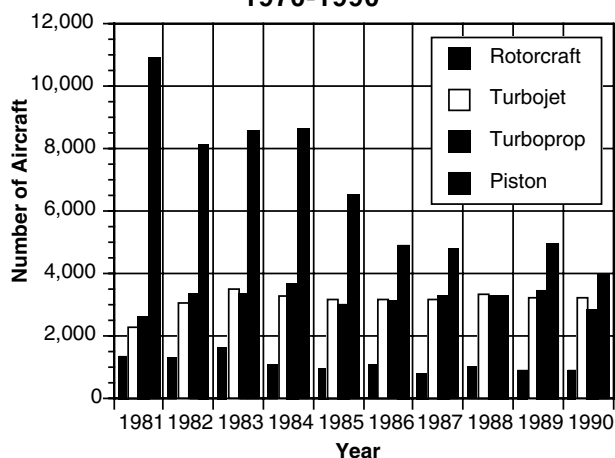
**Graph 3**

**Executive/Corporate Transportation  
Aircraft Fleet by Aircraft Type  
1970-1990**

Fleet size has changed dramatically. Graph 3 shows the changes in fleet size by aircraft type between 1981 and 1990. The total fleet size dropped from as great as 18,580 aircraft in 1981 to 10,906 aircraft in 1990 — a decline of 41 percent. The most significant decrease
