MARCH-APRIL 2002

D I G E S T

**Data Show That U.S.
Wake-turbulence Accidents Are
Most Frequent at Low Altitude and
During Approach and Landing**

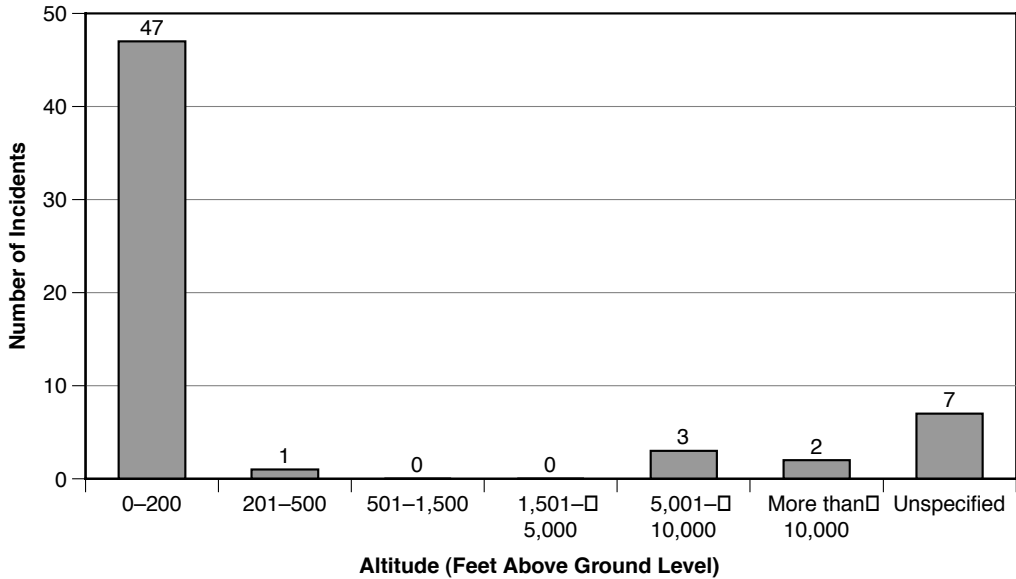
Figure 4

Altitude of U.S. Wake-turbulence Incidents, 1983–2000

Source: Patrick R. Veillette, Ph.D., from U.S. Federal Aviation Administration data on 60 incidents

- Eighty-seven accidents (67 percent), 47 incidents (78 percent) and 78 events (47 percent) occurred as a result of wake turbulence at and below 200 feet above ground level (AGL [Figure 3, page 4; Figure 4, page 5, Figure 5, page 5]);
- Wake-turbulence accidents and wake-turbulence incidents most frequently involved small aircraft that were flown

Of the 130 accidents in the NTSB database, 87 accidents (67 percent) occurred at or below 200 feet AGL (Figure 3). Of the 60 incidents in the FAA database, 47 incidents (78 percent) occurred at and below 200 feet AGL (Figure 4). Of the 165 events in the ASRS database, 78 events (47 percent) occurred at and below 200 feet AGL (Figure 5).

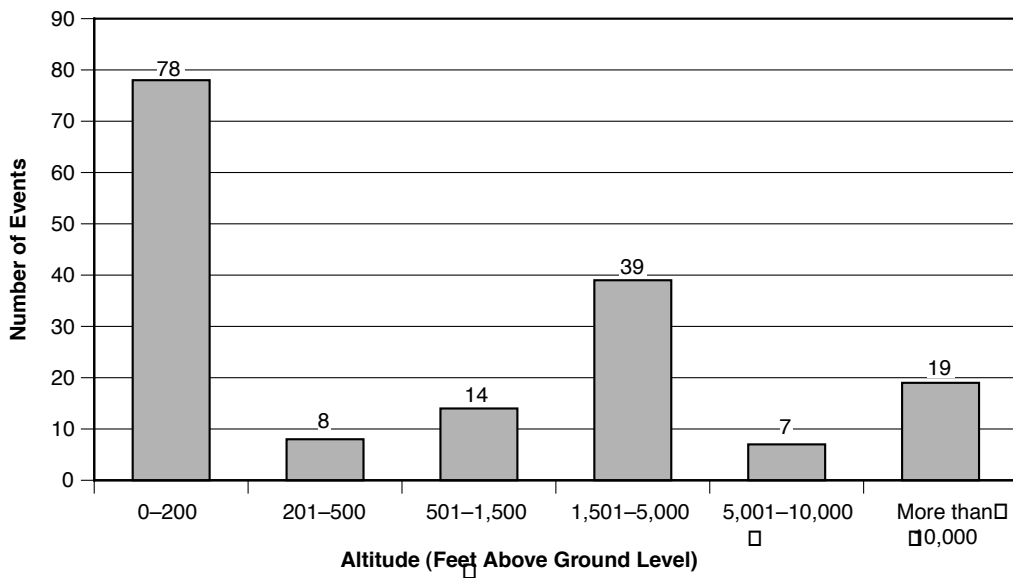
Figure 5

Altitude of U.S. Wake-turbulence Events, 1988–1999

Source: Patrick R. Veillette, Ph.D., from U.S. National Aeronautics and Space Administration Aviation Safety Reporting System data on 165 events

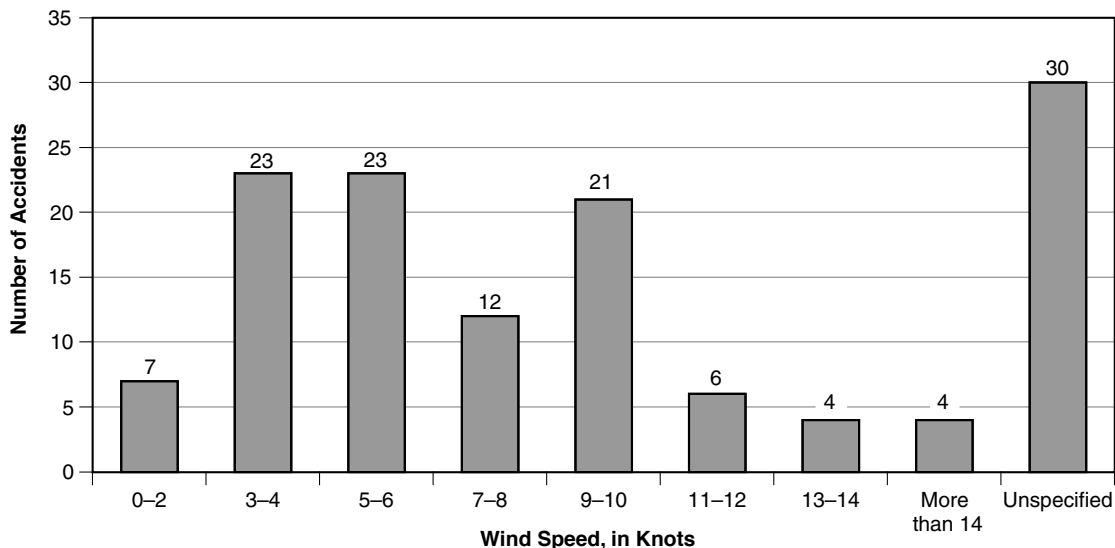
Figure 6

Reported Wind Speed in U.S. Wake-turbulence Accidents, 1983–2000

Source: Patrick R. Veillette, Ph.D., from U.S. National Transportation Safety Board data on 130 accidents

- Eighty-six accidents (66 percent), 27 incidents (45 percent) and 110 events (67 percent) occurred during wind conditions of 10 knots or less (Figure 6, page 12; Figure 7, page 12; Figure 8, page 13).

Of the 130 accidents in the NTSB database, 79 accidents (61 percent) occurred when winds were between three knots and 10 knots (Figure 6). Of the 60 incidents in the FAA database, 26 incidents (43 percent) occurred in winds between three knots and 10 knots (Figure 7). Of the 165 events in the ASRS database, 99 events (60 percent) occurred in winds between three knots and 10 knots (Figure 8).

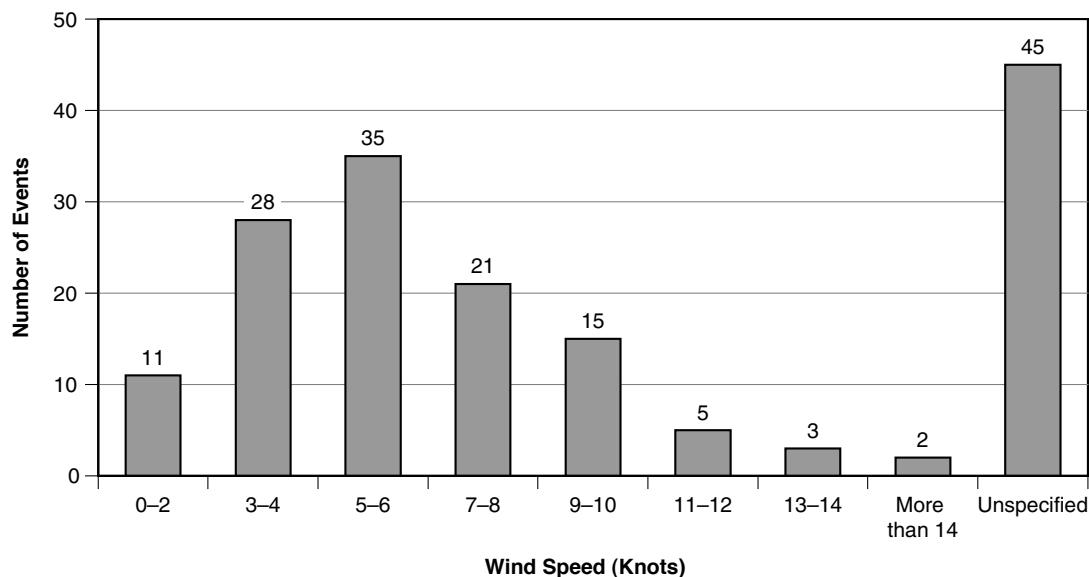
Figure 8

Reported Wind Speed in U.S. Wake-turbulence Events, 1988–1999

Source: Patrick R. Veillette, Ph.D., from U.S. National Aeronautics and Space Administration Aviation Safety Reporting System data on 165 events

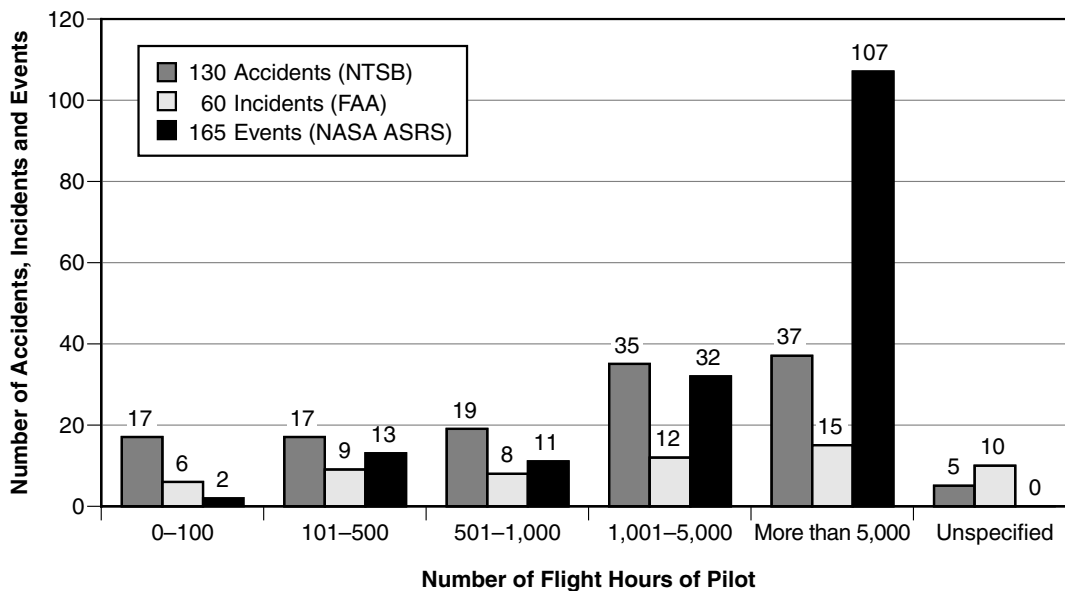
Flight Hours of Pilots Involved in U.S. Wake-turbulence Accidents and Incidents, 1983–2000, and in Wake-turbulence Events, 1988-1999

Source: Patrick R. Veillette, Ph.D., from U.S. National Transportation Safety Board (NTSB) data on 130 accidents, U.S. Federal Aviation Administration (FAA) data on 60 incidents and U.S. National Aeronautics and Space Administration (NASA) Aviation Safety Reporting System (ASRS) data on 165 events

Figure 9 shows that, of the 130 pilots of trailing aircraft involved in accidents, 37 pilots (28 percent) had more than 5,000 flight hours. Of the 60 pilots of trailing aircraft involved in incidents, 15 pilots (25 percent) had more than 5,000 flight hours, and of the 165 pilots of trailing aircraft involved in events, 107 pilots (65 percent) had more than 5,000 flight hours.

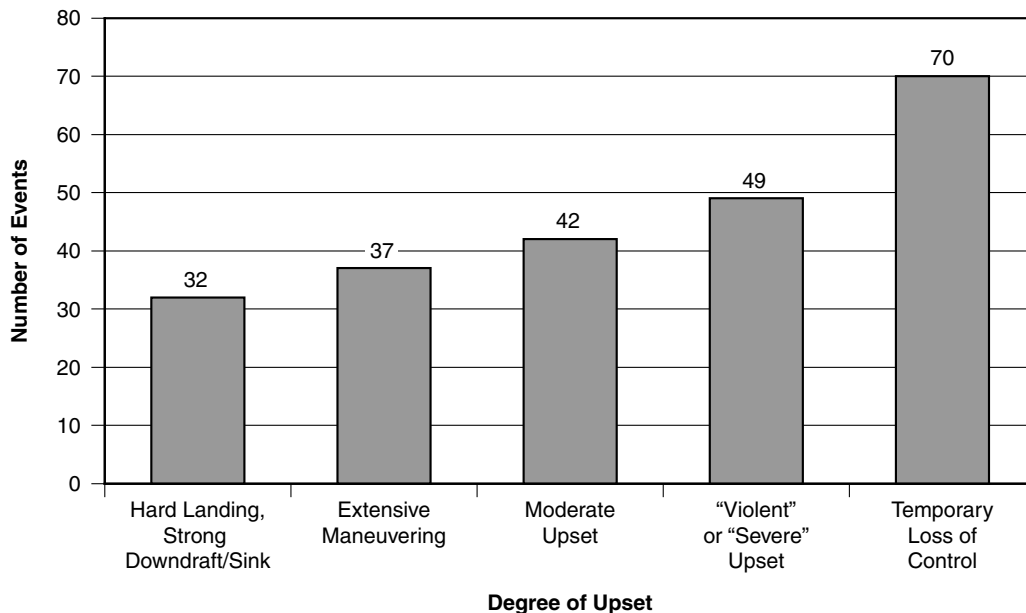
Degree of Upset in U.S. Wake-turbulence Events, 1988–1999

Note: Some of the 165 events were recorded in more than one category.

Source: Patrick R. Veillette, Ph.D., from U.S. National Aeronautics and Space Administration Aviation Safety Reporting System data on 165 events

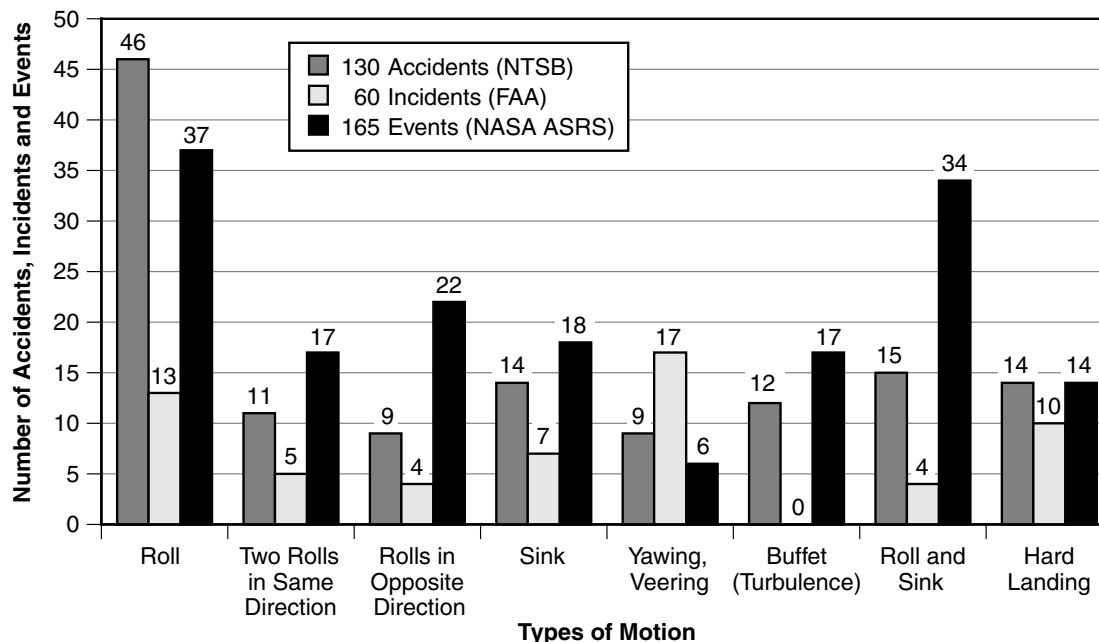
Types of Motion Induced in U.S. Wake-turbulence Accidents and Incidents, 1983–2000, and in Wake-turbulence Events, 1988-1999

Source: Patrick R. Veillette, Ph.D., from U.S. National Transportation Safety Board (NTSB) data on 130 accidents, U.S. Federal Aviation Administration (FAA) data on 60 incidents and U.S. National Aeronautics and Space Administration (NASA) Aviation Safety Reporting System (ASRS) data on 165 events

Figure 11 (page 29) shows the types of motion induced by flights into wake turbulence by the aircraft involved in the NTSB accidents, the FAA incidents and the ASRS events. The most common type of motion induced among the 130 accident aircraft was a rolling motion in one direction, experienced by 46 aircraft (35 percent). Veering/yawing motions were most prevalent among the 60 incident aircraft; in 17 incidents (28 percent), the aircraft experienced veering/yawing. A rolling motion in one direction was most prevalent among the 165 events; in 37 events (22 percent), the aircraft experienced primarily a rolling motion in one direction.
