FLIGHT SAFETY FOUNDATION
Aviation Mechanics Bulletin

**Atmospheric Monitors
Show Safety of
Environment for Workers in
Airplane Fuel Tanks**

Sensors detect hazardous concentrations of jet-fuel vapor and other toxic substances that present the risk of an explosion and endanger the health of maintenance technicians.

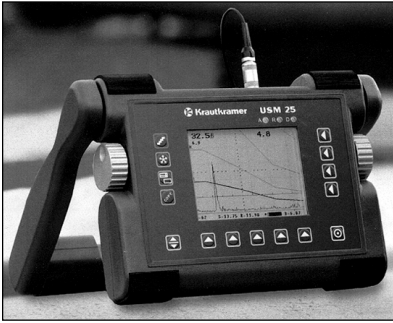
Krautkramer's portable ultrasonic flaw detectors are designed for a variety of measuring tasks. Two rotary knobs and menu keys control the functions, and liquid crystal display technology helps make the instrument screen easy to read, the manufacturer said.

The USM 22 model, with a frequency range of 0.5 megahertz to 15 megahertz, is suited for thickness measurements of tanks and piping, as well as for lamination tests or flaw tests on sheets and plates. The USM 25, with a selectable frequency range to 20 megahertz, can be used for weld testing and other applications.

*Portable Ultrasonic Flaw Detector
Krautkramer Branson*
