FLIGHT SAFETY FOUNDATION
Aviation Mechanics Bulletin

JANUARY-FEBRUARY 2001

**Documentation, Inspection,
Workload Problems Cited
In Incorrect Installation of
Aileron-trim Cables**

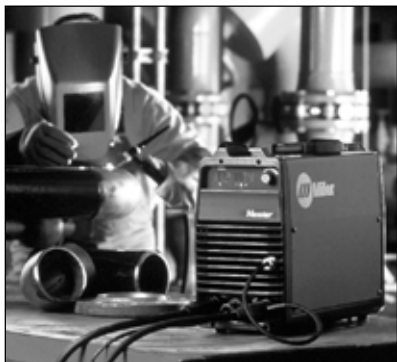
Inverter-based Power Supply

The Maxstar 200, a direct current, tungsten inert gas (TIG)/stick inverter-based welding power supply designed for aerospace applications, can be powered by any type of primary electric alternating current, said the manufacturer, Miller Electric Manufacturing Co.

The 37-pound (16.8-kilogram) Maxstar 200 is portable, has an output of 200 amps; produces code-quality TIG and stick arcs; and accepts input power from 115 volts to 460 volts, single-phase or three-phase, and 50 hertz or 60 hertz without manual relinking. The device is available in three versions with a variety of options.

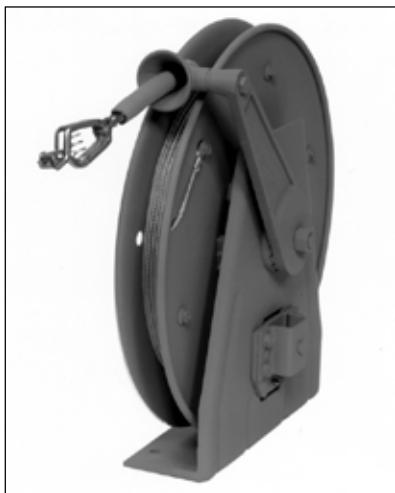
Spring Rewind Cable Reel

HGR Series reels are available with four cable lengths, ranging from 20 feet to 100 feet (six meters to 31 meters) of static-grounding cable and a spring rewind for smoother operation.

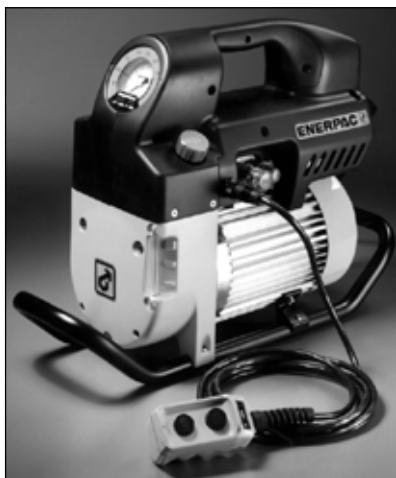
Electric Torque Wrench

with safety button for one-person operations.
