FLIGHT SAFETY FOUNDATION  
**Aviation Mechanics Bulletin**

JANUARY–FEBRUARY 2002

# **Internet Provides Information Tools for Maintenance Technicians**

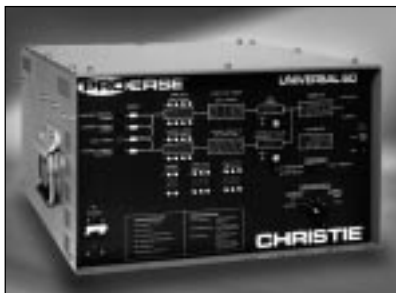
The Universal 60 provides four battery-servicing functions for in-house servicing of vented nickel-cadmium batteries and vented/sealed lead-acid batteries, said the manufacturer, Marathon Power Technologies Co.

The Universal 60 charger/analyzer has digital current settings, clearly labeled indicators, temperature protection, single-cell charging capability and on-site self-calibration without disassembly, the manufacturer said.

*Universal 60 Charger/Analyzer*

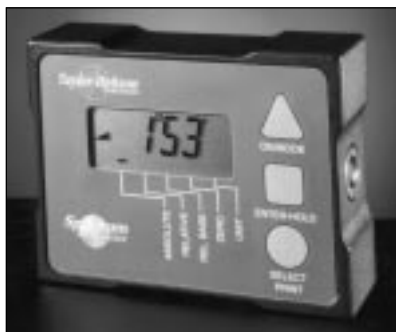
ensures accurate calibration, the manufacturer said.

*Digital Clinometer*
