FLIGHT SAFETY FOUNDATION
Aviation Mechanics Bulletin

JANUARY–FEBRUARY 2004

Faulty Shift Handoff Cited in Failure to Close B-747 Static Lines

Vol. 52 No. 1

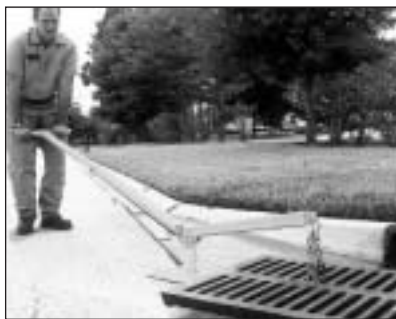
Grate Lifter

The Ultra-Grate Lifter is designed to enable one person to lift, remove and replace the grates from drains and catch basins. A telescoping handle and single pivot point provide the leverage needed to move grates, the manufacturer said.

The product can be disassembled and stored or transported in a carrying case.

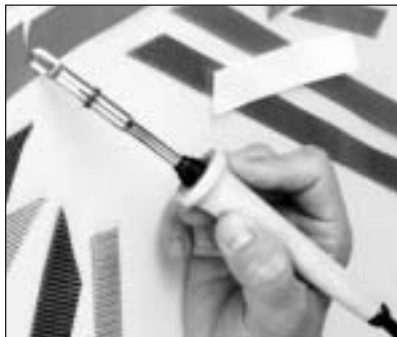
Hot Knife

The tool features a tapered wooden handle that remains cool because the heating element is under the blade, and the copper blade can be resharpened.

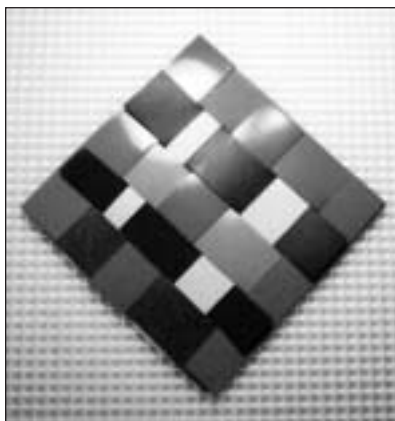
Colored Tapes

Colored UHMW tape from CS Hyde Co. is designed for many applications for reducing friction, sliding, noise, wear and sticking, the manufacturer said. The tape is available in thicknesses ranging from 0.030 inch to 0.125 inch (0.762 millimeter to 3.175 millimeters), with or without adhesive backing.

Described by the manufacturer as extremely strong and abrasion resistant, colored UHMW tape is suitable for applications that require matching to any color in the Pantone color system.

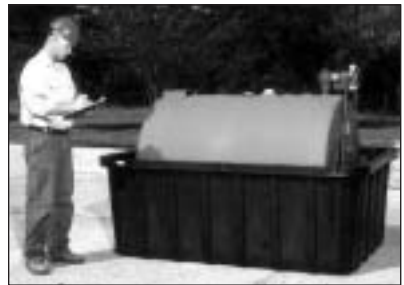
The Ultra-550 Containment Sump captures spills and leaks from 500-gallon (1,893-liter) and 550-gallon (2,082-liter) fuel tanks and oil tanks. The polyethylene construction will not rust or corrode and is chemical-resistant, the manufacturer said.

The sump can be used outdoors with an optional Ultra-SelfBailer that allows storm water to passively drain from the sump while retaining hydrocarbons.
