FLIGHT SAFETY FOUNDATION
Aviation Mechanics Bulletin

JANUARY–FEBRUARY 2005

Misrigged Elevator-trim Cable Cited in Raytheon Beech 1900 Loss-of-control Accident

Vol. 53 No. 1

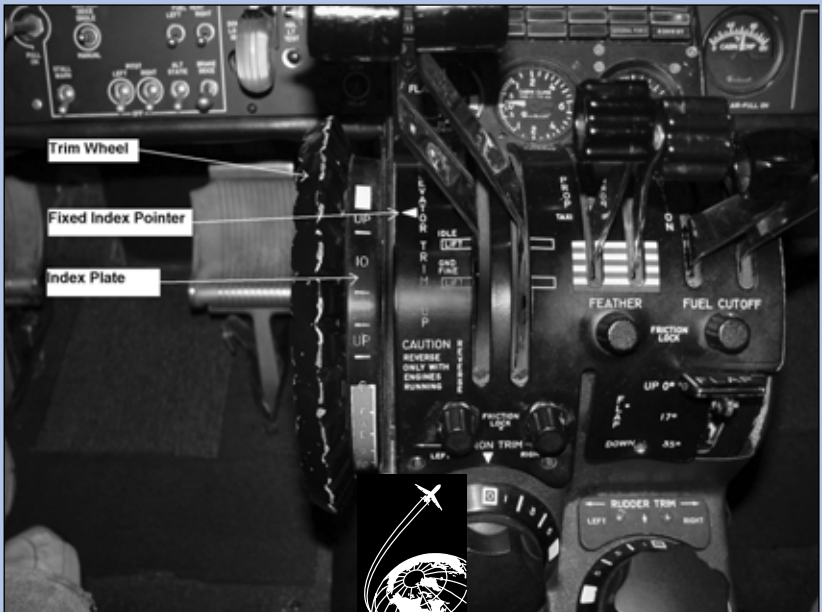
On the cover: Pitch trim on a Raytheon Beech 1900 can be controlled by electric means or manually, as shown in this photograph of cockpit controls in an airplane that resembles the accident airplane. (Photo: U.S. National Transportation Safety Board)

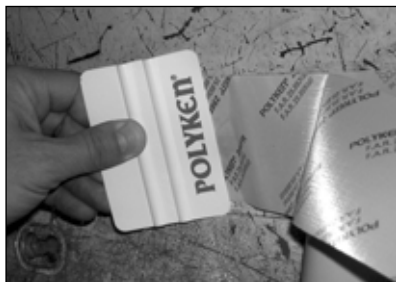
Aerospace Tape

The tape, consisting of fiberglass-cloth backing with an acrylic adhesive, meets Boeing, Airbus, U.S. and European flame-retardant-content testing requirements, the manufacturer says. It conforms to a recent European Union directive (EU 76/769/EEC) eliminating some fire-retardant materials.

Polyken 296FR is said to be highly flexible to accommodate angles and turns, while being repositionable so as to be capable of being reapplied. The tape's fiberglass-cloth construction resists flame penetration, and its high-adhesion properties are said to eliminate lifting and curling.

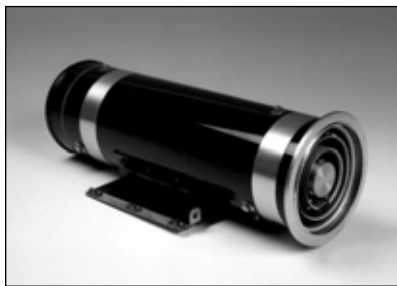
Silicone Heater

Airscrew Modular Aircraft Heaters from Ametek Aerospace & Defense can be used alone or with a fan for applications that include cargo bays or animal bays, crew-rest areas, galley areas, cockpits, door-draft areas and other locations where supplementary heating is desired.

The heaters use silicone heating elements between two thin layers of fiberglass-reinforced silicone, which are connected to aluminum tubes that are the heat-transfer medium. The tubes are arranged in concentric circles with an air gap, and air is warmed as it flows through the unit.

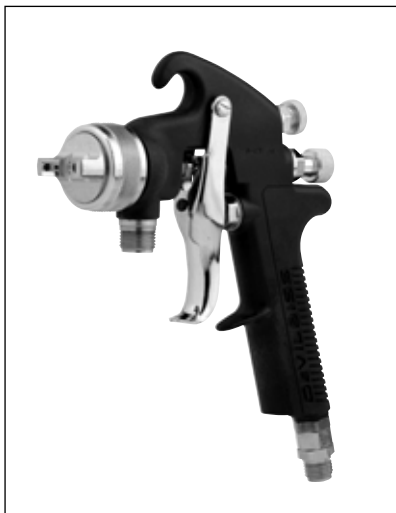
Lightweight Aluminum Spray Gun

Spray-gun finishing, touch-up painting or complete repainting of aircraft can be performed with greater comfort using the DeVilbiss JGP/V Production Gun, the manufacturer says. The unit is constructed of a lightweight, solvent-resistant composite material, designed to be easier to handle during paint application.

The reduced weight, compared with aluminum spray guns, is said to

reduce operator fatigue and lessen the risk of cumulative muscle stress, while maintaining the spray consistency of conventional units.
