FLIGHT SAFETY FOUNDATION
Aviation Mechanics Bulletin

Loose Fasteners Cited in Dash 8 Pitch-control Anomaly

January–February 2006

Vol. 54 No. 1

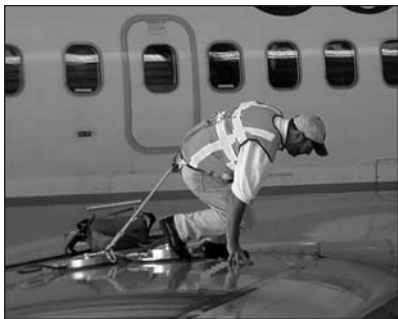
Fall-restraint System

Lightweight, portable fall protection is offered by the Wingrip Vacuum Pad Fall Restraint System. The product consists

of a vacuum pad, vacuum module, hose, harness, safety lanyard and work-positioning rope. The rope and safety lanyard are connected to a vacuum pad held in place against the aircraft skin by negative compressed-gas pressure.

Pads can also be connected in series to enable a greater range of motion by the maintenance technician.

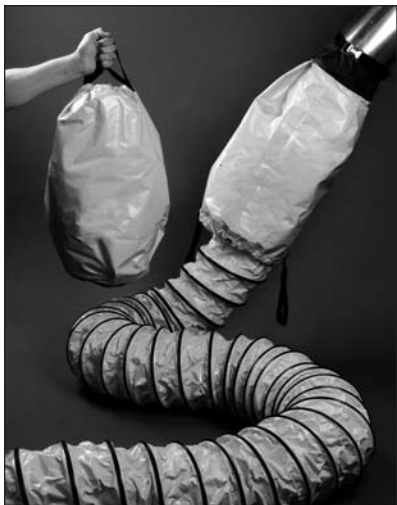
Ventilation Hose

Hi-Tech Hose offers a polyvinyl chloride (PVC)-coated polyester duct that includes a built-in storage pouch and belted cuffs at both ends for moving large volumes of air, smoke or fumes.

The hose, which is reinforced by a wire helix, is suitable as an outlet for portable or temporary ventilation blowers. The product is manufactured from flame-retardant materials and has a wear strip for external abrasion resistance. It is available in sizes from four inches to 24 inches (10 centimeters to 61 centimeters) interior diameter and in standard 15.0-foot and 25.0-foot (4.6-meter and 7.6-meter) lengths.

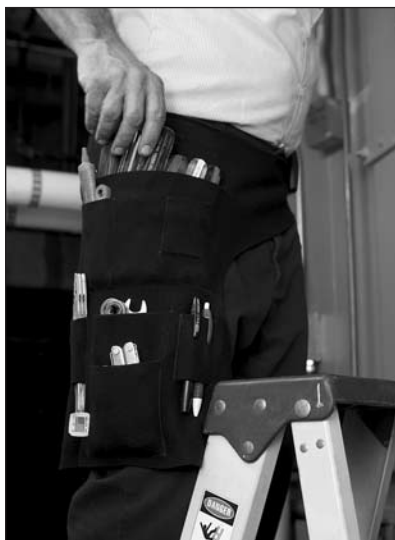
Tool Belt

of the tools it holds, the Toolster Pro Utility Belt is constructed of six ounces (170 grams) of nylon and neoprene. The belt's wrap-around configuration enables a close fit, and it supports the lower back, reducing strain and the possibility of injury, the manufacturer says.

The ergonomic design and Velcro closings are said to keep tools closer to the body. Supplementary Dock-It Pockets can be added for carrying additional tools when needed and removed when not required.
