FLIGHT SAFETY FOUNDATION
Aviation Mechanics Bulletin

**Overhaulers' Tips for
Taking the Mystery out of
Aircraft Engine Break-in**

Vol. 43 No. 1

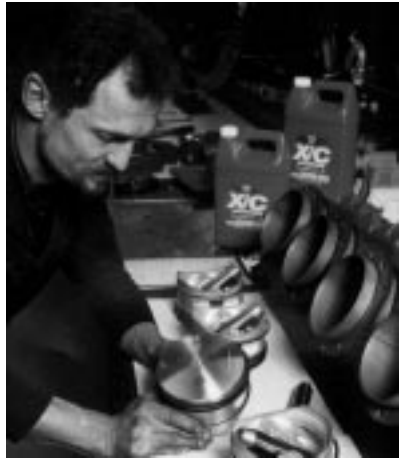
Technician completes final inspection of cylinders, pistons and rings before reassembly of an engine. During break-in, the piston rings seat within the cylinders of new or freshly overhauled engines.

tapered edge. To seat the rings properly, this edge must wear quickly across approximately 10 percent of the ring surface area. During the break-in process, rings exert a tremendous amount of pressure against the cylinder walls. This pressure forces oil away from the ring/cylinder area, allowing the metal-to-metal contact necessary for ring seating. This contact causes temperatures to rise within the cylinder. During break-in, the hottest temperatures within the engine are at the contact point, where it can reach 600 degrees to 650 degrees F (318 degrees to 346 degrees C). At that heat level, the oil film is forced away from the cylinder walls

When the ring edge has worn away and seated, the pressure against the cylinder wall is reduced, allowing for improved lubrication and the return to normal operating temperatures.

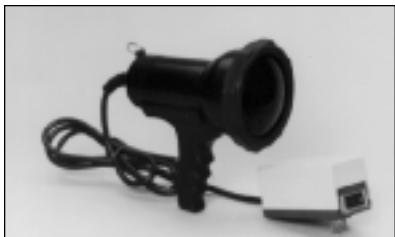
The SSC-100, manufactured by Spectronics Corp., is a solid-state, high-intensity UV lamp.

Inspectors who use an ultraviolet (UV) lamp to perform fluorescent examination are familiar with the bulky and heavy UV lamps normally used. Spectronics Corp. has introduced a compact UV light head which it claims is the smallest and lightest unit available. According to the manufacturer, C-100 and SCC-100 units weigh only 1.75 pounds (0.79 kilogram) and measure only 5.5 inches (14 centimeters) in diameter. Both units produce a steady-state 365-nanometer intensity of 4,000 μW per square centimeter at 15 inches (38.5 centimeters).

The C-100 is powered by a magnetic ballast. The SSC-100 has a solid-state power supply available in 115- or 230-

volt versions or can be operated from an optional battery pack containing a high-frequency inverter and “smart” charger that requires only 3.5 hours to recharge. A 12-volt, 17-amp/hour battery is available separately.

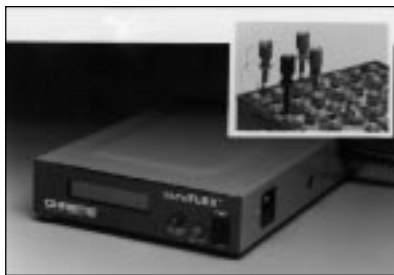
The DataFLEX system from Christie Electric Corp.

Through an optional serial printer, a complete hard-copy report on the battery's performance can be provided.
