FLIGHT SAFETY FOUNDATION  
**Aviation Mechanics Bulletin**

# Fatal Accident Shows Risk of Using Blind Rivets

*In-flight separation of the vertical fin from a Eurocopter BK 117 was accelerated by the use of blind rivets in place of solid rivets during installation of a replacement part.*

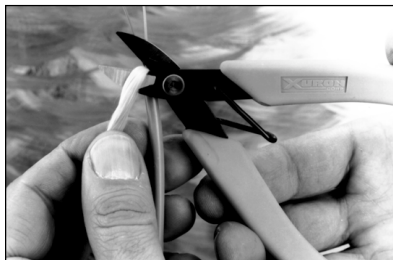
*Kevlar Shear*

The Xuron Model 9180 Kevlar Shear has cushioned rubber grips and a return spring that opens the cutting head after every cut. The shears have a serrated edge to prevent fibers from sliding and a sharp edge for cutting. The shears are designed for use on fiber optic cables and other cable insulations.

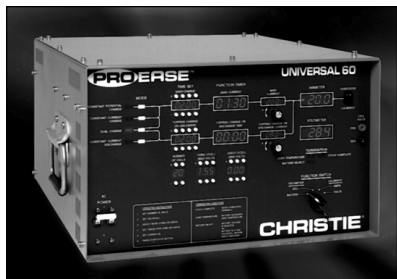
The Universal 60 has digital-current settings, and its design enables the Universal 60 to charge batteries and discharge batteries at specified current settings of up to 60 amperes.

*Universal 60 Battery Charger*

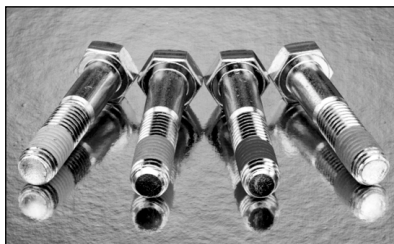
*Precote Screw-locking and  
Thread-sealing Adhesive System*

The chemical adhesive for fasteners can be applied to internal threads or external threads of fasteners or nuts and to thread sizes M4 and larger. The adhesive is available in several grades for thread-sealing and screw-locking under varying conditions.
