FLIGHT SAFETY FOUNDATION  
**Aviation Mechanics Bulletin**

JULY–AUGUST 2001

**Improper Assembly  
Of Trim Actuator  
Causes In-flight  
Separation of Stabilizer**

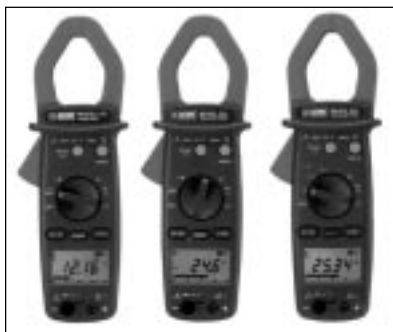
Three AEMC clamp-on meters measure alternating current (AC) amperage to 1,000 amperes, AC and direct current (DC) voltage to 600 volts, ohms, continuity and frequency, said the manufacturer. The clamp-on meters also have a diode-test function.

*Clamp-on Electrical Meters*

The Model 514 provides AC and DC current measurements to 1,000 amperes. The Model 511 provides average sensing; Model 512 and Model 514 provide true RMS (root mean square, which indicates the effective voltage of an AC signal) measurements.

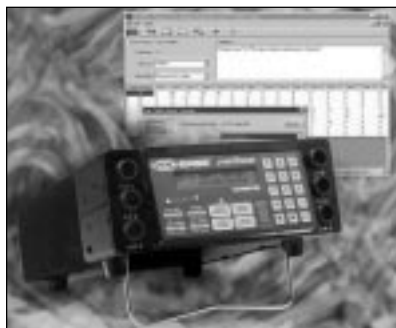
The TD-750 software includes a data-logging system for instant data capture and documentation. The software maintains a record of service tasks performed, eliminating the need for manual documentation, and allows for easy calibration and testing of emergency battery packs, said the manufacturer.

*Battery-maintenance  
System Software*

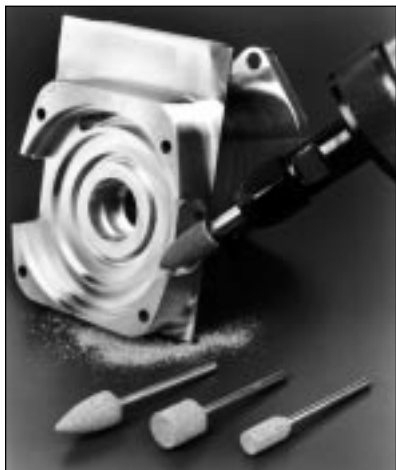
Rex-Cut Mounted Points are available in bullet shapes and cylindrical shapes. Their non-woven cotton fiber and abrasive grains of aluminum oxide or silicon carbide provide smooth, controlled grinding, and

they reveal fresh abrasives as they grind. They are available in very-fine-grain sizes to coarse-grain sizes; in soft bonds, medium bonds or hard bonds; and with shanks of 0.25 inch (6.35 millimeters) and 0.13 inch (3.30 millimeters). They are suitable for titanium, stainless steel and highly alloyed parts, said the manufacturer.

*Mounted Points*
